Air Accidents Investigation Branch

**Report on the incident to
Airbus A320-214, registration G-BXKD
at Runway 09, Bristol Airport
on 15 November 2006**

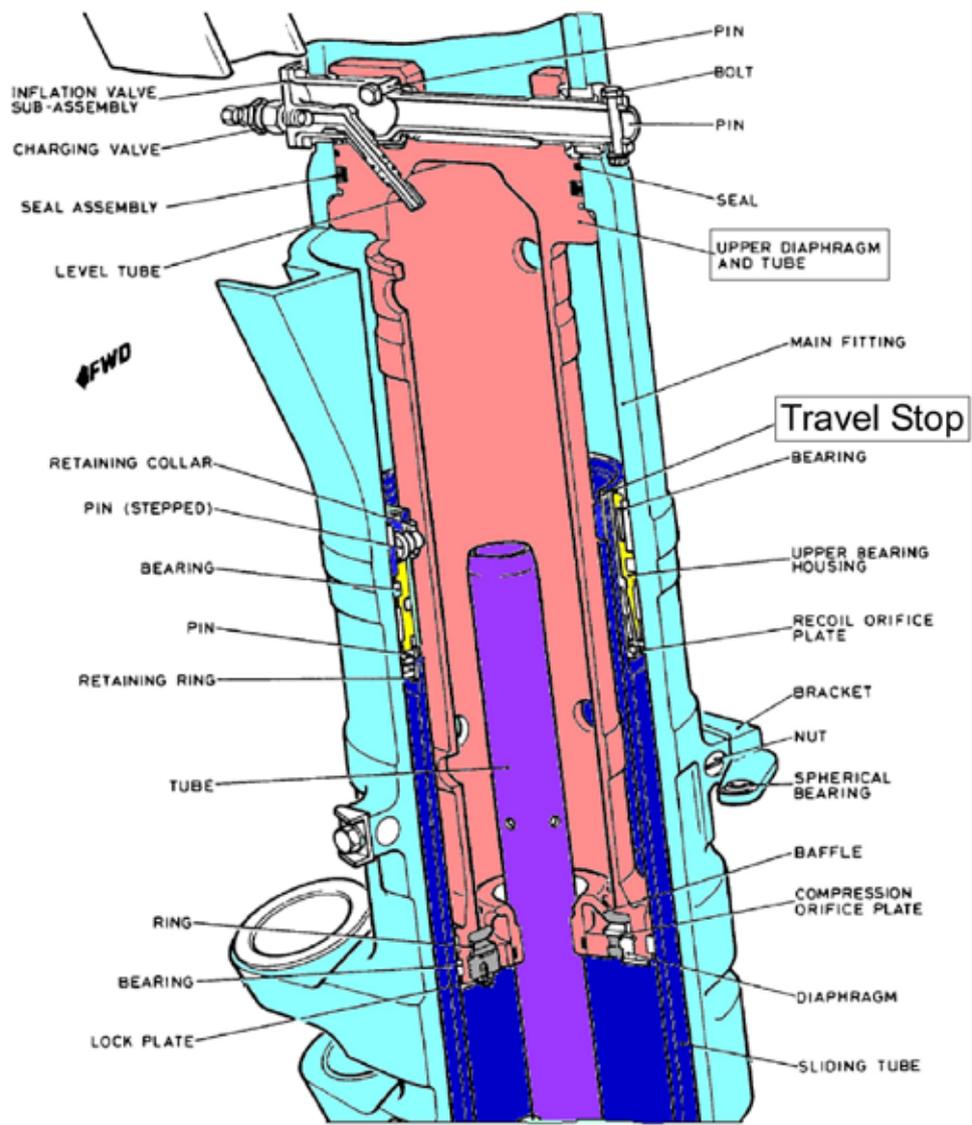
Figure 2

upper end. This pin also contains the charging valve for the first stage chamber. The upper diaphragm tube is fixed, but the sliding tube moves vertically between the tube and the main fitting. The sliding tube has travel stops that engage with the bottom of the upper diaphragm tube, preventing the sliding tube from extending beyond the bottom of the tube during an extension, as depicted in Figure 2.

Upper section of the main landing gear

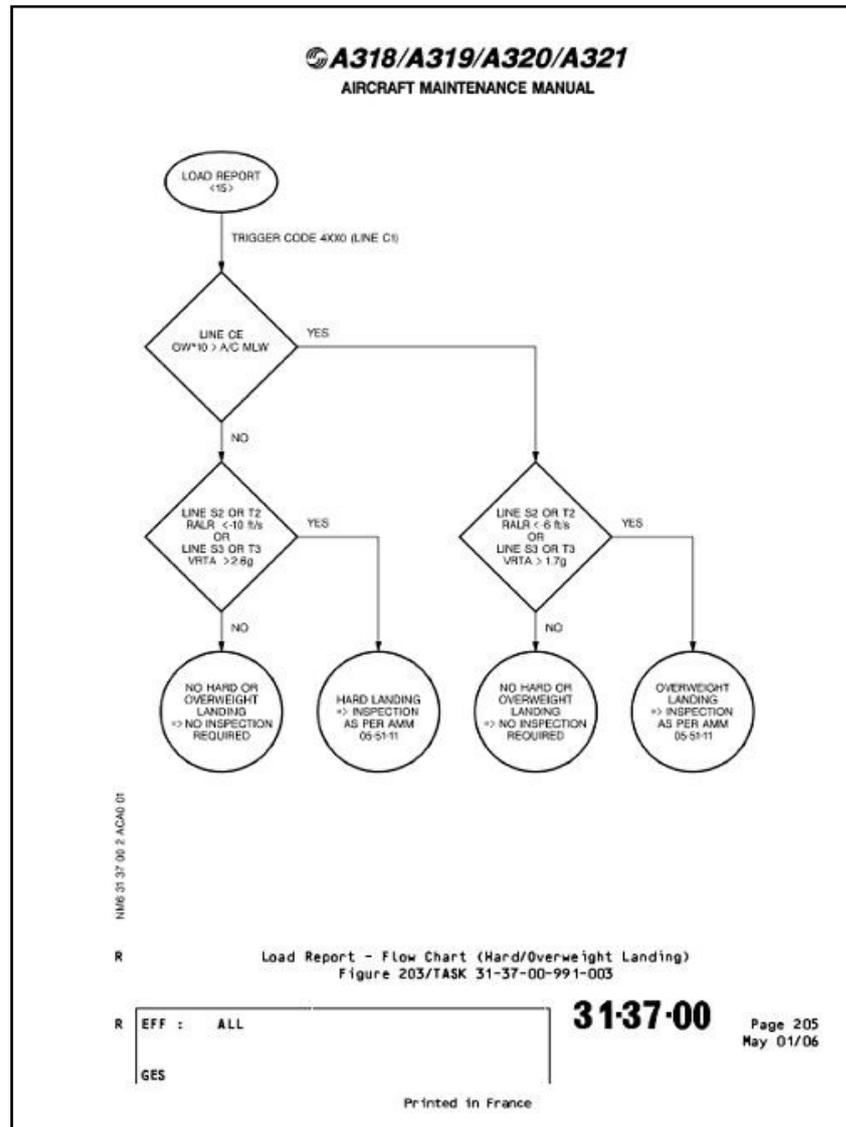
Figure 6

When a LOAD <15> report is generated it is in the format as shown in Appendix A; the report requires interpretation by the ground engineer with reference to the maintenance manual. The section that deals with the LOAD <15> report is 'MM 31-37-51 AIDS – STRUCTURE REPORTS – DESCRIPTION AND OPERATION'. This part of the manual provides a description of each of the parameters produced by the report. Having interpreted the report, reference is then made to 'MM 31-37-00 page 201 AIDS INPUT INTERFACE ((FDIMU)) - MAINTENANCE PRACTICES'. This provides instructions on how to read the LOAD <15> report and to determine what action is required. Figure 203 of this procedure contains a flow chart, giving required actions depending on the information on the LOAD <15> report (see Figure 6). For the case involving G-BXKD the flow chart ends in 'HARD LANDING => INSPECTION AS PER AMM 05-51-11'.

LOAD <15> report flow chart

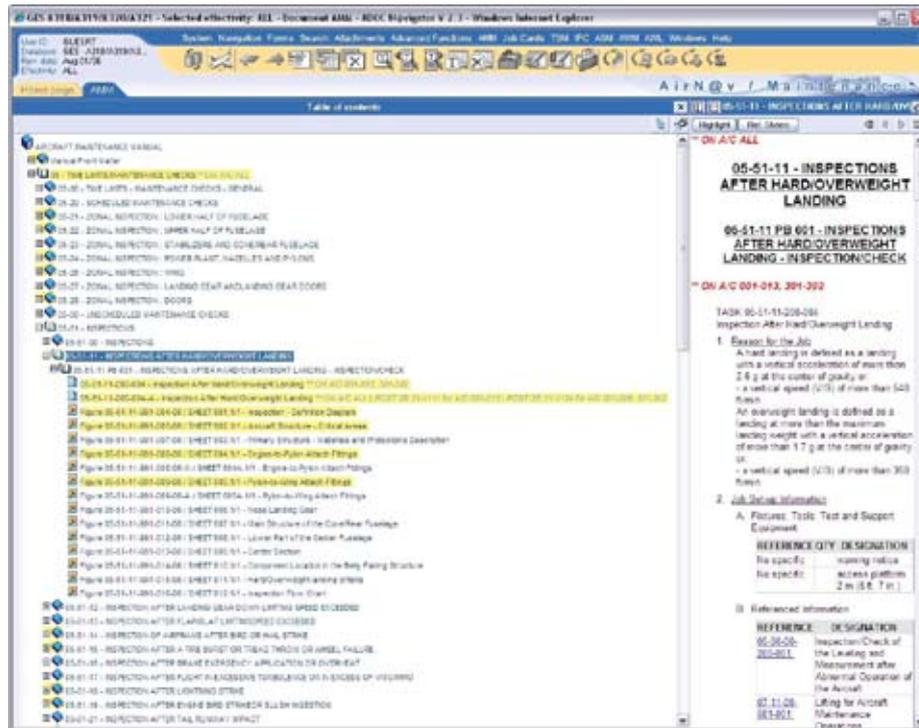
Figure 10

The '+' to the side of the check shows that there are more sections to the task. Fully expanding the menu shows that there are two checks '05-51-11-200-004' and '05-51-11-200-004A', each with an effectivity shown by the side of the text, as shown in Figure 10.

Fully expanded list of contents on AirN@V

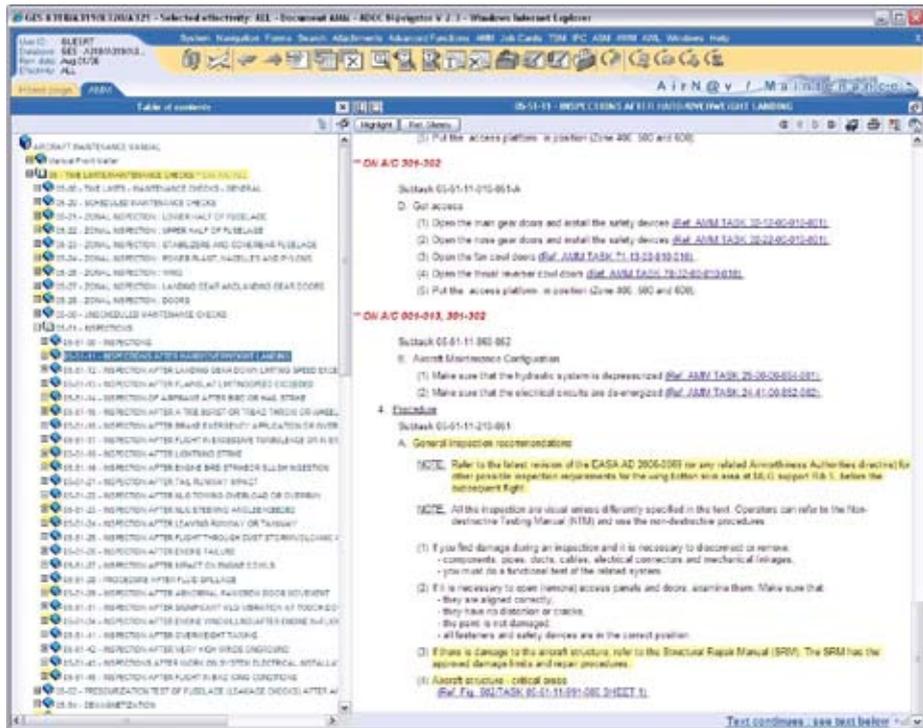
Figure 11

If the engineer wishes to scroll through a check, it is not a simple case of using the mouse scroll button or the side bar. At the bottom of a small section of text the following appears:

'TEXT CONTINUES – SEE TEXT BELOW'.

This line must then be selected before the next section of text appears. Also, figures do not appear in the right pane as they would in the paper manual. To view the images they have to be selected either using the hot link on the right pane or by using the table of contents: see Figure 11.

Screen shot of AirN@V showing ‘text continues...’
