BULLETIN RE-ISSUED

INCIDENT

Aircraft Type and Registration:	Airbus A319-131, G-DBCI
No & Type of Engines:	2 International Aero Engines V2522-A5 turbofan engines
Year of Manufacture:	2006
Date & Time (UTC):	18 April 2007 at 0944 hrs
Location:	Amsterdam Schiphol Airport, The Netherlands
Type of Flight:	Commercial Air Transport (Passenger)
Persons on Board:	Crew - 5 Passengers - 112
Injuries:	Crew - None Passengers - None
Nature of Damage:	None
Commander's Licence:	Airline Transport Pilot's Licence
Commander's Age:	53 years
Commander's Flying Experience:	11,123 hours (of which 3,493 were on type) Last 90 days - 132 hours Last 28 days - 44 hours
Information Source:	AAIB Field Investigation

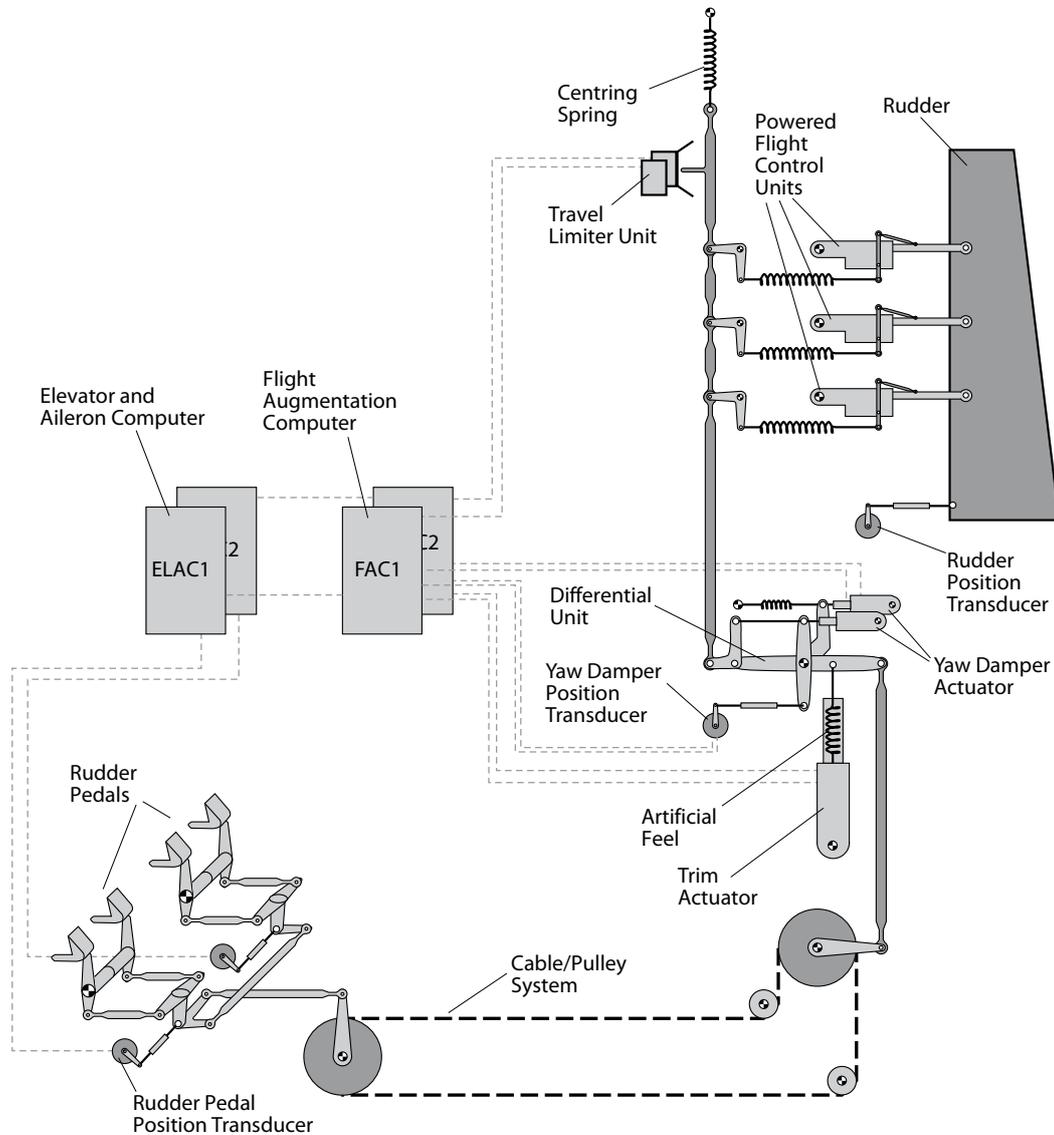
Figure 1
A319 Rudder Control System Schematic

The rudder is controlled by three hydraulic Powered Flight Control Units (PFCUs) in the fin, each fed from a different hydraulic system and signalled mechanically (Figure 1). A transducer mechanically linked to the rudder surface provides rudder position signals. Commands from the pilots' rudder pedals are

transmitted by a cable-pulley system to a mechanical differential unit in the fin and thence to the PFCUs via a rod and bellcrank system. The input to each PFCU is in the form of a spring-centred rod that allows continued rudder operation in the event of one of the PFCUs ceasing to function. The two pairs of rudder pedals are mechanically linked and do not have a separation facility. Each pair of pedals drives a transducer which supplies pedal position information to the respective Elevator and Aileron Computer (ELAC) and thence to the respective Flight Augmentation Computer (FAC).

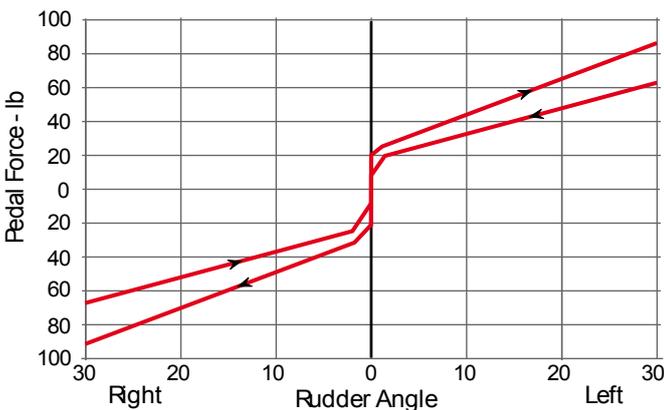
Figure 2

Artificial feel for the pedals is generated by a feel spring acting on the mechanical input system in the fin. A centring spring also acts on the input mechanism for the upper two PFCUs to prevent rudder runaway in the event of disconnection of the input system. The arrangement provides a constant pedal force/displacement characteristic irrespective of the flight conditions. Pedal force/deflection characteristics for the A319 are shown in Figure 2.

A319 Normal Rudder Pedal Force vs Rudder Deflection
