Cessna 310J, N1158V

AAIB Bulletin No: 9/2003	Ref: EW/C2003/04/01	Category: 1.2
Aircraft Type and Registration:	Cessna 310J, N1158V	
No & Type of Engines:	2 Continental IO-470U piston engines	
Year of Manufacture:	1965	
Date & Time (UTC):	7 April 2003 at 1815 hrs	
Location:	In a field close to Sandtoft Airfield, Humberside	
Type of Flight:	Private	
Persons on Board:	Crew - 1	Passengers - None
Injuries:	Crew - 1 (Fatal)	Passengers - N/A
Nature of Damage:	Aircraft destroyed	
Commander's Licence:	United Kingdom Private Pilot's Licence	
Commander's Age:	59 years	
Commander's Flying Experience:	302 hours (of which 84 hours were on type)	
	Last 90 days - 6.5 hours	
	Last 28 days - 5.5 hours	
Information Source:	AAIB Field Investigation

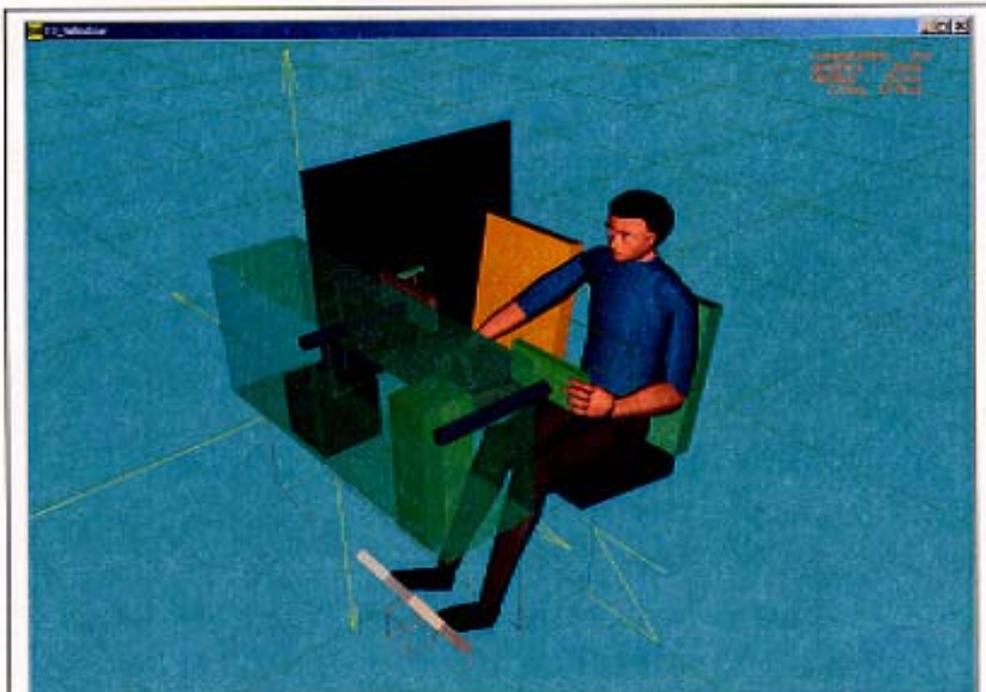
Figure 2: The pilot in the normal seating position left hand on the control yoke, right hand on the throttles and both feet on the rudder pedals.

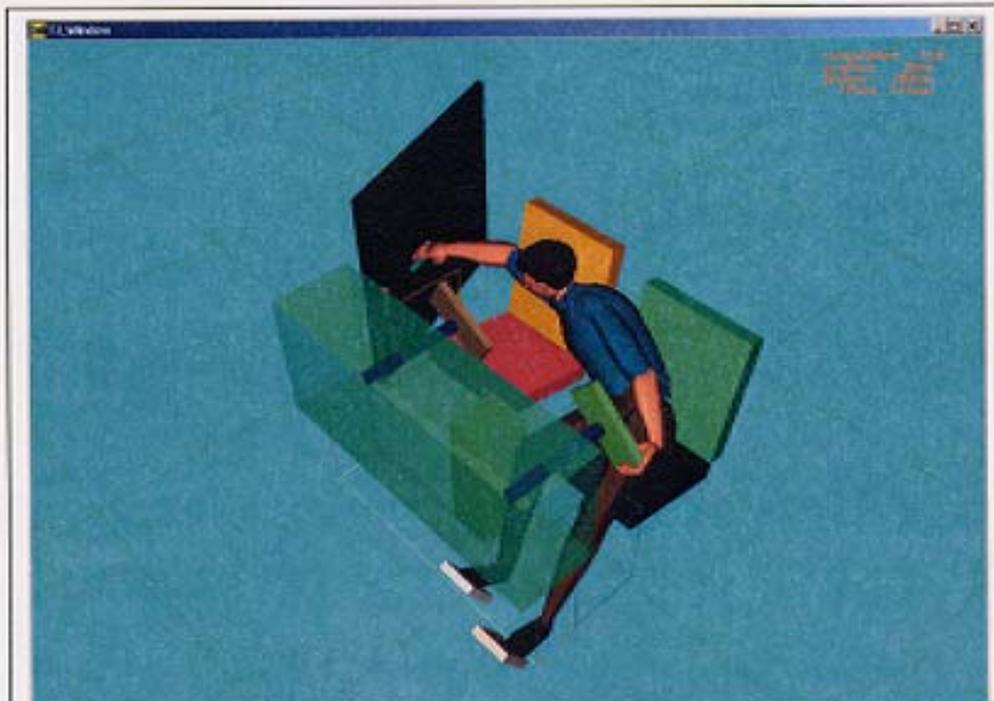
Figure 3: When the pilot reaches across the cockpit and pushes the door into the airflow, his left leg moves to the left with the result the left pedal goes forward. The left hand moves the control yoke down on the left side. This combination of control inputs probably caused the rapid roll to the left.

aircraft. If a conscious effort was being made to keep his feet on the rudder pedals, then this could have been translated into forward movement of the left rudder pedal, causing the rapid roll to the left. This effect would increase if the door was pushed into the airflow in order to allow it to be slammed. The scenario is illustrated at Figure 3, and this position is similar to that of the pilot as found in the wreckage.

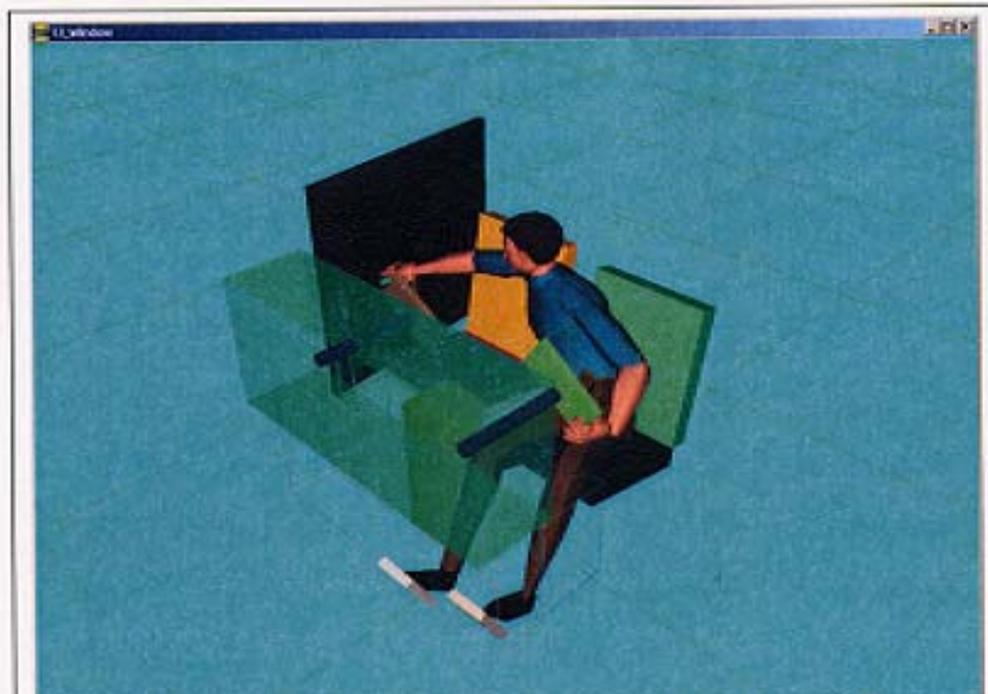
Figure 4: The pilot when pulling the door closed transfers his weight to the right foot, which causes the right rudder pedal to move forward.

The study also showed that when the door was pulled shut the tendency was for the left leg to relax its pressure, which was then transferred to the right foot. This had the potential of applying a force to the right rudder pedal, with the attendant possibility of causing the aircraft to roll to the right. The apparently normal rate of roll seen to return the aircraft to wings level, before the right wing dropped, was considered to be either such an application of right rudder when pulling the door closed, as shown in Figure 4, or AP driven, if engaged. At this stage the pilot would have had no external visual references. With reduced power on the engines, to limit the airspeed, and the aircraft manoeuvring in the manner indicated in the nose high attitude described by a witness, it is quite likely that the aircraft could stall and drop the right wing, as seen by the witnesses.
