INCIDENT

Aircraft Type and Registration:	Boeing 737-528, G-GFFE	
No & Type of Engines:	2 CFM56-3C1 turbofan engines	
Year of Manufacture:	1995	
Date & Time (UTC):	3 September 2005 at 0920 hrs	
Location:	Stand 110, North Terminal, London Gatwick Airport	
Type of Flight:	Public Transport (Passenger)	
Persons on Board:	Crew - 6	Passengers - None
Injuries:	Crew - None	Passengers - N/A
Nature of Damage:	APU failure with extensive axial ejection of turbine debris	
Commander's Licence:	Airline Transport Pilot's Licence	
Commander's Age:	Not known	
Commander's Flying Experience:	18,500 hours (of which 9,400 were on type)	
Information Source:	AAIB Field Investigation

Synopsis

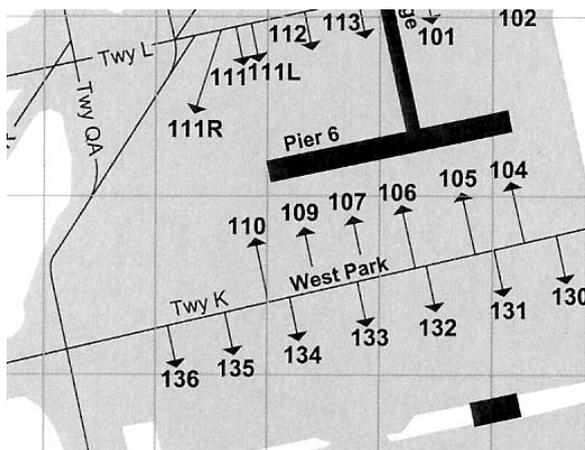
Figure 1

The aircraft was parked on Stand 110 adjacent to Pier 6 facing in a northerly direction. Immediately to the south of the stand was Taxiway K and beyond that were Stands 134 and 135 upon which aircraft are parked facing in a southerly direction. The orientation of the stands is shown in Figure 1.

Orientation of Stands
