**INCIDENT**

| <b>Aircraft Type and Registration:</b> | Airbus A310-222, F-OHPE |
| <b>Date &amp; Time (UTC):</b> | 9 July 1995 at 0118 hrs |
| <b>Location:</b> | On departure from Glasgow Airport |

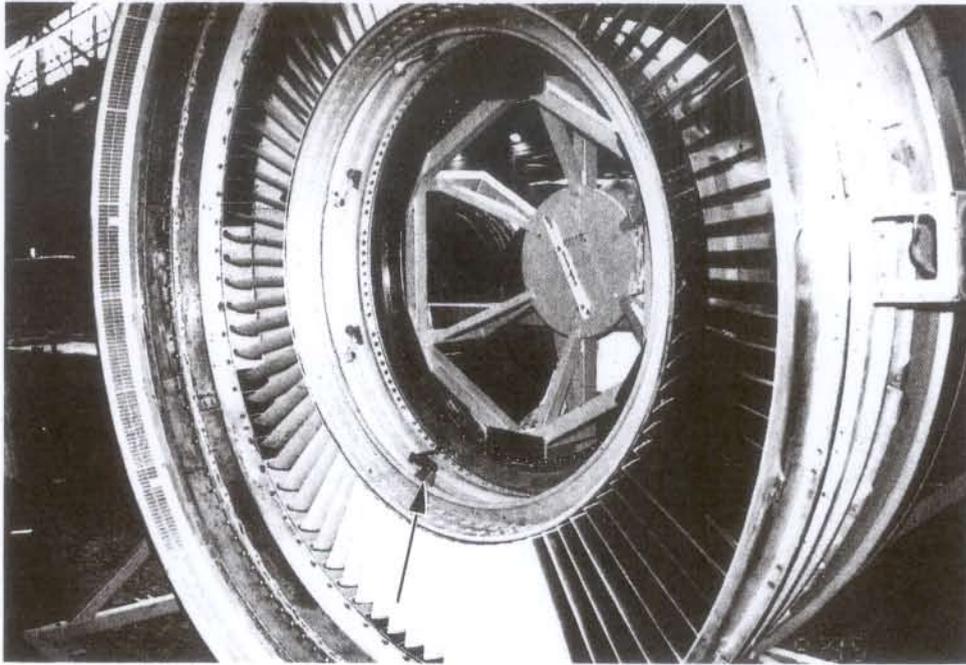
The engine was subsequently stripped at an engine overhaul facility in Brussels, and a summary of the findings was later presented to the AAIB. It was established that 3.0 bleed ring had become detached from the actuating linkage due to a failure of a clevis bolt in the bellcrank that attached to the actuator rod. The position of the failure is indicated on the accompanying diagram and photographs. The bolt tail and clevis pad were found in the compressor casing, and it was apparent that the fracture face consisted of approximately 90% fatigue, the remainder being overload. Following the migration of the top portion of the bolt out of its location, the bellcrank would have become disconnected from the clevis. The detached portion of the bolt presumably fell into the bleed annulus and was ingested into the high pressure compressor. Severe damage was caused to the blades and vanes. It was subsequently discovered that the powerplant engineers had not boroscoped this part of the engine at Glasgow. Following the discovery of the broken feedback cable (a failure that they had seen on previous occasions) they had merely wished to check the turbine for evidence of overheat damage. The maintenance organisation's report did not give a reason for the fatigue failure. However, some wear was evident on the shank of the remaining portion of the bolt. The report also noted evidence of wear elsewhere in the actuating linkage.

VIEW OF DIASSEMBLED FAN CASE AND 3.0 BLEED RING ON SIMILAR ENGINE
