## Dornier 328-100, G-BWIR

<b>AAIB Bulletin No: 3/2004</b>	<b>Ref: EW/C2002/03/06</b>	<b>Category: 1.1</b>
<b>Aircraft Type and Registration:</b>	Dornier 328-100, G-BWIR	
<b>No &amp; Type of Engines:</b>	2 Pratt & Whitney PW-119B turboprop engines	
<b>Year of Manufacture:</b>	1995	
<b>Date &amp; Time (UTC):</b>	6 March 2002 at 2046 hrs	
<b>Location:</b>	Runway 24, Edinburgh Airport, Scotland	
<b>Type of Flight:</b>	Public Transport	
<b>Persons on Board:</b>	Crew - 4	Passengers - 16
<b>Injuries:</b>	Crew - None	Passengers - None
<b>Nature of Damage:</b>	Damage to forward door attachment and restraint mechanism. Consequent dent in fuselage skin	
<b>Commander's Licence:</b>	Airline Transport Pilot's Licence	
<b>Commander's Age:</b>	50 years	
<b>Commander's Flying Experience:</b>	3,100 hours (of which 1,000 hours were on type)	
	Last 90 days - 80 hours	
	Last 28 days - 24 hours	
<b>Information Source:</b>	AAIB Field Investigation

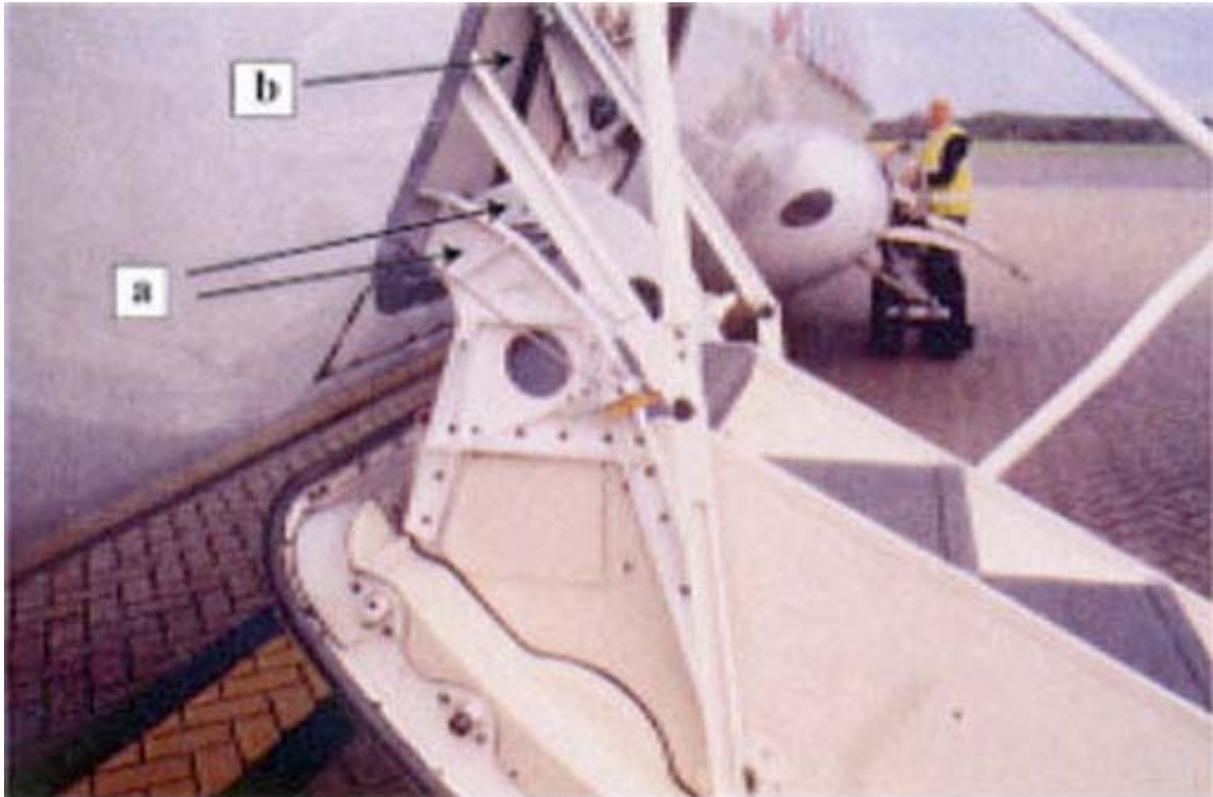
**Figure 4**  
Undamaged example of door fully open,  
showing hinge arms (a)  
attaching air-stairs to cabin floor.  
Damper strut (b) visible within vestibule.

A system of banister rails enables the fully deployed airstairs, and hence the door, to be pulled towards the closed position from within the aircraft. It operates in conjunction with the springs within the door mechanism. Damping struts form part of the banister geometry, as shown in Figure 4 (b). This combination controls the rate of movement in both the opening and closing directions. The banister geometry forms the limit stop of deployment of the stairs and door in the open direction.

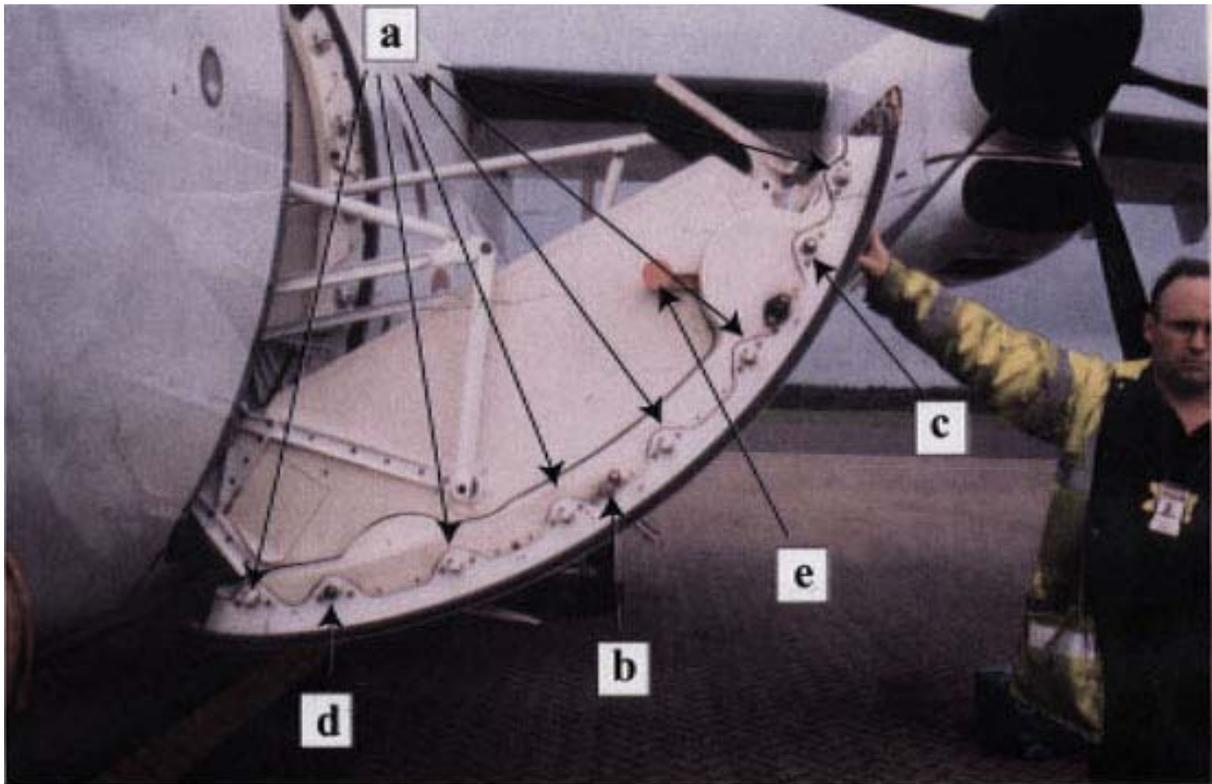
**Figure 6**  
Undamaged example of door partly open.  
Six adjustable stops (a), crank (b),  
upper roller (c), lower roller (d)  
and handle (e) in open position

A striker plate is mounted on the forward edge member of the door aperture. This operates in conjunction with a crank projecting from the forward edge member of the door, depicted at Figure 6 (b). The crank is operated by the door mechanism and prevents the latter from completing its movement should the door not be correctly aligned for closure. Correct alignment requires the door to be positioned with the rollers located in their tracks and the adjustable stops positioned to pass downwards behind the fixed abutments. Thus, the final phase of door movement to the fully closed

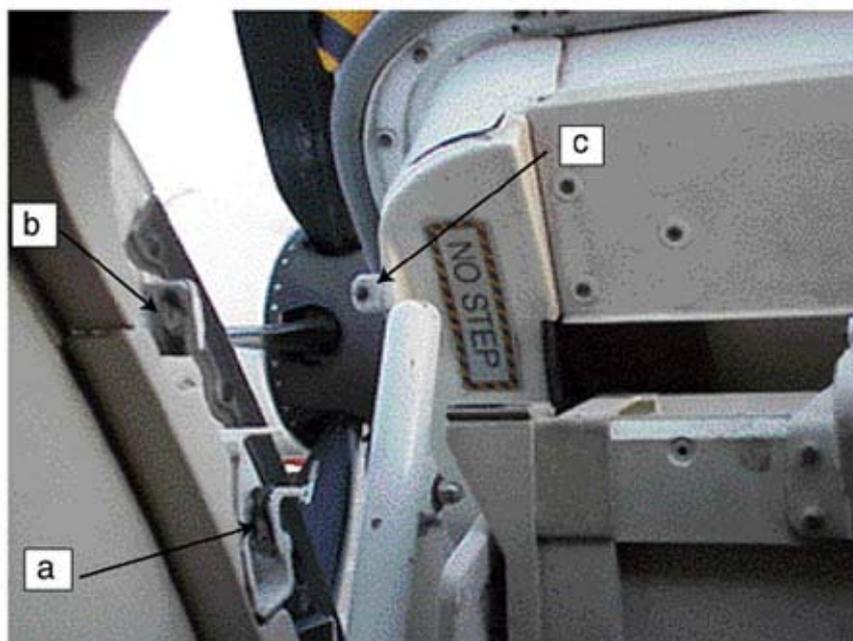
Figure 7

Each roller engages in a corresponding fixed track mounted at a matching position on the adjacent edge member of the door aperture. The lower tracks are straight and orientated approximately vertically. The upper tracks each incorporate an acute angle turn, allowing the rollers to enter horizontally before changing direction to descend approximately parallel to the local skin contour, as shown at Figure 7(a).

Aft edge of opening door, as upper roller (not visible) moves clear of fixed upper aft track (a) on door aperture. Top fixed abutment (b) visible on aperture above fixed track. Adjustable stop (c) visible on door edge member

When fully closed, the six adjustable stops on each of the door edge members fit behind, and react against, six corresponding fixed abutments mounted on each of the edge members of the door aperture. An abutment (b) and a stop (c) are visible in Figure 7. Pressurisation forces on the door cause the stops to bear firmly against the fixed abutments and force the upper pair of rollers firmly into recesses at the lower end of available travel in the upper pair of roller tracks.
