## BAe 146-200, G-JEAX

| <b>AAIB Bulletin No: 2/2004</b> | <b>Ref: EW/C2002/12/02/03</b> | <b>Category: 1.1</b> |

### Synopsis

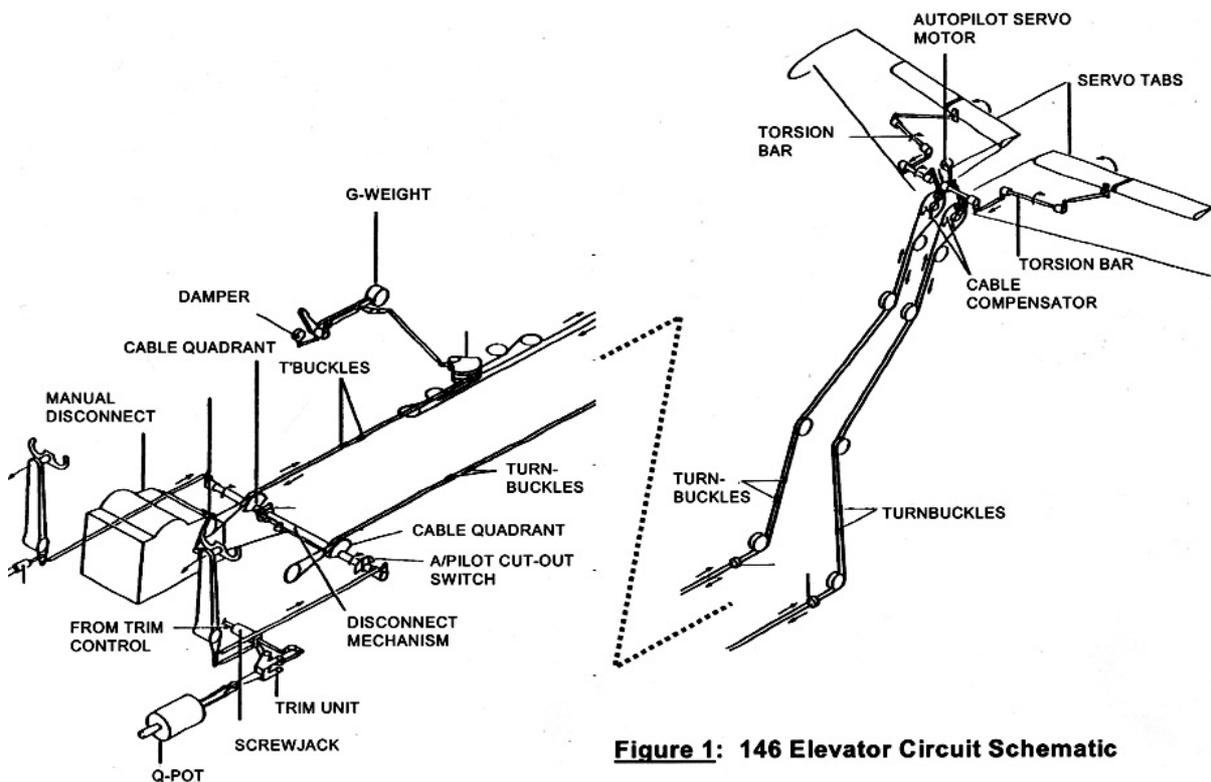
**Figure 1: 146 Elevator Circuit Schematic**

The BAe/Avro 146/RJ series aircraft possess manually operated elevators with mechanical control circuits which operate the left and right elevators independently (see Figure 1). Control column inputs are transmitted via cables, pulleys and rods to a servo tab mounted on each elevator, which provides aerodynamic force to move the elevator. Torsion bars on the inputs to the tabs limit the aerodynamic forces that can be applied to the tabs. If sufficient control force is applied, the torsion bars will contact stops and the control columns will then move the elevators directly, with significantly higher control forces required. A mechanical elevator feel system provides artificial feel which helps prevent excessive control deflection at high speed.

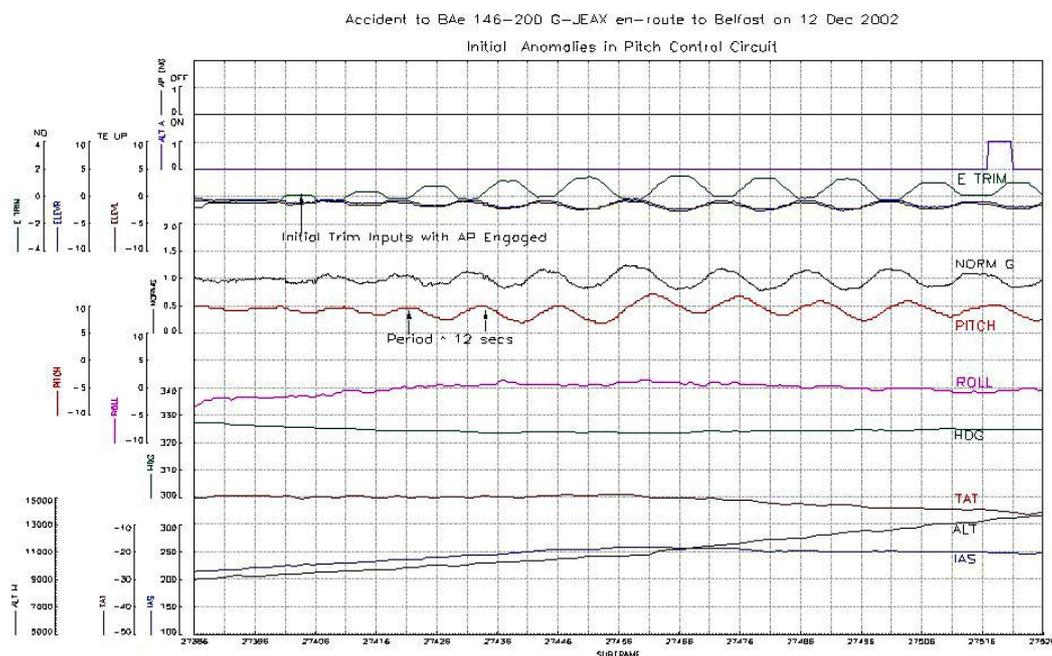
A time history of the relevant parameters during the climb to FL140 is shown in Figure 2. The 'E TRIM' parameter indicates the elevator trim tab position. It can be seen that, with the autopilot engaged, the elevator trim started to provide trim inputs to the pitch control system on a 12 to 15 second cycle beginning at about FL90. The elevators appeared to respond correctly to the applied trim, and the aircraft also responded in the conventional sense, describing a 'phugoid' motion also of period 12 to 15 seconds.

The Total Air Temperature (TAT) at which the trim started to operate was about +1° C. At the prevailing flight conditions, this equates to an Outside Air Temperature (OAT) of about minus 8° C. The cyclic trim inputs appear to be present throughout those climb phases where the autopilot was engaged, but not when the autopilot was disengaged.

The data depicted in Figure 2 show a 12 to 15 second period oscillation in pitch. This phenomenon is discussed in the next paragraph entitled 'Aircraft pitch response'.
