**INCIDENT**

<b>Aircraft Type and Registration:</b>	Piper PA-28-181 Cherokee Archer II, G-BNGT	
<b>No &amp; Type of Engines:</b>	1 Lycoming O-360-A4M piston engine	
<b>Year of Manufacture:</b>	1985	
<b>Date &amp; Time (UTC):</b>	17 December 2005 at 1130 hrs	
<b>Location:</b>	Edinburgh Airport	
<b>Type of Flight:</b>	Private	
<b>Persons on Board:</b>	Crew - 2	Passengers - 1
<b>Injuries:</b>	Crew - None	Passengers - None
<b>Nature of Damage:</b>	Damage to nose landing gear assembly and propeller tips	
<b>Commander's Licence:</b>	Commercial Pilot's Licence	
<b>Commander's Age:</b>	53 years	
<b>Commander's Flying Experience:</b>	5,729 hours (of which 1615 were on type) Last 90 days - 39 hours Last 28 days - 12 hours	
<b>Information Source:</b>	Aircraft Accident Report Form submitted by the pilot and metallurgical examination of components returned to the AAIB

**Synopsis**

Prior to takeoff the aircraft suffered a nose landing gear collapse. Stress corrosion was identified in the failed component.

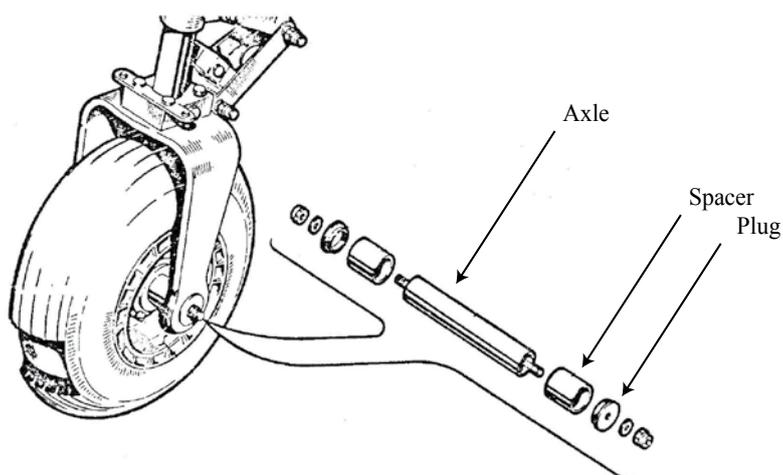
**Figure 1**

This contains a through-bolt, a spacer and an axle plug on each end, which are fastened with a washer and nut (see Figure 1). The aircraft maintenance manual contains information for the assembly and installation of the nose wheel. It states '*tighten nuts until no side play is felt (allow wheel to rotate freely)*'. It is necessary to remove the axle rod assembly whenever the wheel is removed.

PA-28-181 Nose wheel axle assembly
