ACCIDENT

Aircraft Type and Registration:	McDonnell Douglas Helicopters Hughes 369E, G-KSWI	
No & Type of Engines:	1 Rolls Royce Allison C250-C20B turboshaft engine	
Year of Manufacture:	1986	
Date & Time (UTC):	19 June 2011 at 1317 hrs	
Location:	Glastonbury, Somerset	
Type of Flight:	Private	
Persons on Board:	Crew - 1	Passengers - None
Injuries:	Crew - 1 (Serious)	Passengers - N/A
Nature of Damage:	The aircraft was destroyed	
Commander's Licence:	Private Pilot's Licence	
Commander's Age:	57 years	
Commander's Flying Experience:	730 hours (of which 720 were on type) Last 90 days - 20 hours Last 28 days - 10 hours	
Information Source:	AAIB Field Investigation

Synopsis

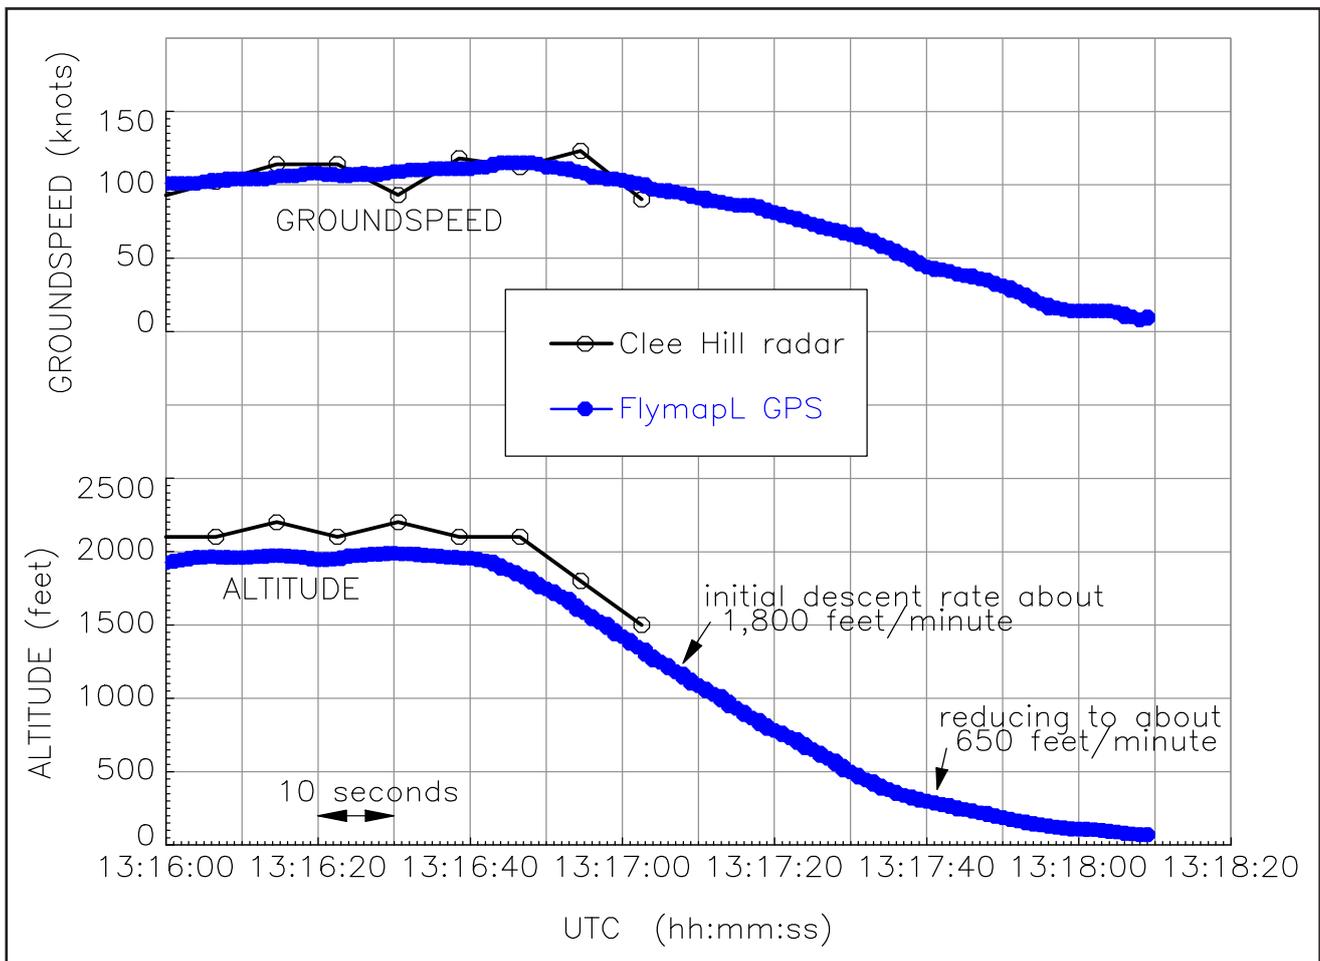
that exceeds a user defined groundspeed, which in this case was set to 40 kt¹. Data was successfully recovered for the accident flight, together with a number of previous flights. Radar data was also recovered from the Clee Hill radar head, positioned about 70 nm to the north of the accident track; however, coverage was lost as the helicopter descended below 1,500 ft when line-of-sight contact was lost. Figure 1 compares the GPS and radar recorded data for the last two minutes of

the flight. The radar groundspeed is an average speed based on the straight-line distance covered between each consecutive radar contact, every eight seconds, and the radar pressure altitude is based on 1013 mb with ±50 ft accuracy.

Figure 1
Recorded GPS and radar data for the final descent

Approximately 90 seconds before the end of the log, the helicopter started to descend. The first part of the descent lasted about 50 seconds and the rate of descent (ROD) averaged about 1,800 ft/minute, during which G-KSWI decelerated from 110 kt to approximately 60 kt groundspeed. During the final part of the descent, the ROD averaged about 650 ft/minute with the groundspeed reducing to below 30 kt 18 seconds before the last logged point. During the last three seconds of the log, the groundspeed reduced from 10 kt to 8 kt, before increasing to a final value of 10 kt. Figures 2 and 3 show the final part of the aircraft's GPS track to the accident site.

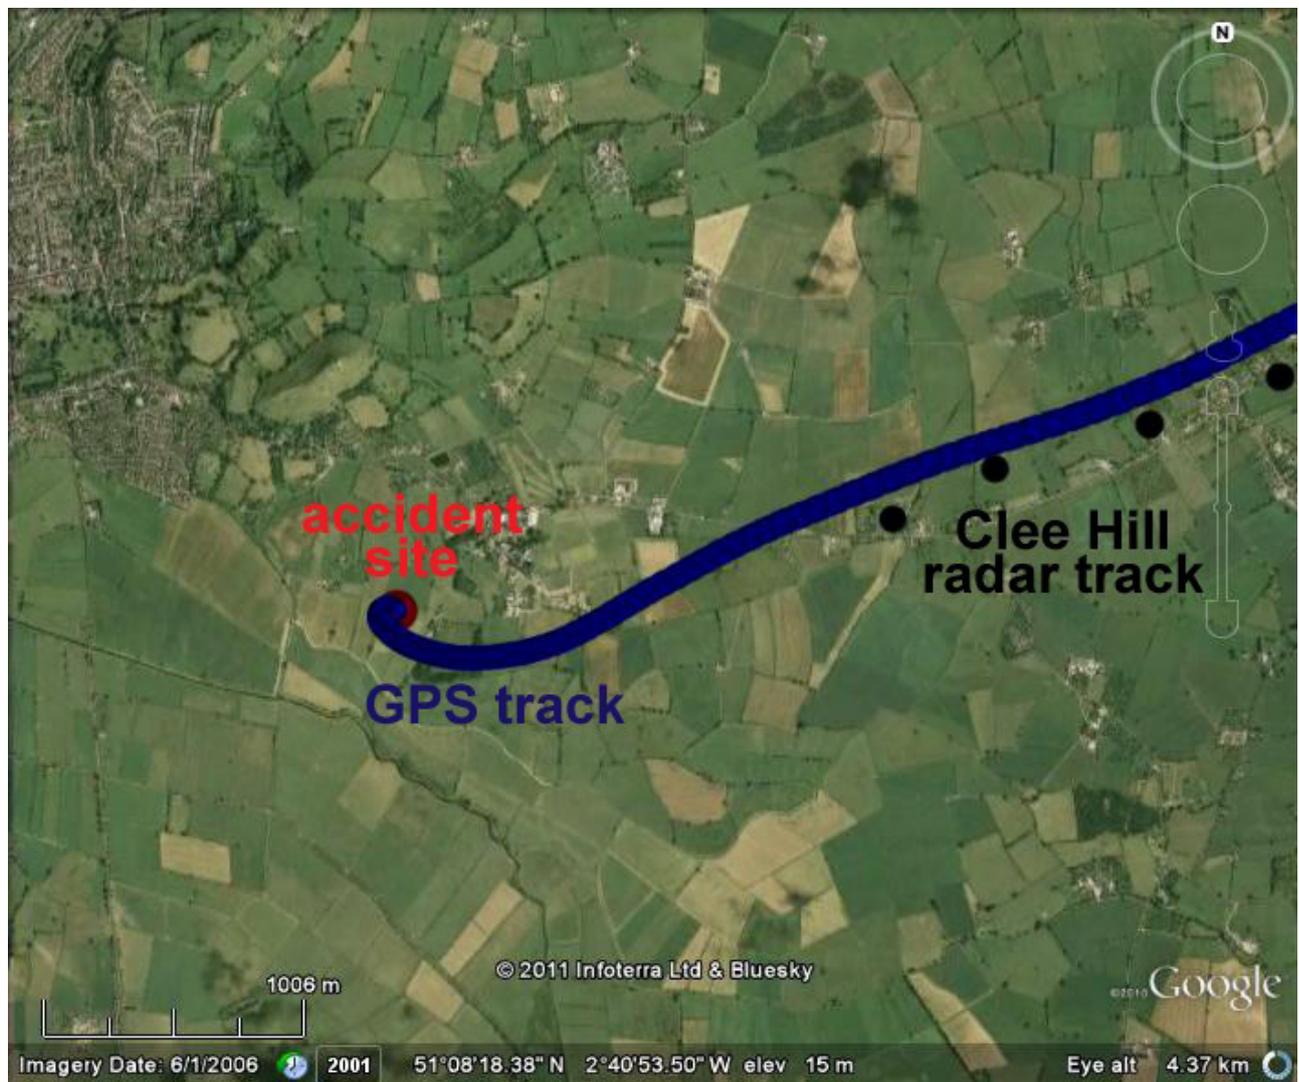
Figure 2

Radar and GPS tracks for the last 90 seconds of flight

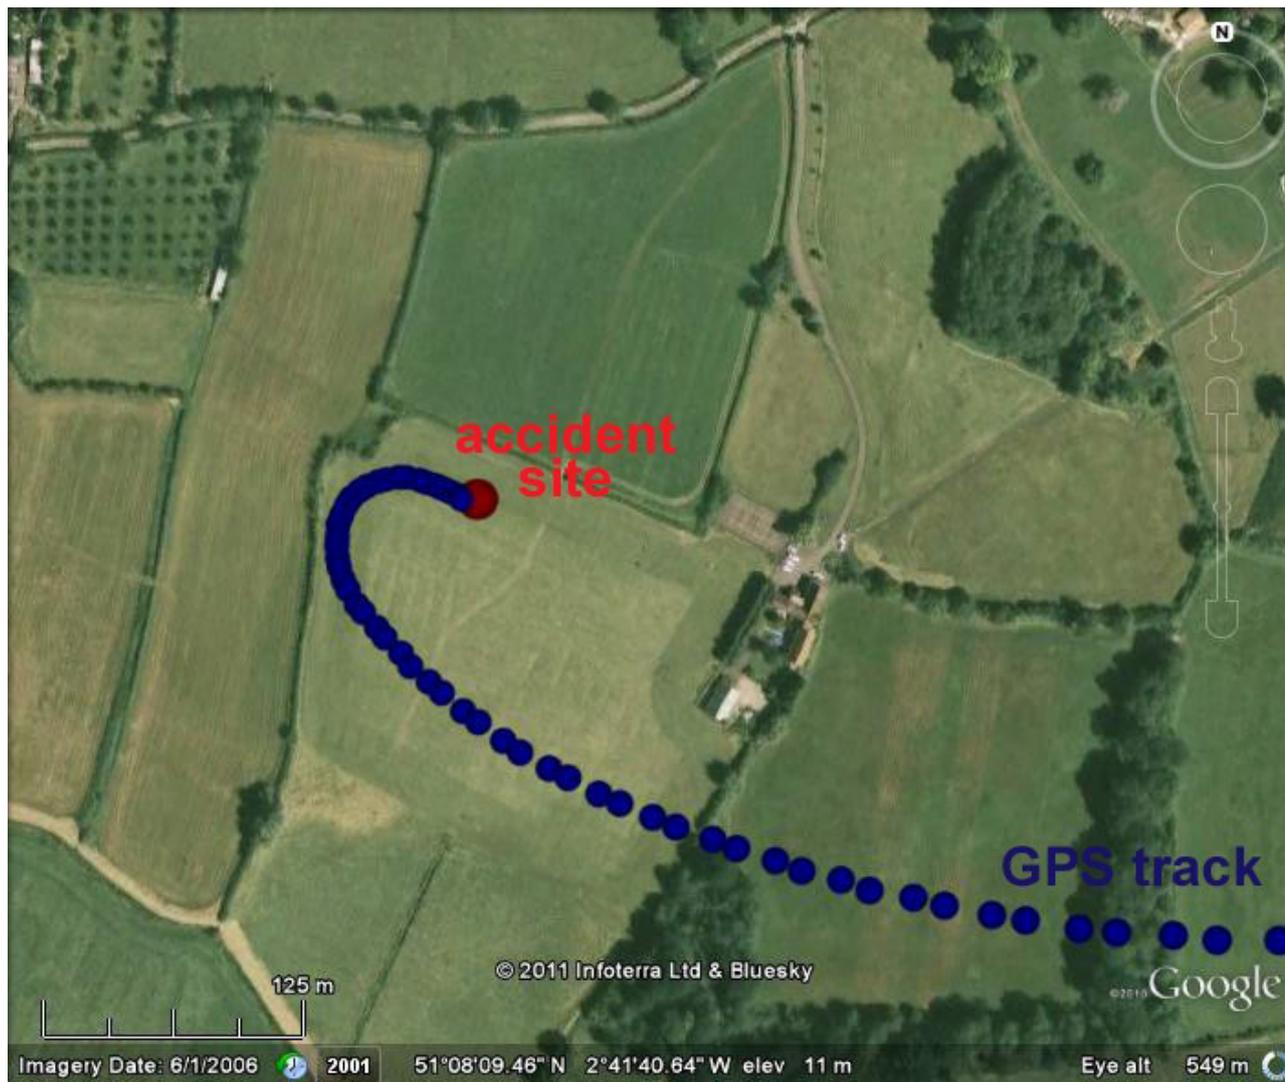
Figure 3

A teacher was playing with her young children on a school tennis court (see Figure 3) when she heard the noise of a helicopter, which was descending towards her house 40 m away. She reported that the helicopter flew at low level, almost over her house,

GPS track for the last 35 seconds of flight

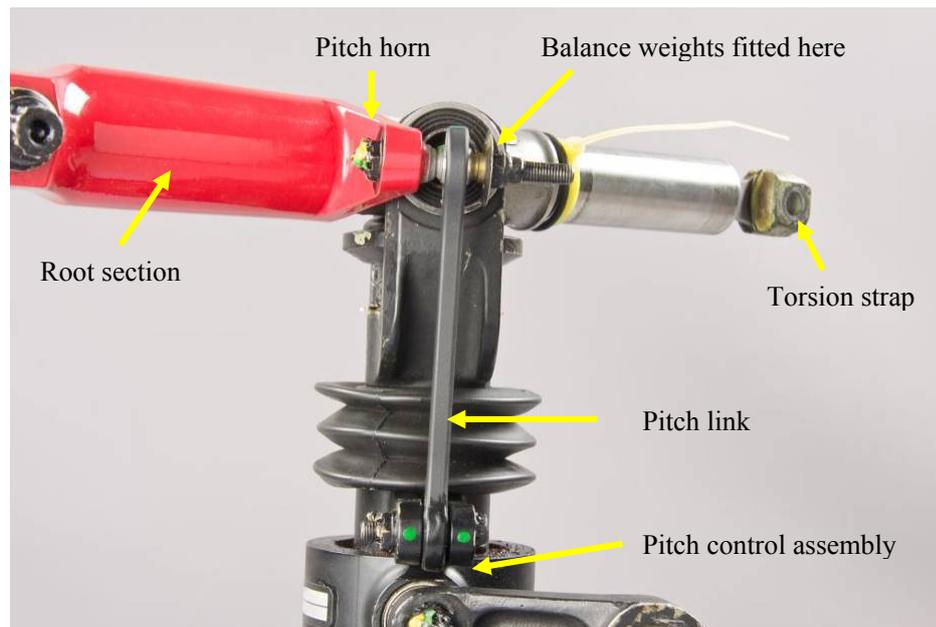
Figure 6

root section that incorporates a pitch horn. A pitch link connects the pitch horn to the pitch control assembly which, in turn, is connected through the control system to the pedals in the cockpit. In the event of a disconnect in the tail rotor control system, the torsion strap will rotate the blade to a preset pitch. The rotor assembly is balanced by weights which can be attached to either the tip of the aerofoil section of the blade or the bolt which secures the pitch link to the pitch horn. (See Figure 6.)

The tail rotor blades fitted to the accident aircraft were identified with colour markings as being either the 'green' or 'blue' blade. While both blades were produced by the same manufacturer, they were of slightly different design with the 'blue' blade incorporating a pocket in the pitch horn.

Significant features on the tail rotor assembly

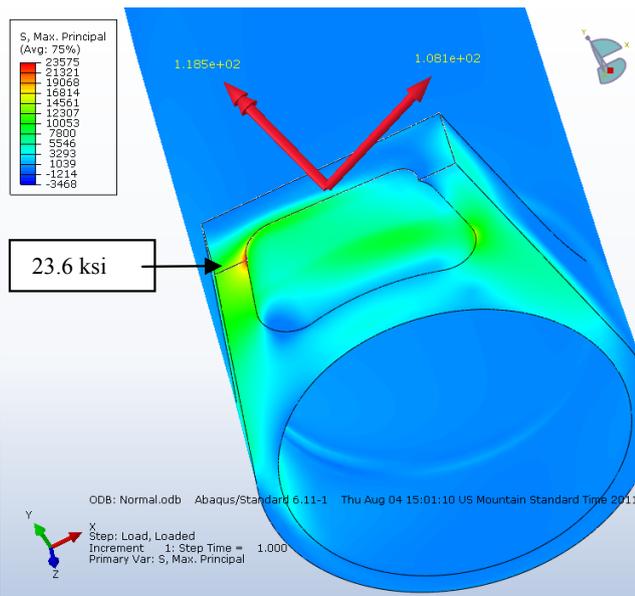
For the normal maximum loading condition, Figure 16a shows that the maximum stress occurs in the outboard upper corner of the pocket. As the pitch link loads are reversible, the maximum stress would be mirrored. In Figure 16b it can be seen that, for the failed pitch link condition, the maximum stress occurs at all four corners of the pocket with the highest stress at the inboard corners.

Maximum stress - normal loading

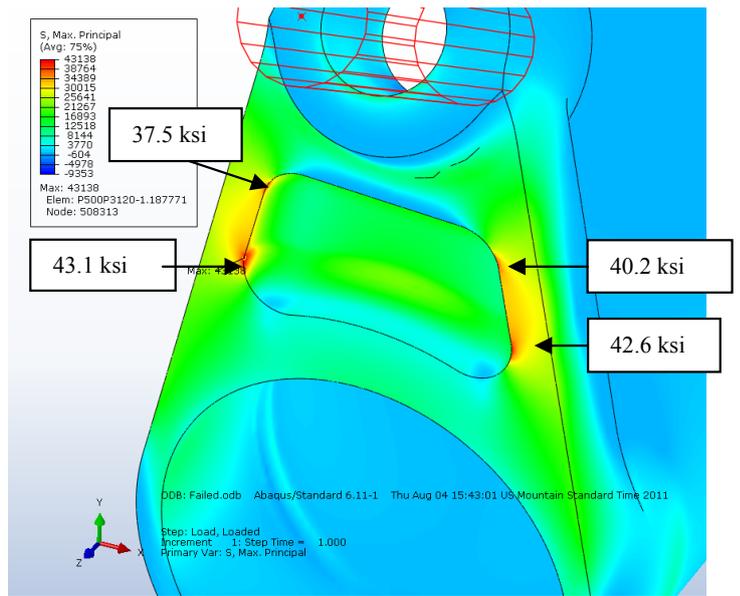
Figure 16b

Maximum stress - failed pitch link
