Midland Ultralights Sirocco 377GB, G-MNDW

AAIB Bulletin No: 11/2004	Ref: EW/C2004/01/04	Category: 1.3
Aircraft Type and Registration:	Midland Ultralights Sirocco 377GB, G-MNDW	
No & Type of Engines:	1 Rotax 377 piston engine	
Year of Manufacture:	1985	
Date & Time (UTC):	27 January 2004 at 1630 hrs	
Location:	1nm north-east of Ashby-de-la-Zouch, Leicestershire	
Type of Flight:	Private	
Persons on Board:	Crew - 1	Passengers - None
Injuries:	Crew - 1 (Fatal)	Passengers - N/A
Nature of Damage:	Aircraft destroyed	
Commander's Licence:	CAA Airline Transport Pilot's Licence	
Commander's Age:	53 years	
Commander's Flying Experience:	9,475 hours (of which 2 were on type)	
	Last 90 days - 80 hours	
	Last 28 days - 16 hours	
Information Source:	AAIB Field Investigation

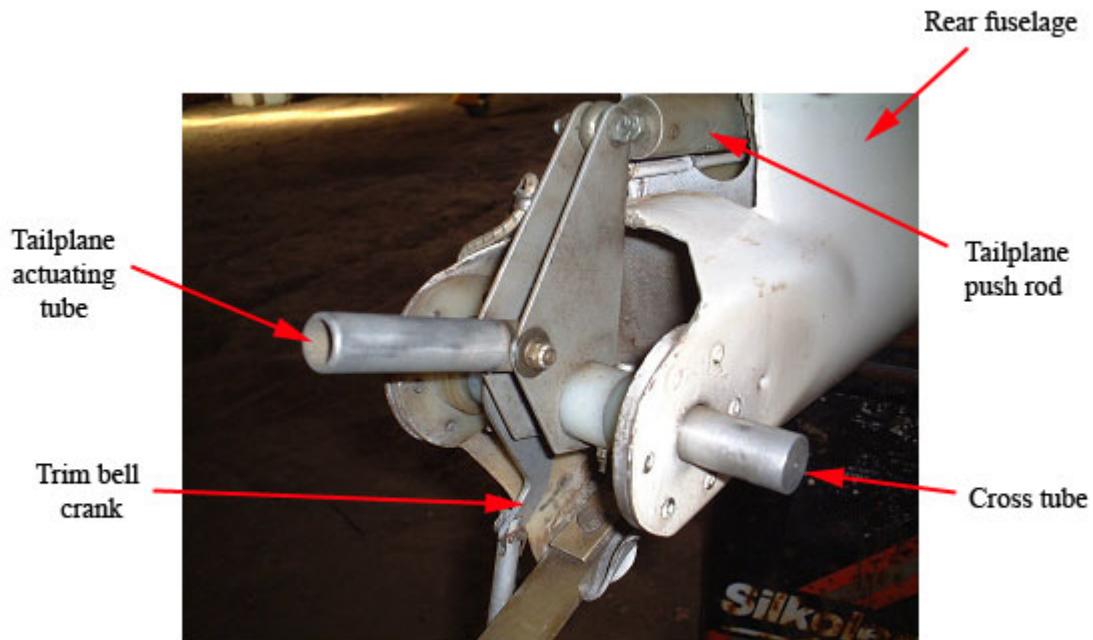
Figure 1 - Tailplane attachment fittings

An anti-balance tab, which also operates as a trim tab, is attached to the trailing edge of the tailplane. Pitch trim is adjusted via a trim lever on the left side of the cockpit. A cable connects the trim lever to the trim bellcrank which is mounted on a cross-tube at the back of the fuselage (see Figure 1).

The cross tube is mounted in nylon bearings to allow it to rotate. A rod attached to the output arm of the bellcrank drives the trim tab. The control stick is connected via a pushrod to the tailplane bellcrank, which is also mounted on the cross-tube. Its output arm is connected to an actuating tube which slots into the tube in the centre of the tailplane. Fore and aft stick movement rotates the bellcrank and hence the tube, thus varying the angle of the tailplane. Whilst on the ground, the control stick is kept in the neutral position by a bungee cord which is attached to the tailplane and secured to the fuselage.

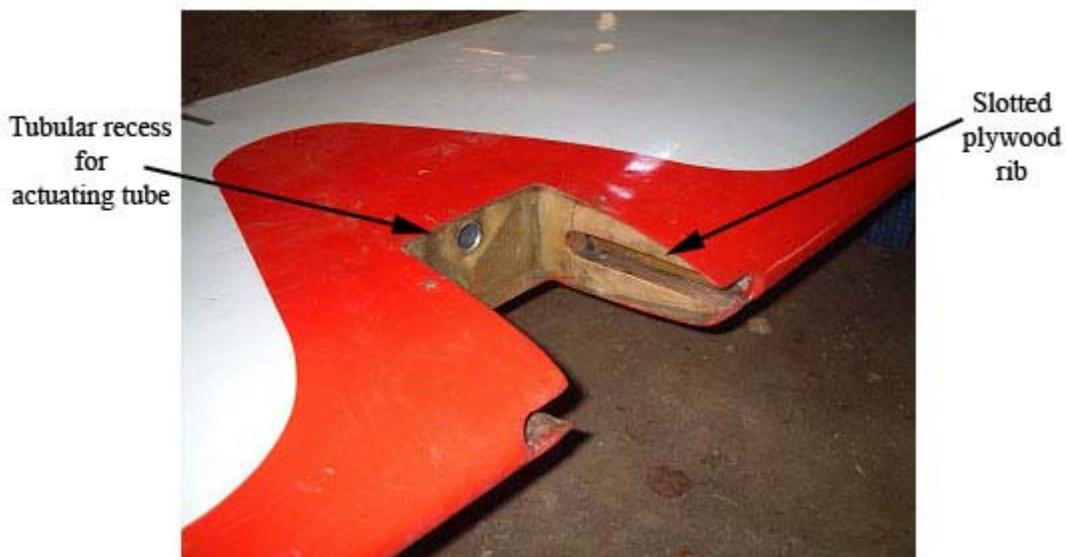
Figure 2 - Tailplane central cutout

The cross tube also provides for retention of the tailplane. The tailplane has a central cutout in its leading edge, with plywood ribs located either side of the cutout (see Figure 2).

The two ribs are angled inwards from front to back, such that the opening is widest at the front and the ribs have 20 mm wide slots cut into them. The tailplane is attached to the fuselage by engaging the slots in the ribs onto the cross tube and sliding the tailplane forward. It is then secured to the cross tube with retaining bolts that are inserted into the ribs in front of the cross tube. The bolts bear directly onto the cross tube in point loading contact. A schematic of the tailplane attachment is presented in Figure 3.
