**AIRCRAFT ACCIDENT REPORT 1/2006**

**Report on the accident to  
Fairey Britten Norman BN2A Mk III-2 Trislander  
registration G-BEVT  
at Guernsey Airport, Channel Islands  
on 23 July 2004**

**Air Accidents Investigation Branch**

**‘Examination of G-BEVT  
Trislander De-icing Boot Failure’**

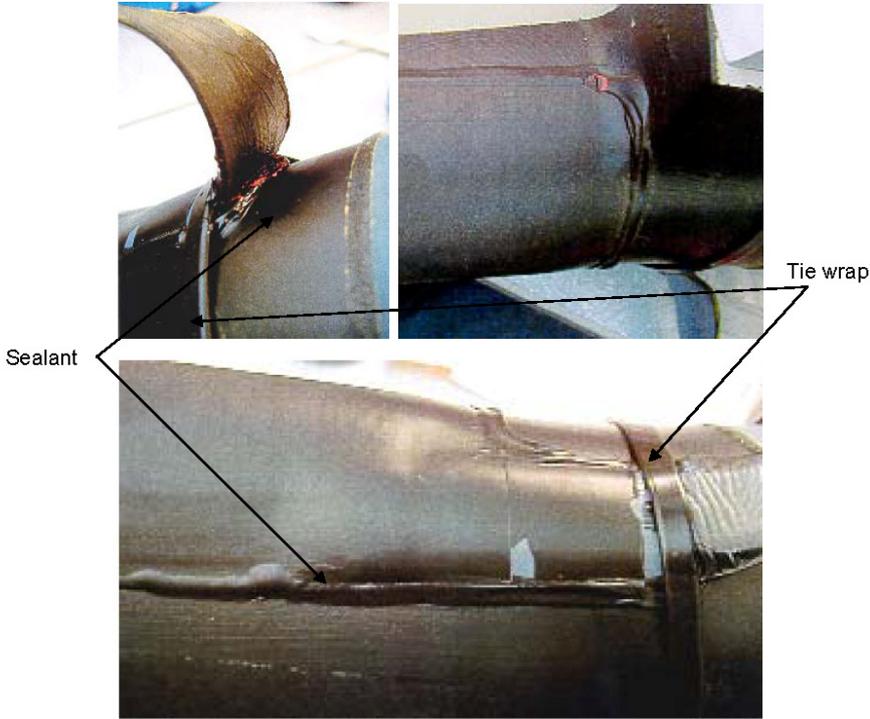
- 2.7 The position of the tie wraps on Blades 2 and 3 was significantly further from the root end of the boot than shown in the manufacturer's example images (Figure 1). The tie wrap is applied over the bonded region in the manufacturer's example but on Blades 2 and 3 the tie wrap was applied over the strap beyond the bonded region. This resulted in a region of unbonded strap, approximately 5-8 mm long between the bonded root of the boot and the tie wrap, see Figure 15. The position of the tie wrap with respect to the bonded region on the failed de-icing boot is unknown as the piece of strap that would have been beneath the tie wrap is missing.

Figure 1: Photographs from the manufacturer showing recommended bonding of the de-icing boot.

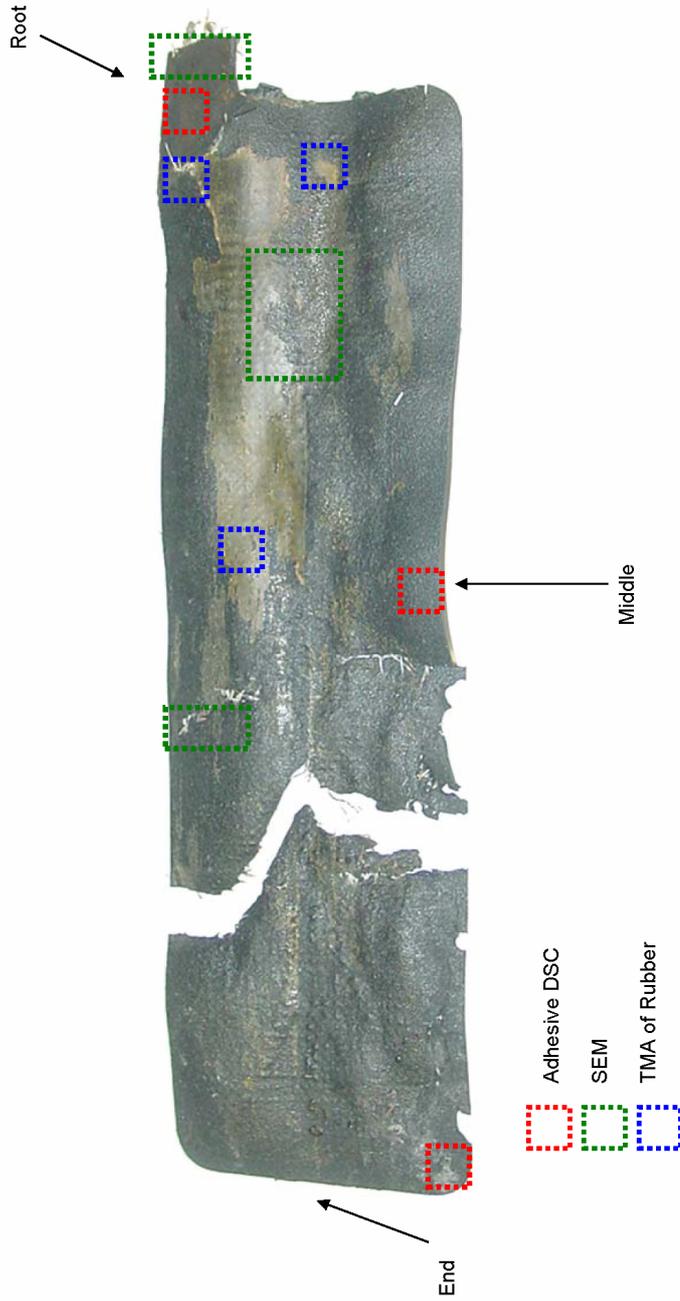
- 4.1 Detailed analysis of the failed de-icing boot from Blade 1 and the de-icing boot from Blade 2 was carried out using a range of techniques including Differential Scanning Calorimetry (DSC), Thermomechanical Analysis (TMA), Infra-Red spectroscopy (IR) and Scanning Electron Microscopy (SEM). Figures 18 and 19 identify the sample locations for analysis from each of the de-icing boots. Samples were taken from the root, middle and end of the boot and from the strap region.

Figure 18: Sampling locations from failed de-icer boot

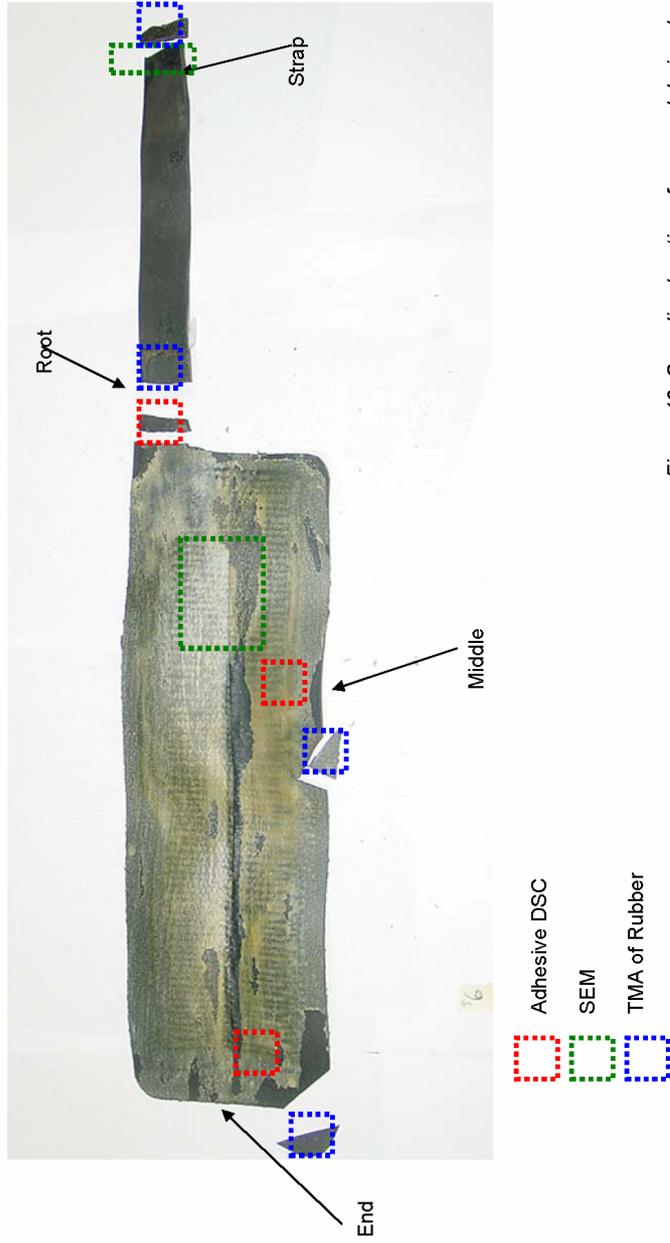
Figure 19: Sampling locations from good de-icer boot (Blade 2)
