INCIDENT

Aircraft Type and Registration:	Falcon 2000, CS-DFE	
No & Type of Engines:	2 CFE 738-1-1B turbofan engines	
Year of Manufacture:	2003	
Date & Time (UTC):	11 November 2009 at 1259 hrs	
Location:	Biggin Hill Airport, Kent	
Type of Flight:	Maintenance	
Persons on Board:	Crew - 3	Passengers - 3
Injuries:	Crew - None	Passengers - None
Nature of Damage:	Fire damage to tyres, fuselage, landing gear and wing	
Commander's Licence:	Airline Transport Pilot's Licence	
Commander's Age:	37 years	
Commander's Flying Experience:	4,152 hours (of which 575 were on type) Last 90 days - 30 hours Last 28 days - 5 hours	
Information Source:	AAIB Field Investigation

Synopsis

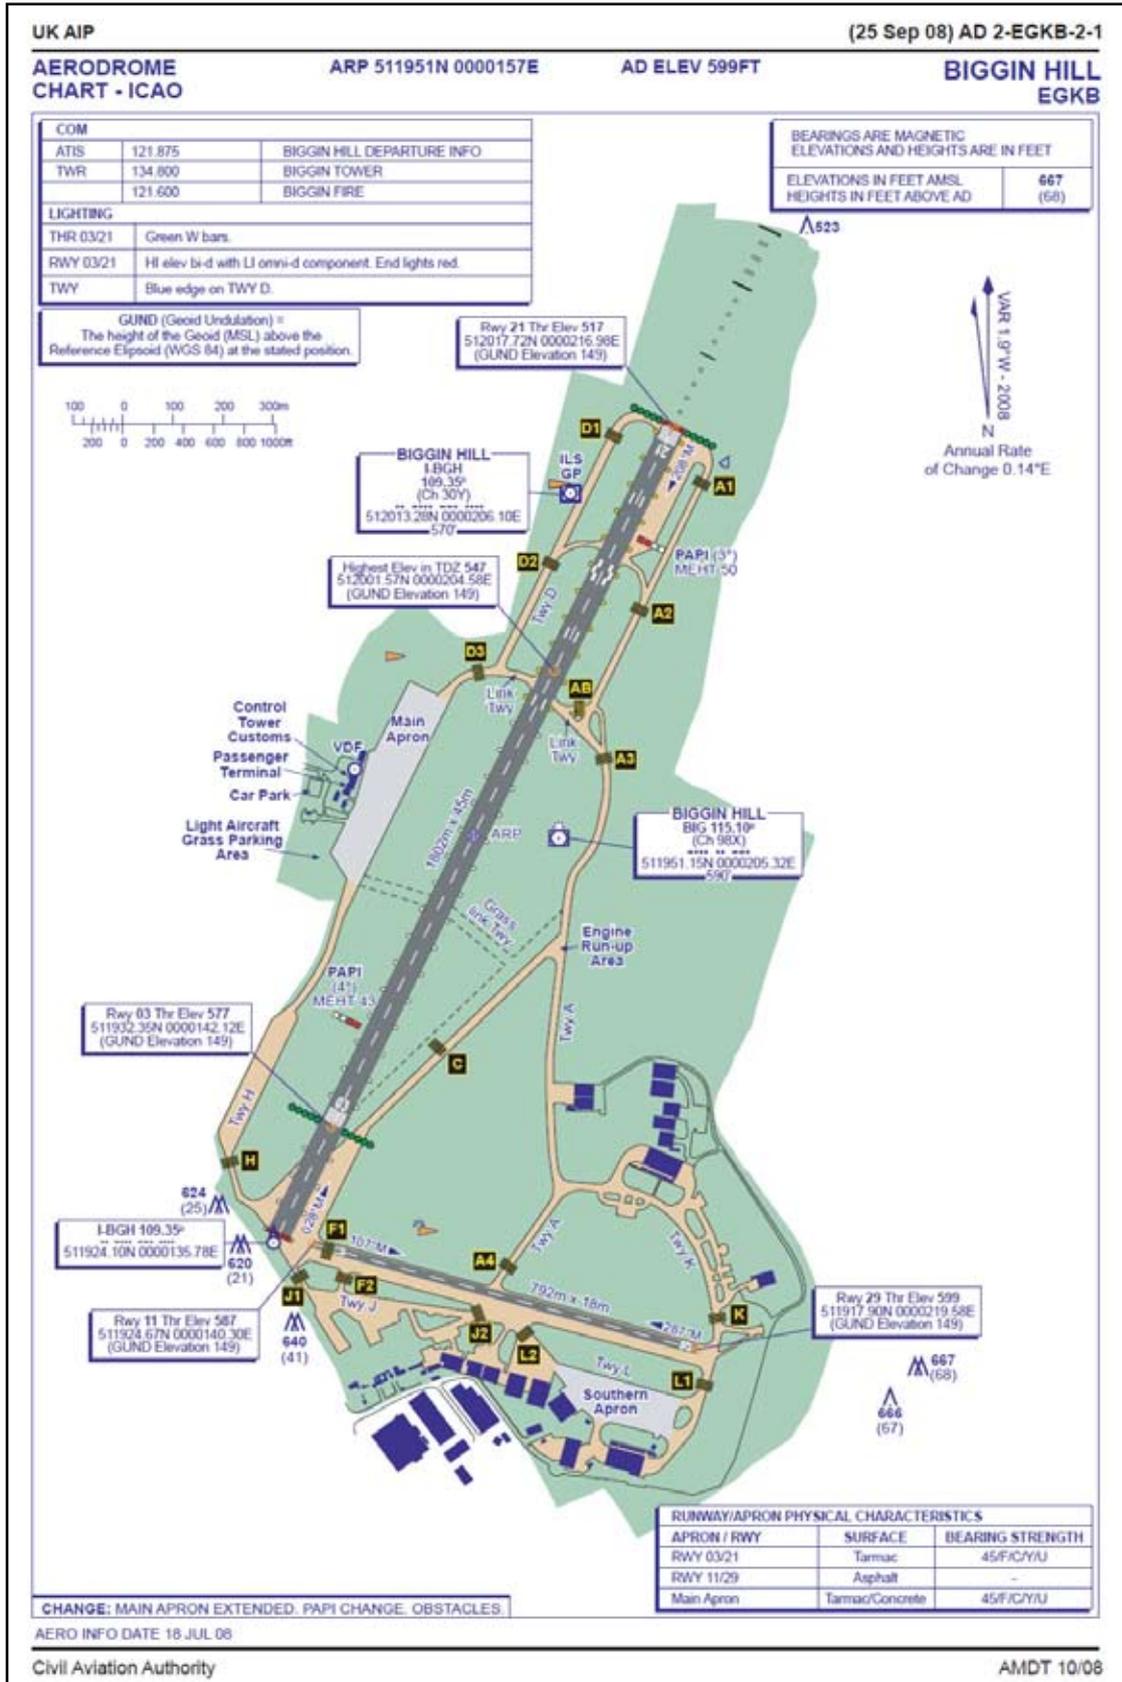
Figure 1
Biggin Hill airport layout

The crew carried out performance calculations to ensure the runway length was adequate for the task to be performed. The main runway at Biggin Hill is orientated 03/21 and is 5910 ft long by 147 ft wide (Figure 1) and has a tarmac surface which was dry. They estimated that the balance field length required for an abandoned takeoff at V_1 for the weight and ambient conditions was 3,000 ft. The crew decided that it would be possible to carry out two low-speed runs, one after the other, in the full runway length available.

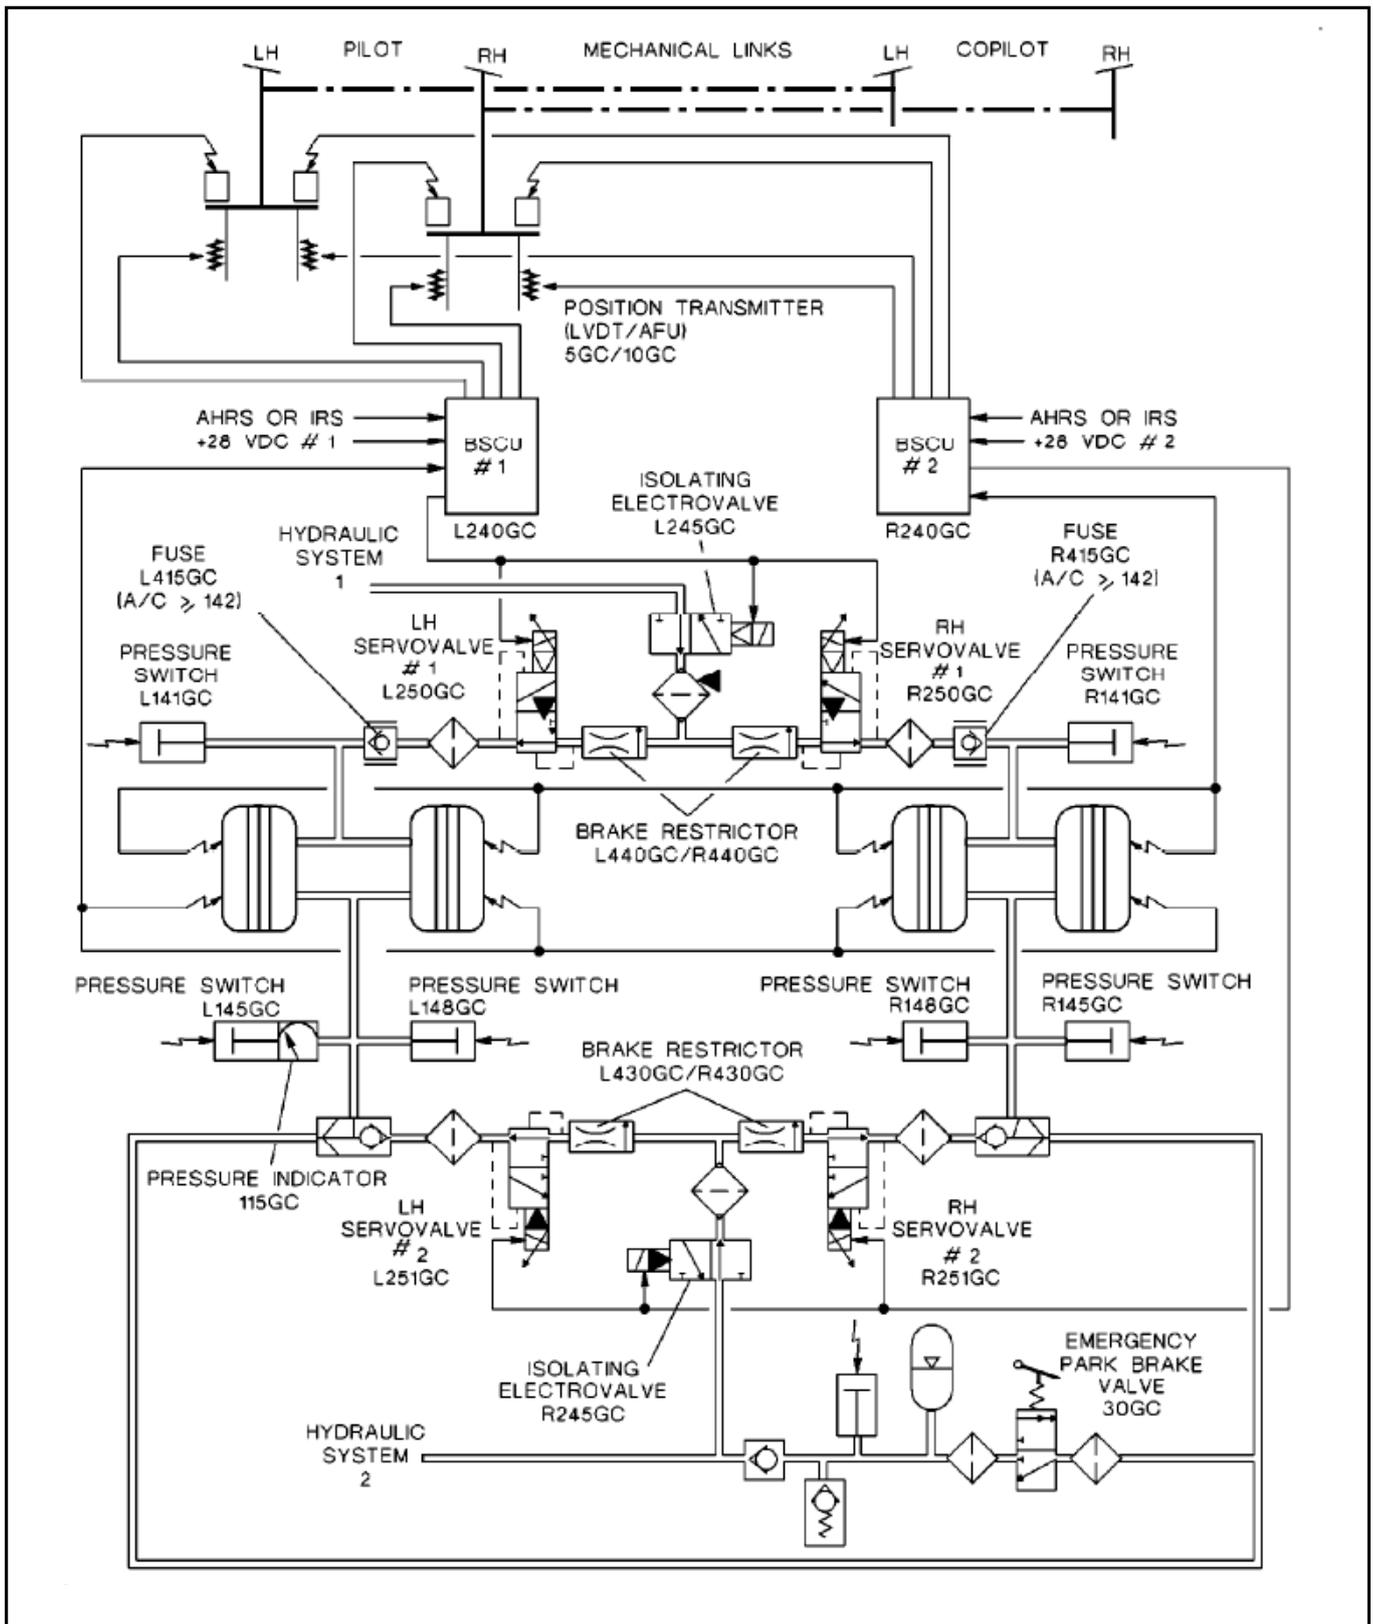
Figure 3
Aircraft braking system

The Dassault Falcon 2000 is certified as a 19-seat, 16.5 tonne maximum takeoff weight business jet, powered by two turbofan engines. It is equipped with a retractable landing gear with two main gears and a nose gear. Each MLG is fitted with two wheels, radial tyres and hydraulically operated, carbon disk brake units. The aircraft is fitted with a wheel well overheat warning system, but there is no measurement or indication of brake temperatures. The aircraft has two main hydraulic systems, both of which supply the braking system (Figure 3).
