INCIDENT

Aircraft Type and Registration:	Airbus A340-311, G-VAEL
No & Type of Engines:	4 CFM56-5C2 turbofan engines
Year of Manufacture:	1993
Date & Time (UTC):	30 April 1995 at 0407 hrs
Location:	Over Liège, Belgium
Type of Flight:	Public Transport
Persons on Board:	Crew - Not known Passengers - Not known
Injuries:	Crew - None Passengers - None
Nature of Damage:	Car destroyed, building roof and ceiling damaged
Commander's Licence:	Airline Transport Pilot's Licence
Commander's Age:	49 years
Commander's Flying Experience:	14,500 hours (of which 250 hours were on type) Last 90 days - 202 hours Last 28 days - 54 hours
Information Source:	Request by Belgian authorities and inquiries and inspection by the AAIB

Potable Water System

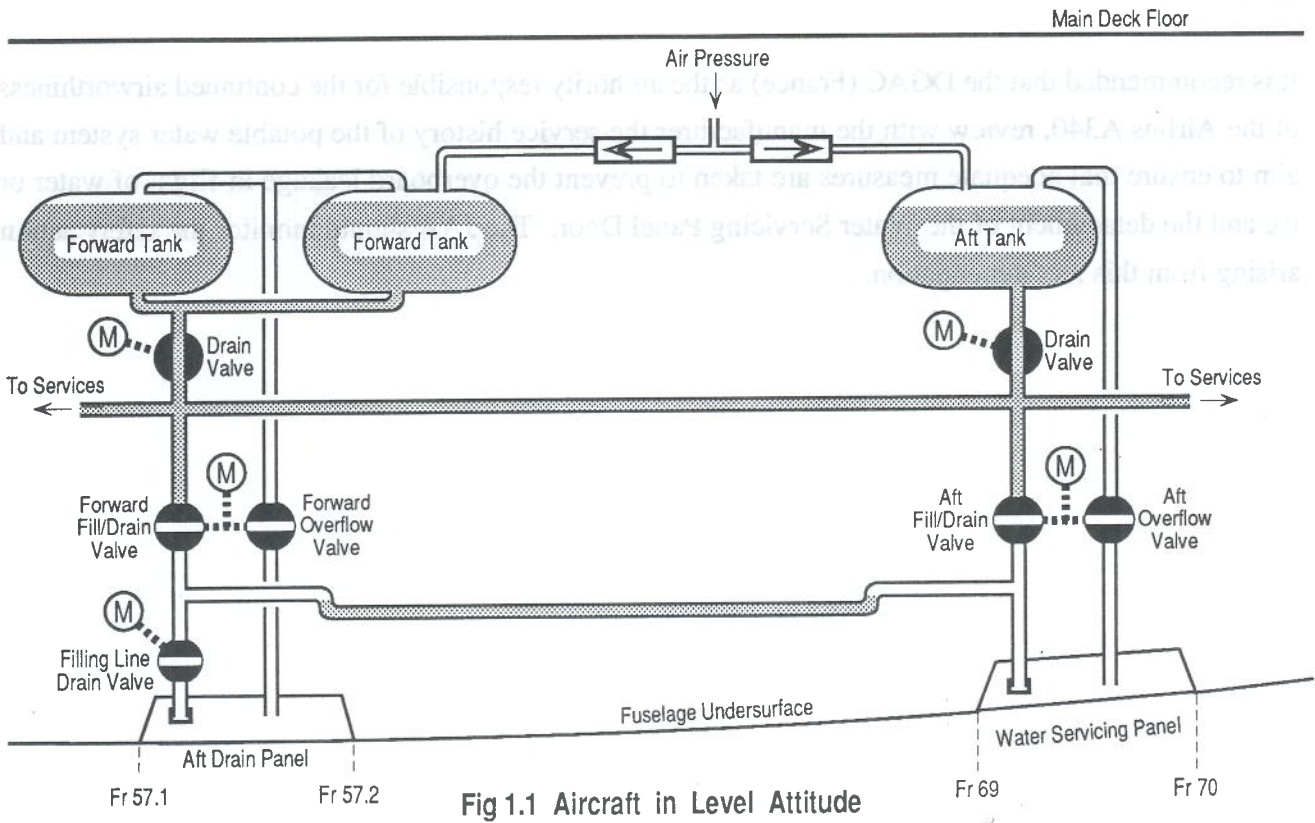
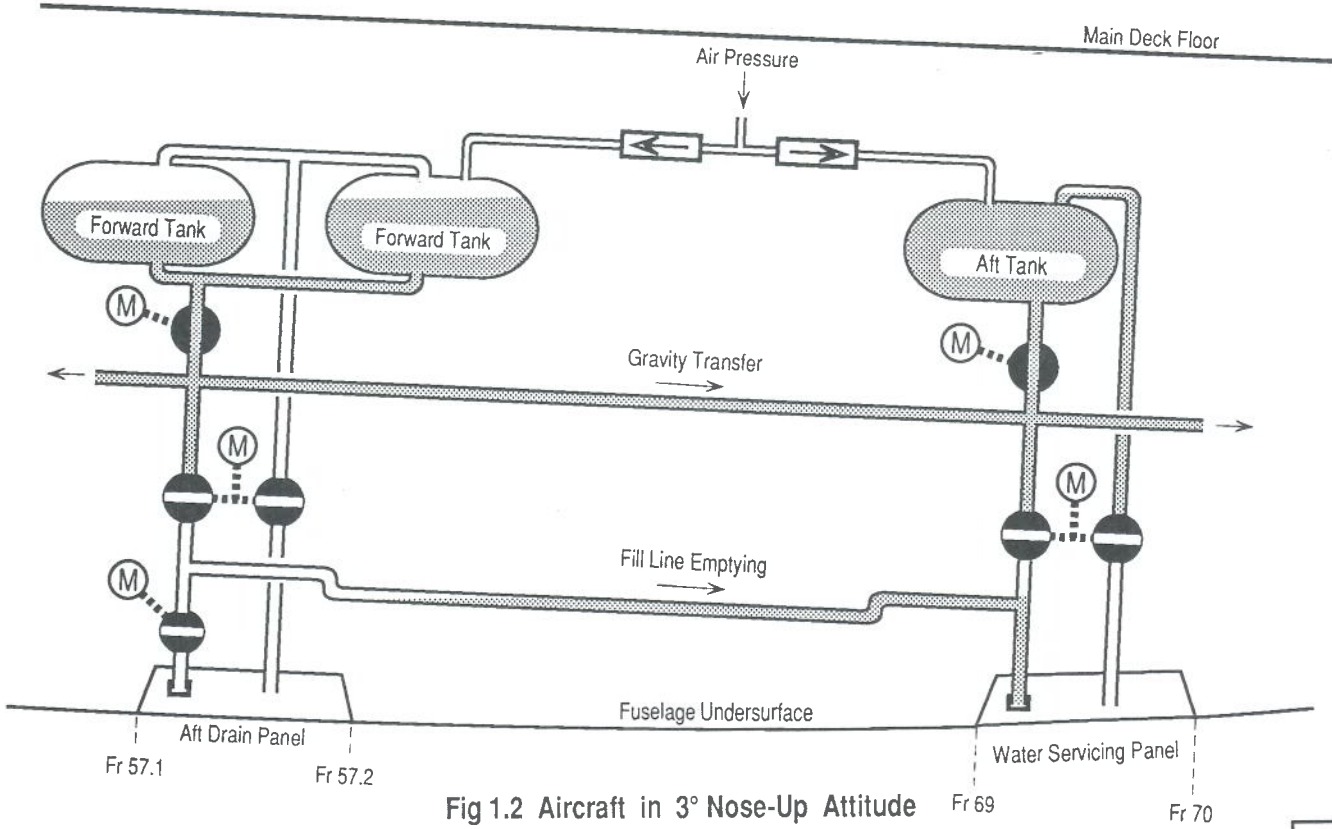
Fig 1

The A340 potable water supply is carried in three 350 ltr capacity cylindrical tanks, located beneath the fuselage main deck floor (Fig 1.1). The two Forward Tanks are situated behind the sidewall lining of

POTABLE WATER SYSTEM SCHEMATIC

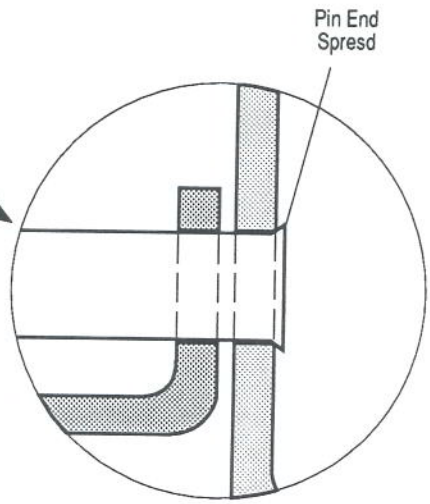
Fig 2

Two sample A340 aircraft (one of which was G-VAEL) inspected during maintenance checks in September 1995 required replacement of the Aft Fill/Drain/Overflow Valve due to leakage. No Fill/Drain Port cap or lanyard was present at the panel in either case. One of the aircraft required replacement of a Water Servicing Panel door hinge due to its partial separation, the hinge pin having migrated axially and disengaged from both the fuselage and the door brackets at one side (Fig 3.3).

Some information suggested that in previous cases ice build-up in the Servicing Panel in-flight due to water leakage past the valves may have inflicted mechanical damage to the door attachments resulting in detachment of the door. However, examination of the failed hinge noted above suggested that partial failure of a hinge in normal service was also a distinct possibility. The 4.93 mm diameter pin normally protruded marginally beyond the fixed bracket, by approximately 0.5 mm, and had been slightly swaged at either end to retain the pin axially (Fig 2). This had produced an end diameter at one end of 5.11 mm, which marginally prevented the end from passing through the bracket holes, but the end which had migrated out had a diameter of only 5.00 mm, allowing it to migrate readily through the brackets. No distress was apparent suggestive of forcible pin migration. Wear markings indicated that the pin may have been in its partially disengaged position for an appreciable period of operation. Further migration of the pin sufficient to disengage it from the other side of the hinge as well would probably be prevented by the surrounding structure but partial disengagement could result in overloading of hinge elements.

Door Hinge Section (Pin disengaged)
