McDonnell-Douglas DC10-30ER, C-GCPH

AAIB Bulletin No: 12/2001	Ref: EW/C99/1/1	Category: 1.1
Aircraft Type and Registration:	McDonnell-Douglas DC10-30ER, C-GCPH	
No & Type of Engines:	3 General Electric CF6-50C2 turbofans	
Year of Manufacture:	Not known	
Date & Time (UTC):	6 January 1999 at 0700 hrs	
Location:	London Heathrow Airport, Block 91	
Type of Flight:	Scheduled passenger	
Persons on Board:	Crew - 11	Passengers - 255
Injuries:	Crew - nil	Passengers - nil
Nature of Damage:	Damage to turbine section of No 1 engine	
Commander's Licence:	Airline Transport Pilot's Licence	
Commander's Age:	Not known	
Commander's Flying Experience:	15,000 hrs total (of which 4,000 were on type)	
	Last 90 days - 180 hrs	
	Last 28 days - 60 hrs	
Information Source:	AAIB Field Investigation

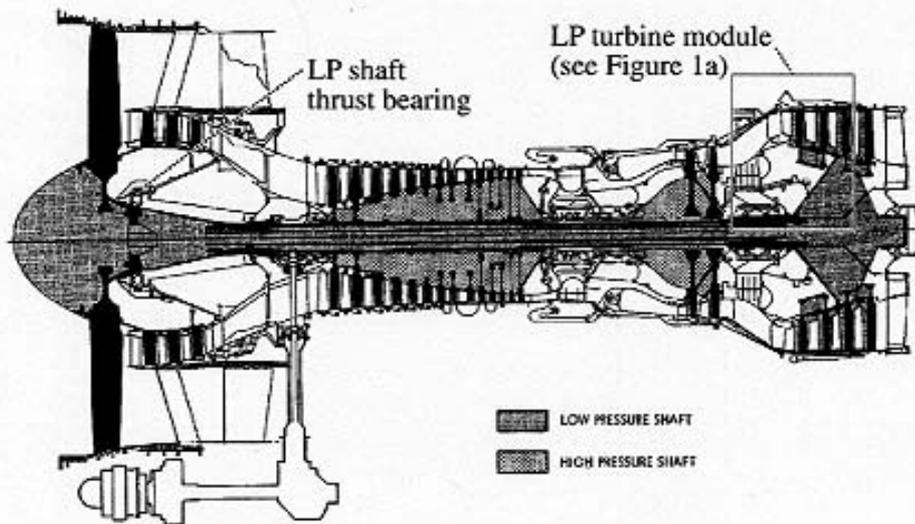
Figure 1 General arrangement of CF6-50 Turbofan

A cross-section of the CF6-50 turbofan engine layout is shown in the diagram at [Figure 1](#).

Before disassembly of the engine the oil filters, fuel filters and chip detectors were checked; no evidence of debris resulting from bearing or oil seal failure was observed. A borescope inspection of the LP turbine was then conducted through the LP turbine case borescope port, but during this examination the LP shaft was not rotated in order to prevent additional damage. This inspection revealed severe damage to those nozzle guide vanes and turbine blades which could be seen. In addition, several of the 1st stage LP turbine (LPT 1) blade root end dovetails were no longer installed in the disc. Further borescope inspections, conducted through the turbine mid-frame and high pressure (HP) turbine ports, indicated that there was no significant damage upstream of the HP turbine nozzle guide vanes. As a result of this inspection it was decided that the investigation would be focussed on the LP turbine module (Figure 1).
