Robinson R22 Beta, G-IORG

AAIB Bulletin No: 9/2003	Ref: EW/C2002/05/04	Category: 2.3
Aircraft Type and Registration:	Robinson R22 Beta, G-IORG	
No & Type of Engines:	1 Lycoming O-320-B2C piston engine	
Year of Manufacture:	1991	
Date & Time (UTC):	14 May 2002 at 0855 hrs	
Location:	Sywell Aerodrome, Northamptonshire	
Type of Flight:	Aerial work	
Persons on Board:	Crew - 1	Passengers - 1
Injuries:	Crew - None	Passengers - None
Nature of Damage:	Main rotor blade cracked	
Commander's Licence:	Commercial Pilot's Licence	
Commander's Age:	57 years	
Commander's Flying Experience:	13,500 hours (of which 8,000 were on type)	
	Last 90 days - 250 hours	
	Last 28 days - 64 hours	
Information Source:	AAIB Field Investigation

Synopsis

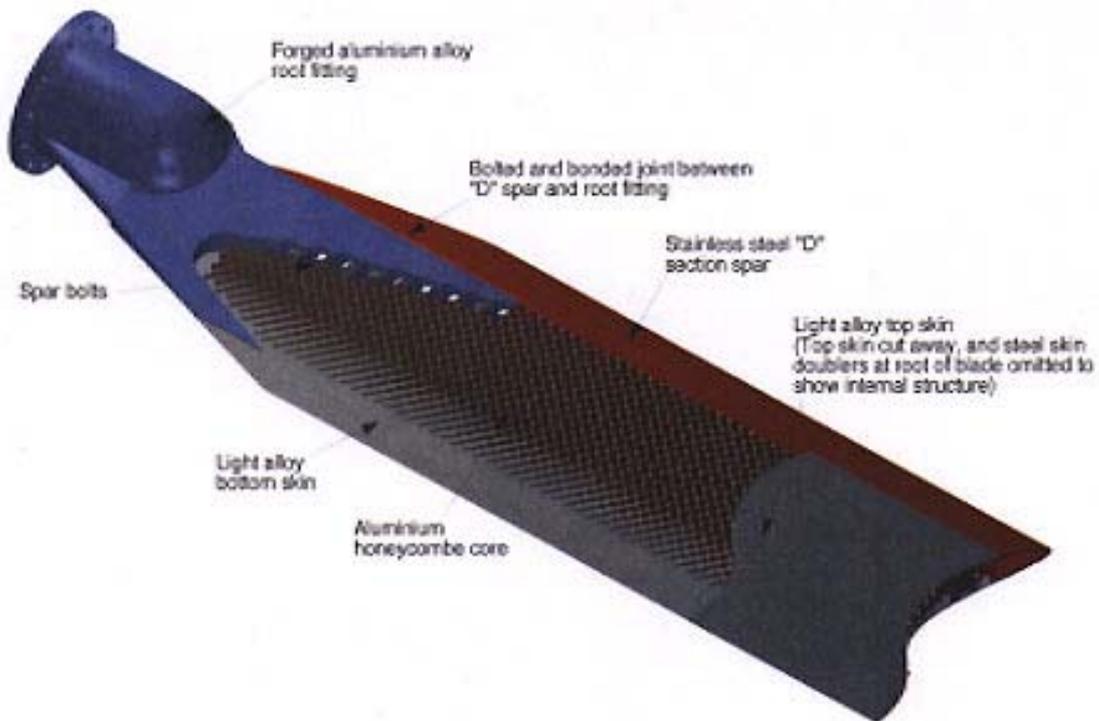
Figure 2a
R22 Main rotor blade construction details

The R22 main rotor blade is of conventional bonded metal construction, comprising top and bottom skins of aluminium alloy with an aluminium honeycomb core, a hollow 'D' section leading edge spar of stainless steel, and a forged aluminium alloy root-fitting, Figure 2. The root fitting incorporates a short stub section which is bonded inside the blade proper, and two fingers which extend further into the blade. The larger of these fingers abuts the rear face of the hollow spar, to which it is fixed by a combination of adhesive bonding and a series of bolts which engage a strip of captive nuts located inside the spar. A smaller finger at the trailing edge of the root fitting is bonded directly to the skins. Aluminium alloy doublers bonded externally to the skins (omitted for clarity from Figure 2) provide local stiffening and reinforcement of the skins in the vicinity of their connection to the root fitting. An aluminium alloy cap is bonded to cover the end of the hollow spar and an adhesive fillet blends the root end of this cap to the root fitting.

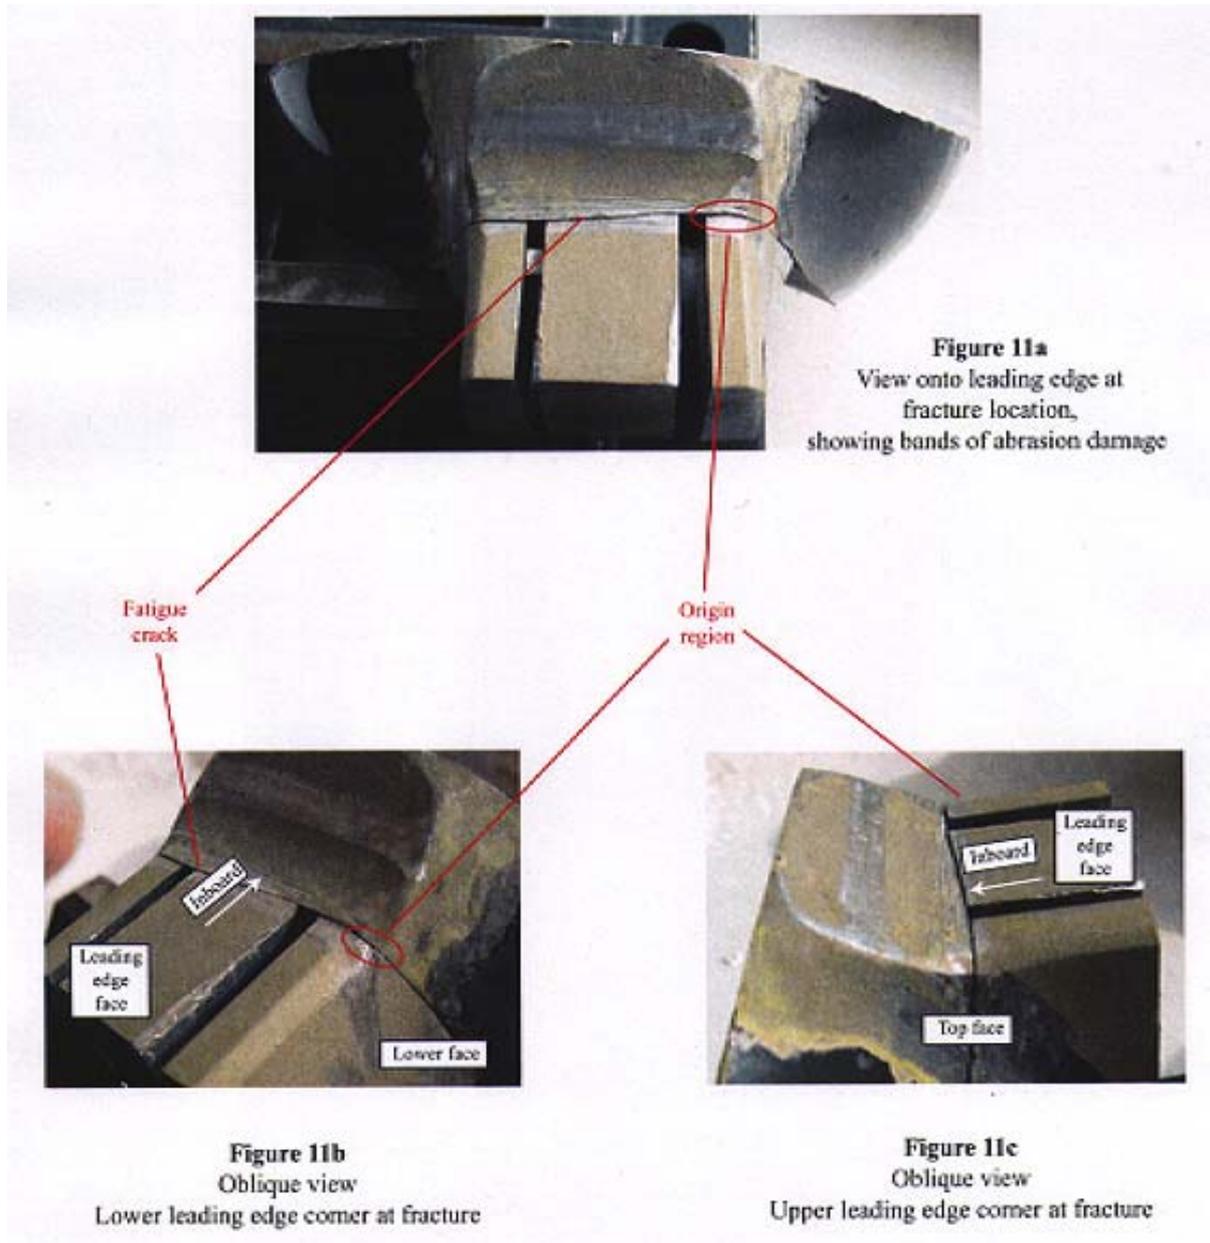
With the root fitting surfaces thus exposed, it was apparent that the scoring observed previously, in the small area of the leading edge exposed originally, Figure 9, was actually part of a much more widespread region of transverse scoring. Two distinct transverse bands of abrasion were present on the leading edge, each approximately 2.5 mm in width, and separated by a spanwise distance of approximately 7.5 mm. Each band extended around the chamfers at the upper and lower corners of the leading edge and continued, for a short distance, chordwise, back across the upper and lower surfaces respectively, see Figures 11a, 11b and 11c. The fatigue crack origin coincided with an area of particularly aggressive scoring around the lower leading edge corner, which formed part of the more outboard of the two bands of abrasion. Similar, though slightly less intensive scoring, was evident on the upper corner.

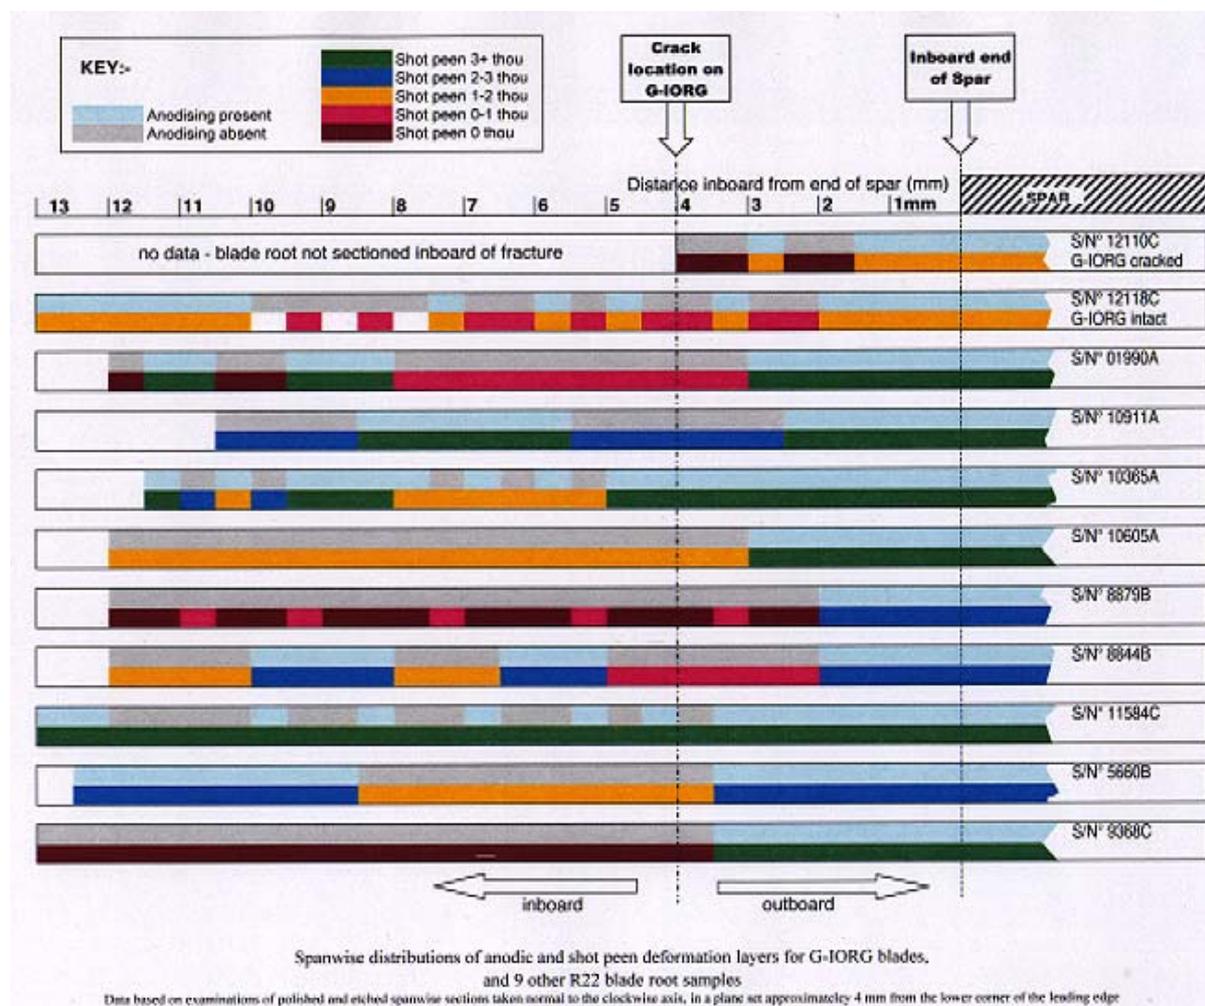
cracked and intact blades from G-IORG. The data clearly shows that the surface layers are intact beneath the spar and for a short distance, typically up to about 3 mm, inboard of the spar end. Further inboard, however, varying amounts of surface have been removed, consistent with an abrasive process during manufacture to remove excess adhesive after bonding, but prior to the application of filler.

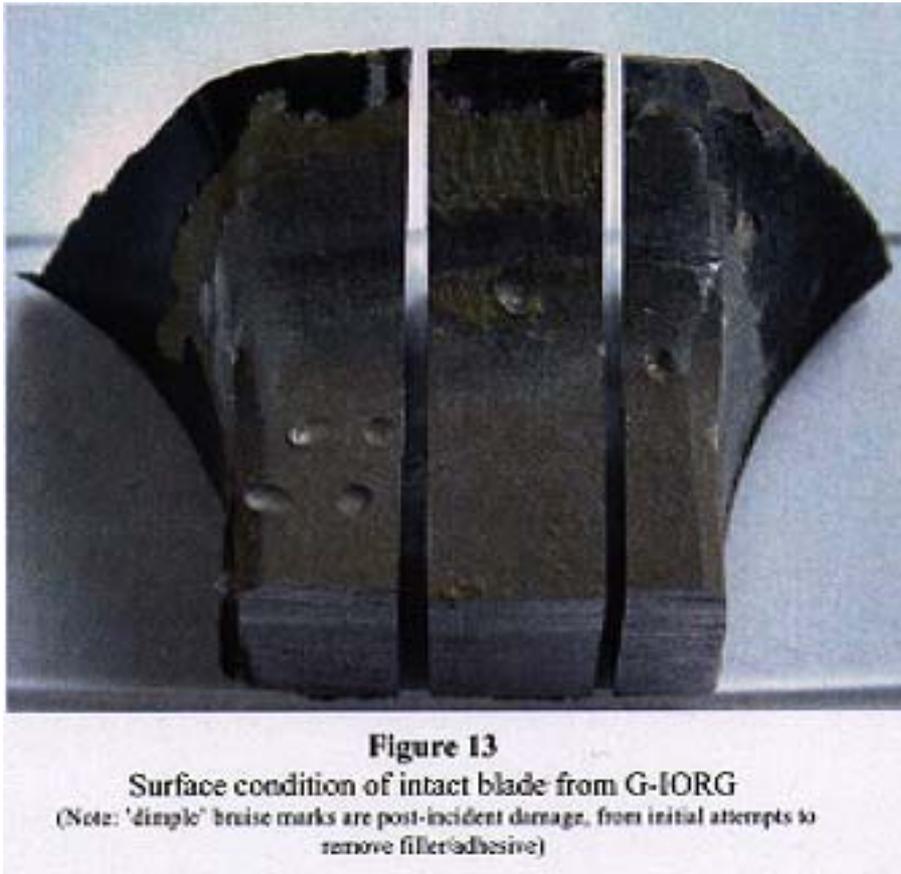
Removal of the filler and adhesive layers from the opposing intact blade from both G-IORG, and the range of sample blades revealed a broadly consistent pattern of transverse abrasion across the leading edge face just inboard of the spar, and around the corners. This was similar to that noted on the cracked blade from G-IORG. Figure 13 shows the opposing blade from G-IORG, and Figure 14 shows these characteristics on the other sample blades examined by the AAIB.
