AIRCRAFT ACCIDENT REPORT 1/2010

Air Accidents Investigation Branch

**Report on the accident to
Boeing 777-236ER, G-YMMM,
at London Heathrow Airport
on 17 January 2008**

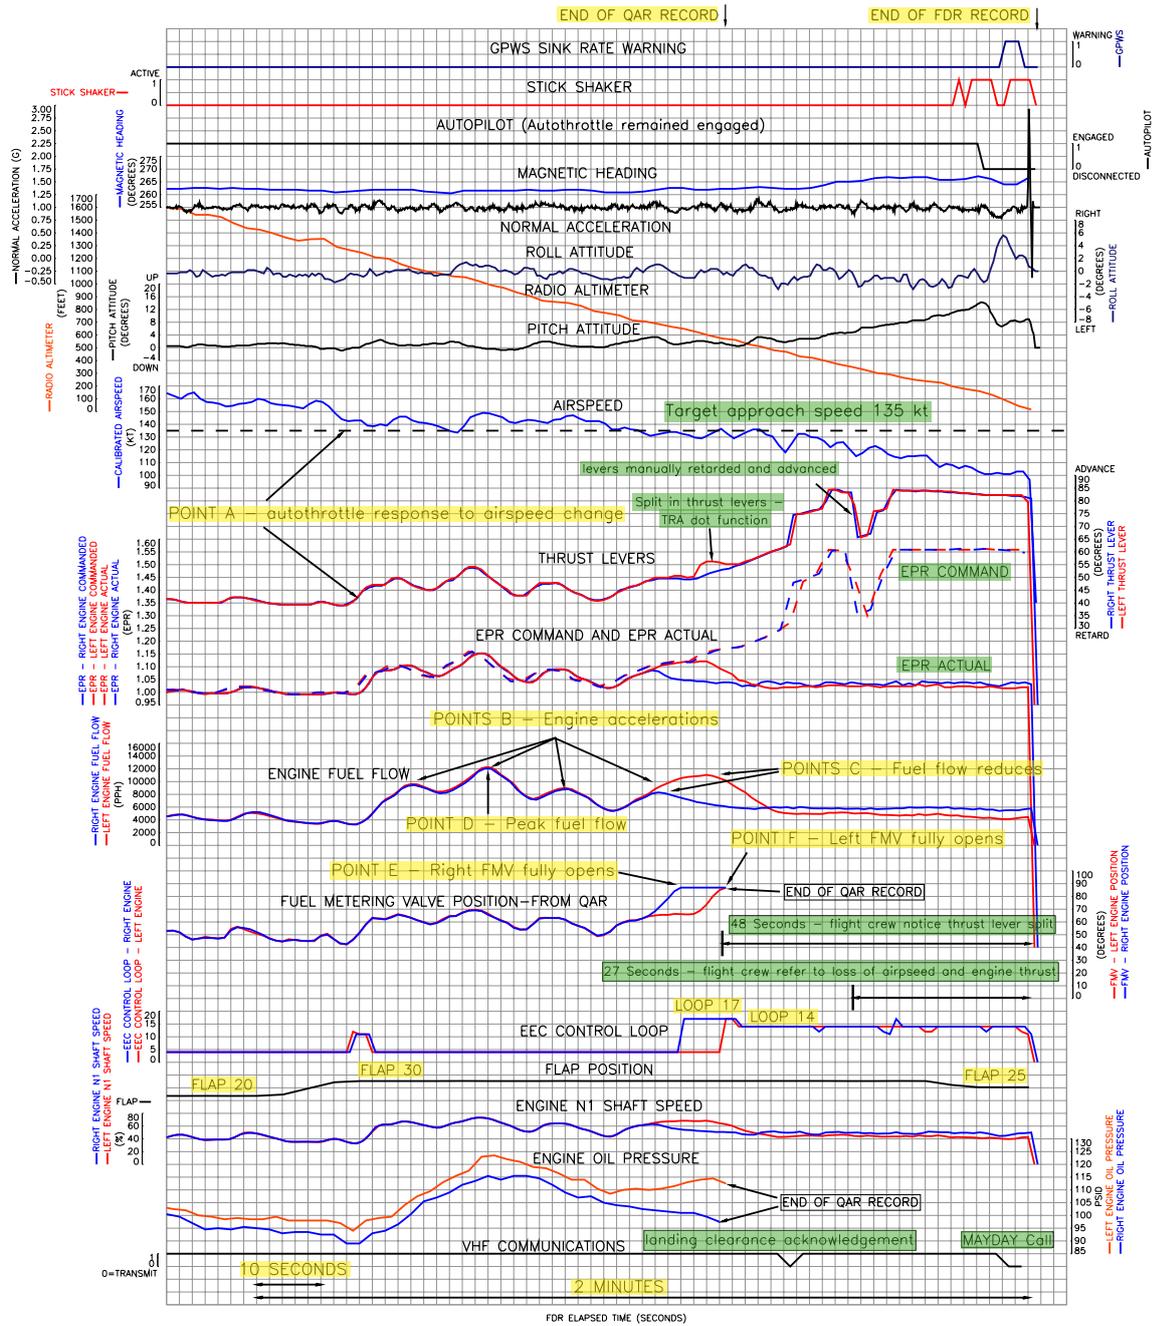
Figure 20

As the flaps reached the 30° position the airspeed had reduced to the target approach speed of 135 kt and the autothrottle commanded additional thrust to stabilise the airspeed (Figure 20, Point A). In response to variations in the wind velocity and associated airspeed changes, there followed a series of four, almost cyclic, thrust commands by the autothrottle (Figure 20, Point B). It was during the fourth acceleration, and as additional thrust was being commanded, that the right engine, followed some seven seconds later by the left engine, experienced a reduction in fuel flow (Figure 20, Point C). The right engine fuel flow reduction occurred at a height of about 720 ft and the left engine at about 620 ft. Just prior to the reduction in right engine fuel flow, about 2.5 nm from the runway, the flight crew were visual with the runway and the co-pilot became pilot flying (Figure 21).

Of the four thrust commands it was the second that resulted in the highest delivery of fuel flow, reaching a peak of 12,288 pph for the left engine and 12,032 pph for the right (Figure 20, Point D). These peaks occurred about 26 seconds prior to the reduction in fuel flow to the right engine. Peak fuel flows during the first and third thrust commands were lower, at about 9,500 pph and 9,000 pph respectively.

During the fourth thrust increase, the right engine fuel flow had increased to 8,300 pph before gradually reducing. The recorded EPR then started to diverge from the commanded EPR and the right engine FMV opened fully (Figure 20, Point E). Some seven seconds later, the left engine fuel flow, which had increased to 11,056 pph, also started to reduce and the left engine FMV also moved to its fully open position (Figure 20, Point F). The QAR record ended shortly after.

The data was examined with respect to oil pressure. This showed that both the left and right engines' oil pressure generally follow each other until the start of the final acceleration, which resulted in first the right and then the left engines rolling back. The left engine oil pressure rose, as expected, as the engine accelerated: the right engine pressure, however, started to decrease, even though the engine was also accelerating prior to its rollback. Whilst, this observation, on the right engine, was based on only a few data points, it can be inferred that this was due to an oil temperature increase at, or close to, the start of the final acceleration. However, the loss of QAR data so close to the left engine rollback meant that it was not possible to draw a similar conclusion for the left engine. (Figure 20)

Final minutes of approach

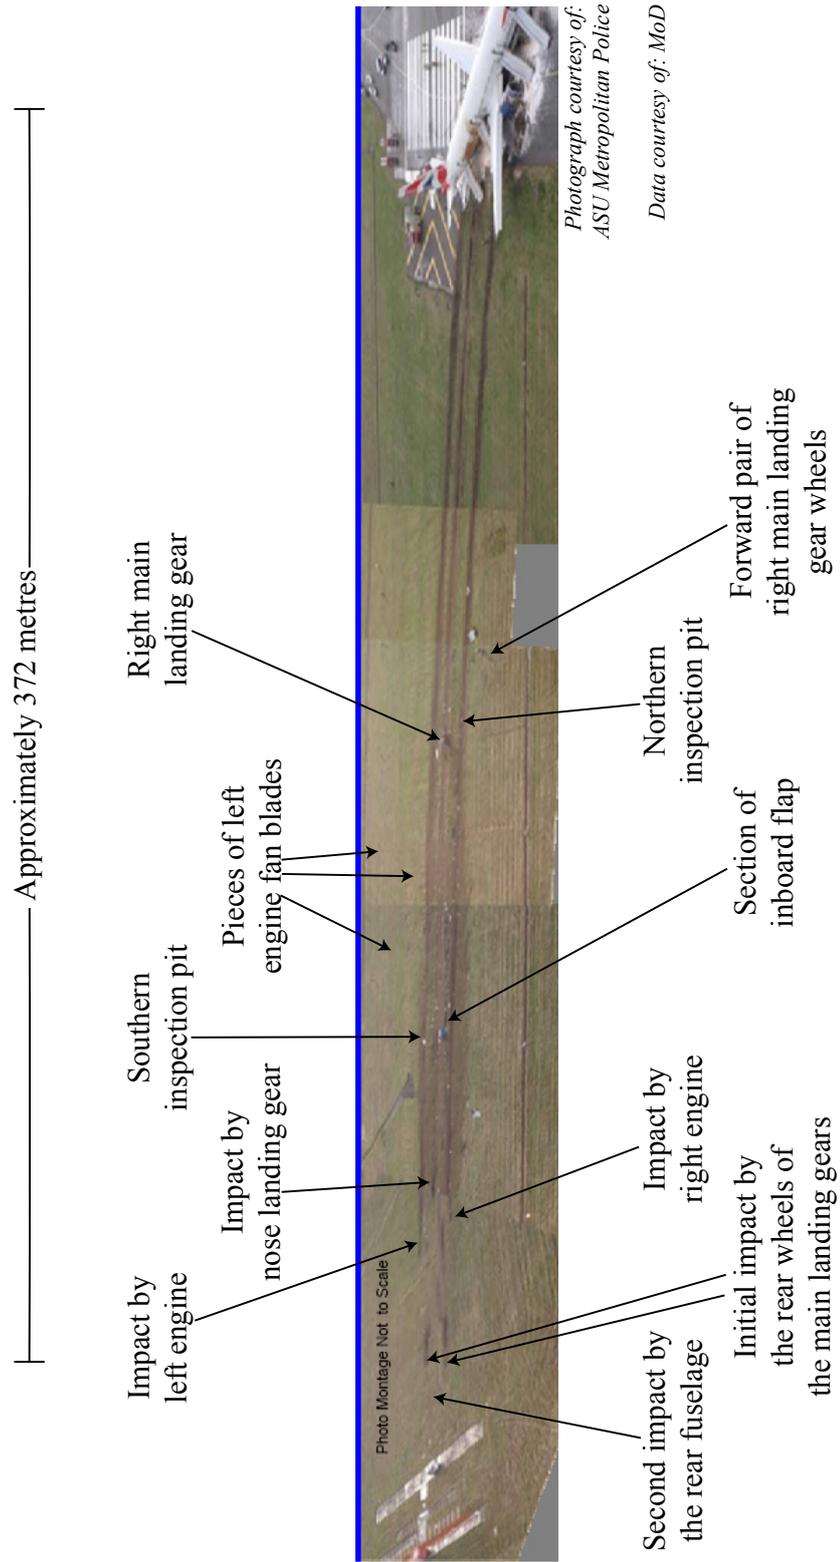
Also shown in Figure 23 is the final position of the main section of right MLG and the front section of the truck beam, with its two wheels.

This caused damage to the lower part of the engine and assisted the deviation of the aircraft's ground slide to the right.

The aircraft came to rest on the tarmac area just to the north of the threshold of Runway 27L, approximately 372 m from the first impact point.

Ground impact marks and wreckage trail

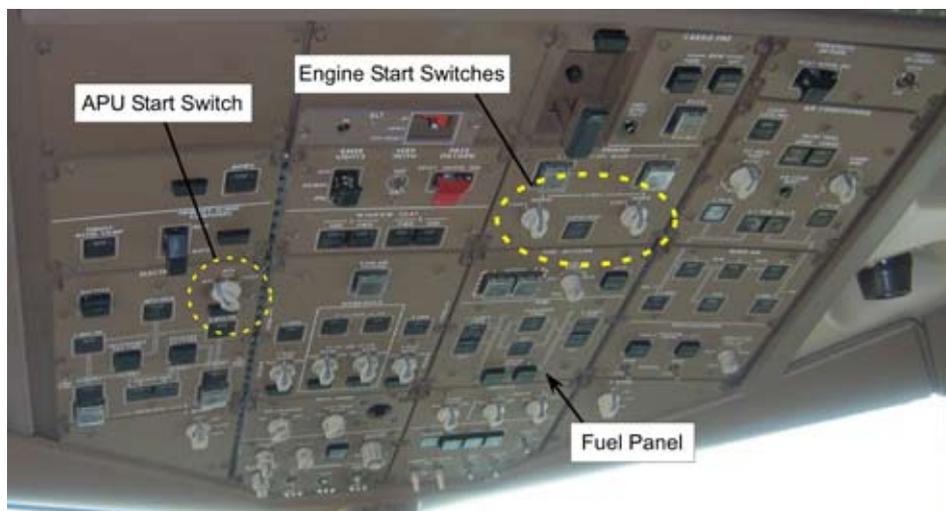
Figure 24

Engine thrust levers - Both engine thrust levers were in the full thrust position.

Flaps - FLAP 25 selected.

Overhead panel shortly after the accident

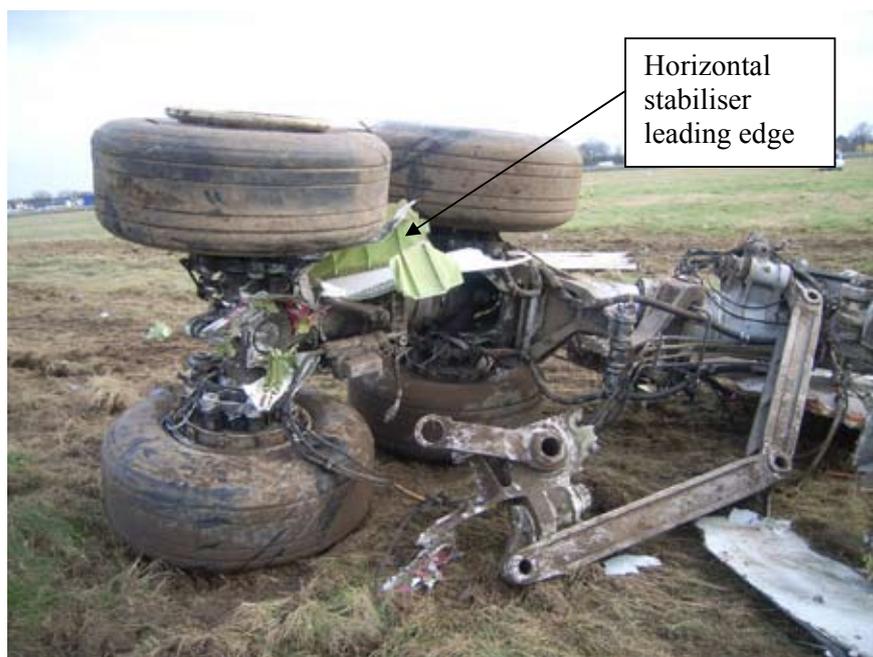
Figure 27

Right Main Landing Gear with embedded portion of right horizontal stabiliser leading edge

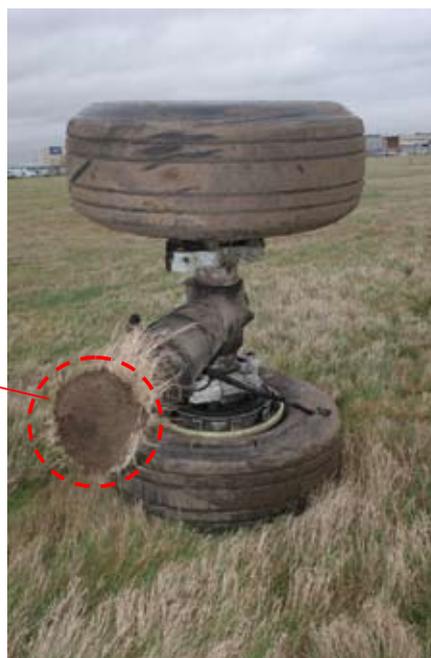
Figure 31

Forward portion of truck beam and two wheels

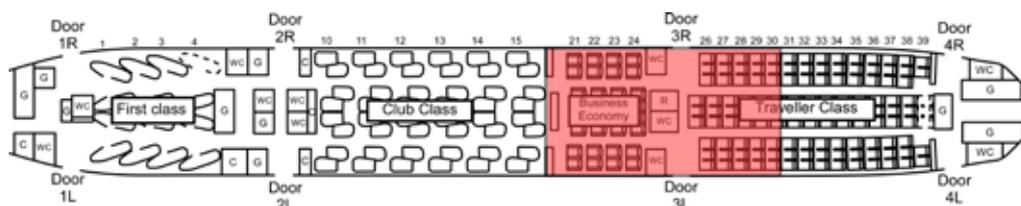
Figure 35

There were significant amounts of glass debris in the forward area of the Traveller cabin section, which was more extensive on the left side of the cabin in the region of Door 3L (Figures 35 to 37). The glass debris extended as far forward as Door 2L and 2R, and as far aft as seat row 31, with highest concentrations in the areas between rows 21 and 29.

Cabin layout showing location of glass debris

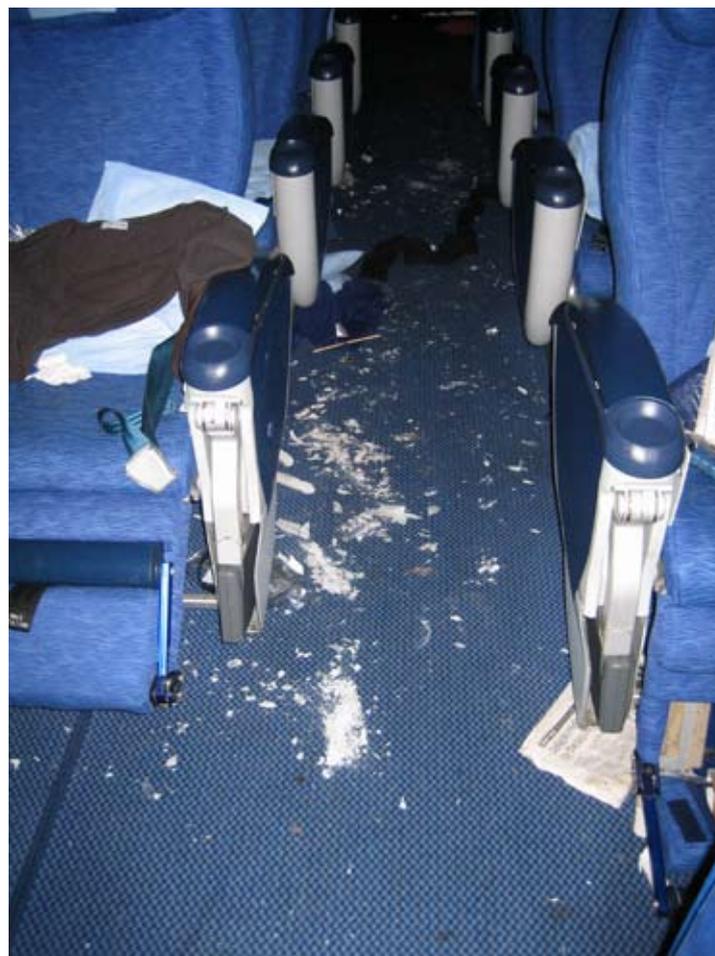
Figure 37

Debris on the floor from fluorescent tubes in area of Door 3L

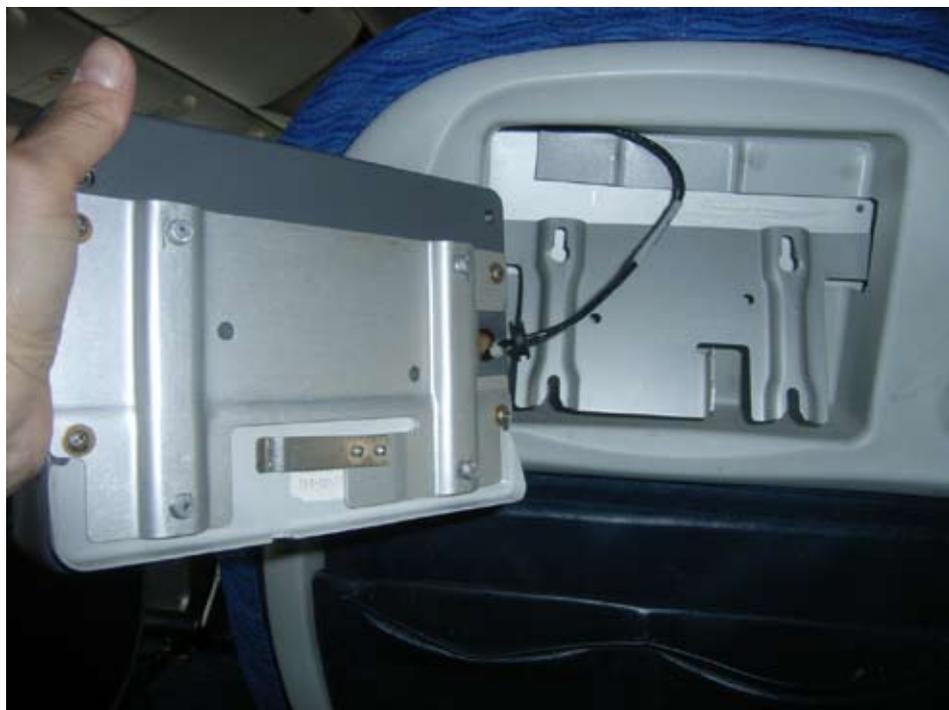
Figure 40

In the Business Economy section, nine of the 32 seat back video monitors had separated; of these, eight remained suspended by their electrical harness but one had separated completely and was found on the cabin floor (Figure 39).

Video monitor attachment fittings

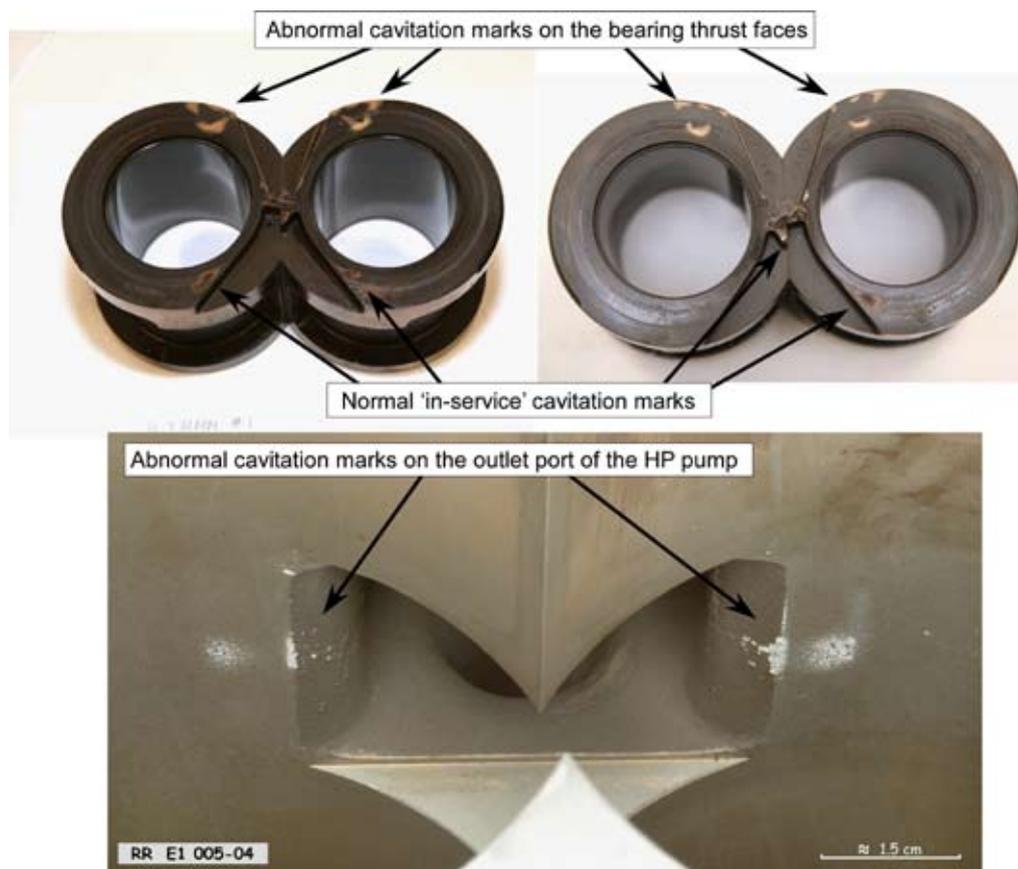
Figure 41

Strip of the HP gear pump did not reveal any mechanical discrepancies other than some unusual marks on the delivery sides of both pumps which the manufacturer described as being indicative of 'cavitation' (Figure 41). The marks comprised slight, but distinct, erosion of the dry film lubricant on the bearings and also of the outlet ports: they appeared fresh and bright.

Advice from the pump manufacturer was that these marks, at this location, were highly unusual. However, local cavitation erosion was to be expected at various known positions, mainly associated with the inlet side of the pump; the marks were hardly ever seen at the outlet ports. A series of tests had been carried out originally to certify the pump. Part of the tests involved running a pump at very low inlet pressures for several minutes. When the unit was stripped, marks were present which were almost identical to those which had been found on the pumps from G-YMMM. (Appendix E 'Explanation of Cavitation'.)

Apart from the marks, which would have had no effect on pump operation, no other abnormalities were found in either MEP from G-YMMM.

Cavitation markings on the HP pumps from G-YMMM

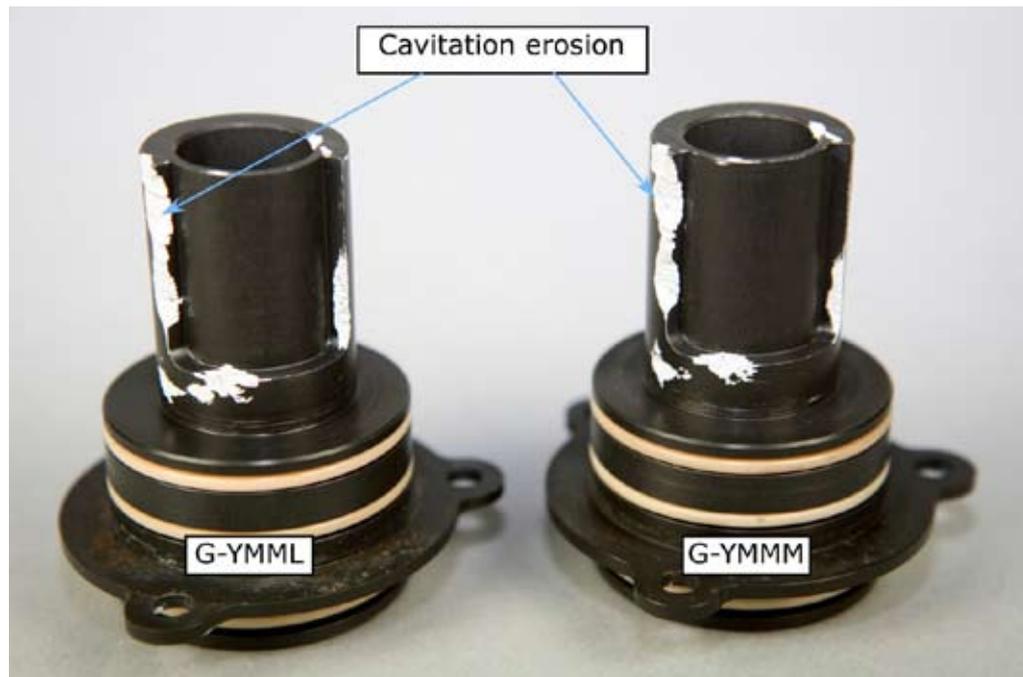
Figure 42

Inspection of the boost pumps revealed cavitation erosion on the re-prime pump stator and discoloration of the surface treatment on the re-prime impeller, which was assessed to have been caused by cavitation erosion. A comparison of this damage was carried out against boost pumps removed from another of the operator's aircraft, G-YMML (Figure 42). All the boost pumps from both aircraft, which had a similar service history, displayed the same cavitation damage to the re-prime stator and impeller. The pump manufacturer demonstrated that this type of damage was normal for pumps of this age.

Cavitation wear marks on the re-prime pump stator

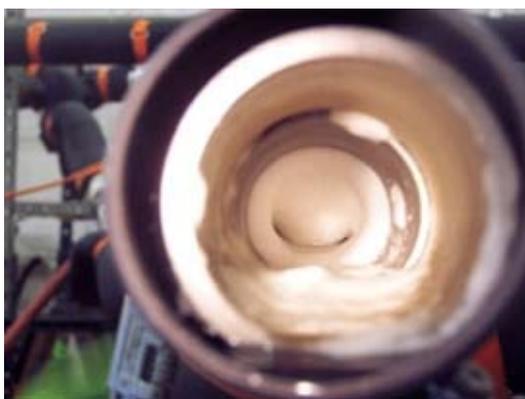
Figure 50

The only occasion when it appeared that there might be a sufficient quantity of ice to block a pipe occurred when approx 6 litres of water had been injected into the boost pump inlet over a period of 7 hours. During this period the flow rate was maintained at 6,000 pph and the water content varied between 100 and 150 ppm. On dismantling the system a large ball of soft ice was found just down stream of the spar valve on a coupling that is not used on the aircraft (Figure 50). Despite the presence of the ice, no pressure drop was detected across this section of tube whilst the fuel was flowing at 6,000 pph.

Ball of soft ice found in pipework in the fuel test rig assembled from steel components that are not used on the Boeing 777

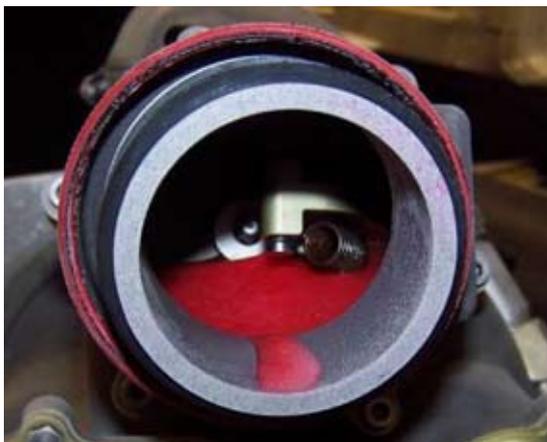
Figure 51

To explore this theory, a number of tests were carried out using dyed water that had been frozen in a check valve housing (Figure 51). In one test, compressed air was applied to the valve which started to open when the pressure was approximately 3 to 4 psi. On another test, with the housing fitted to the rig, it was possible to achieve a flow of 28,000 pph. At the end of these tests the ice chip was still located in the housing.

Dyed ice in check valve housing

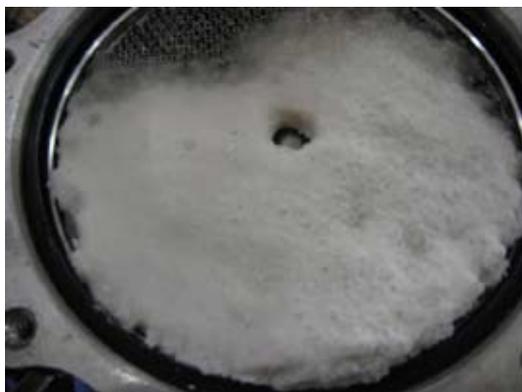
Figure 52

During the 'snowball' tests, with the fuel flow set at 6,000 pph, it took approximately 40 seconds for the water introduced at the boost pump inlet to reach the face of the FOHE. As the water flowed through the fuel system it turned into ice crystals and under certain conditions these crystals would collect on the face of the FOHE, restricting the fuel flow (Figure 52). However, during

all of the testing the fuel flow never fell below that required by an engine at flight idle. Moreover, the restriction could always be cleared by reducing the fuel flow to idle, which resulted in a change in the equilibrium between the cold fuel and hot oil in the heat exchanger, such that the ice melted on the inlet face of the FOHE, sufficient to restore the demanded fuel flow.

Ice collected on the face of the FOHE

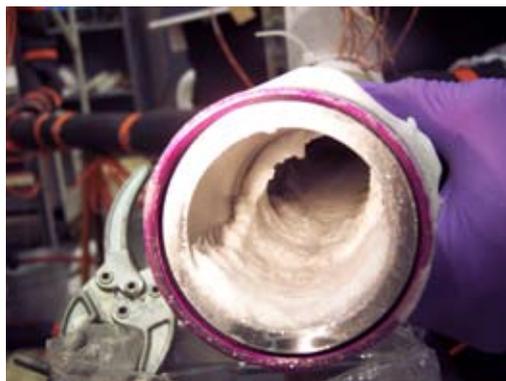
Figure 53

- The ice was soft and easy to move and there appeared to be no difference in the properties of the ice that accumulated at any of the cold test temperatures. However, in the test when the fuel temperature was cooled from -12°C to -33°C, the surface of the ice took on a 'pebbly' appearance.

Ice in the flexible hose located at the rear of the strut

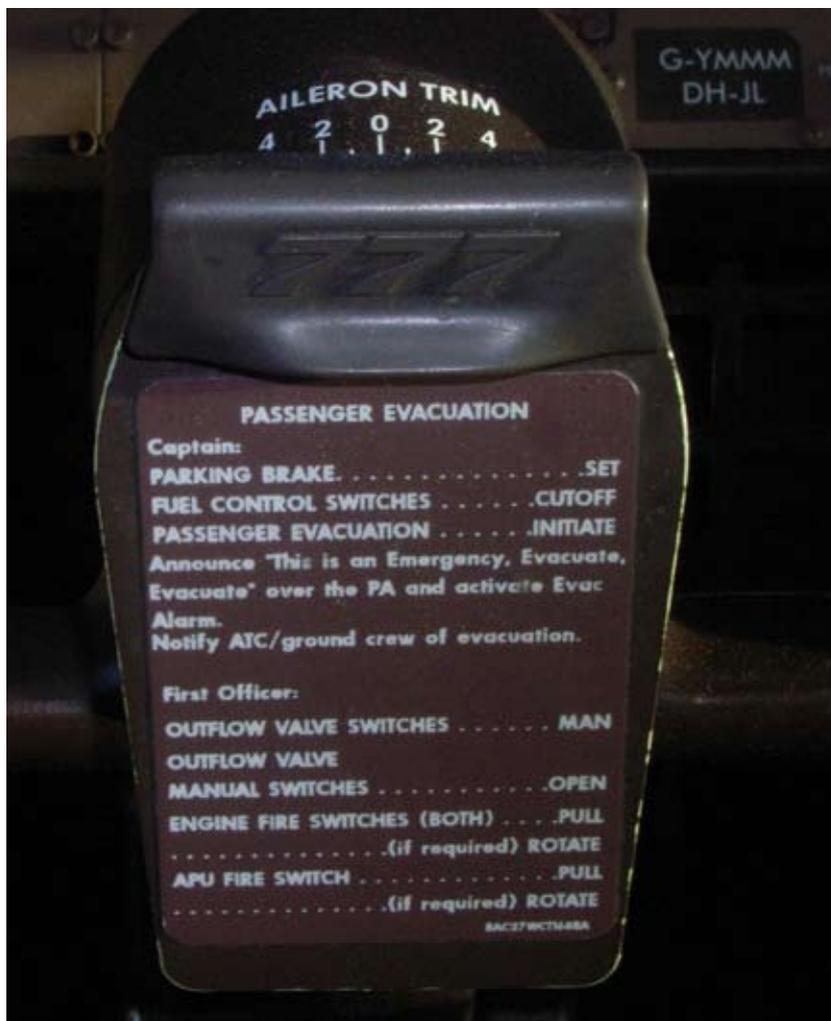
Figure 56

The operator's evacuation checklist, for which Boeing had raised no technical objection, required the commander ('*Captain*') to operate the fuel control switches whilst the co-pilot ('*First Officer*') operated the fire handles, this was in order to reduce the time required to action the checklist. These actions

were carried out independently, with no measure in place to ensure the correct sequencing. The evacuation drill was on a placard mounted on the face of the control column boss (Figure 56).

Evacuation check list on G-YMMM control column

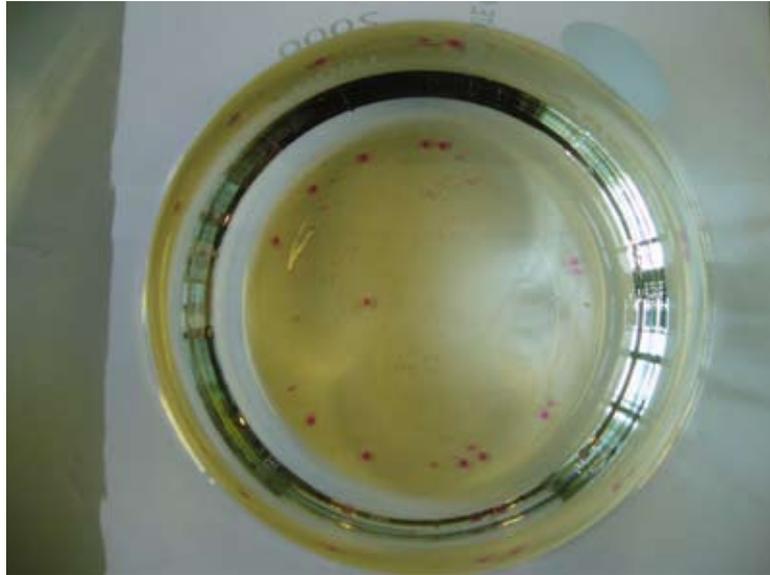
**Figure 59**

Small water droplets were observed in the fuel samples taken from the engine fuel filters and housings. The amount of water was too small to measure and so was classified by reference to the QinetiQ fuel appearance table as being 'small'. Figure 59 is a reconstruction of the QinetiQ description of 'small' using water coloured with food dye.

Reconstruction of a 'small' amount of dyed water in aviation turbine fuel

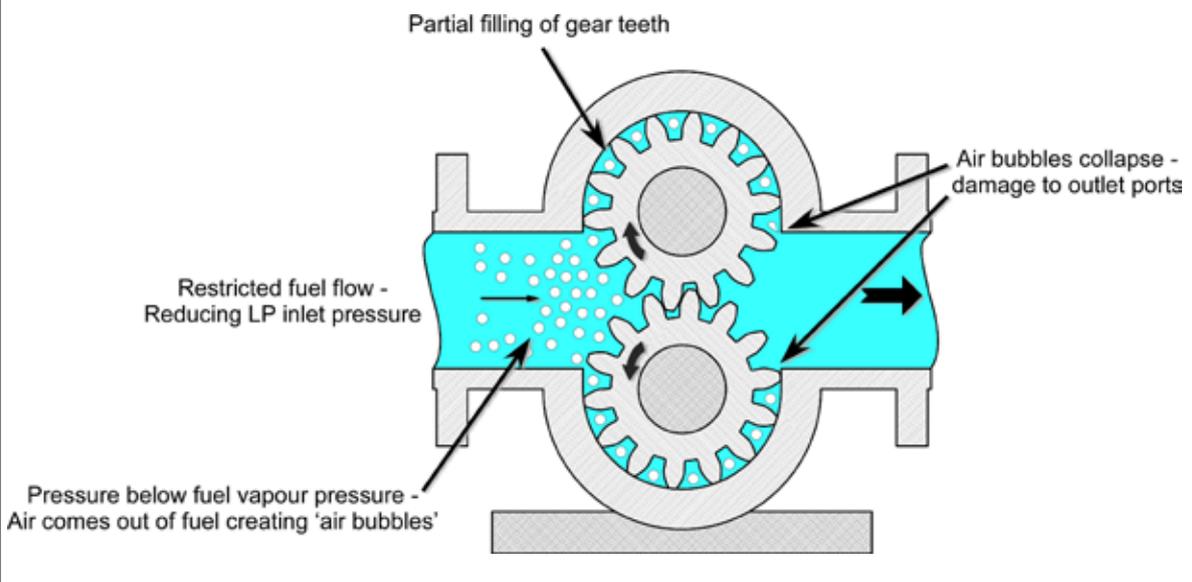
- Picture 4

Cavitation can occur with the presence of fuel vapour or air bubbles in the fluid and, given the low inlet pressure and high velocities, a certain amount of cavitation erosion is not unusual. The erosion is caused by the collapse of the bubbles which occurs violently and creates a shock wave of fluid. Striking a solid surface, the shock wave can cause progressive damage if it persists. In the case of the HP pumps fitted to G-YMMM, a degree of 'normal' cavitation damage is expected on the bearings where the teeth mesh and on the teeth themselves (Picture 4). The rate of erosion is a known quantity and does not affect operation of the pump within its overhaul life.

The inlet pressure to the pump should be maintained such that formation of air/vapour bubbles is minimised and, on most jet aircraft, this is achieved by the combination of aircraft booster and engine low pressure pumps. However, even if these are working correctly, a restriction in fuel flow upstream can result in the HP pump lowering its inlet pressure to the point at which a large quantity of air and vapour bubbles are formed. This gives rise to a mixture of fluid and gas bubbles filling the gear teeth. As these gear teeth open to the high pressure outlet port of the pump, the gas bubbles collapse and the high pressure fuel in the outlet port rapidly fills the available space. Both these actions result in shock waves being formed that cause damage to the outlet port and the delivery side of the bearing faces. This is the abnormal cavitation damage seen on both HP pumps from G-YMMM.

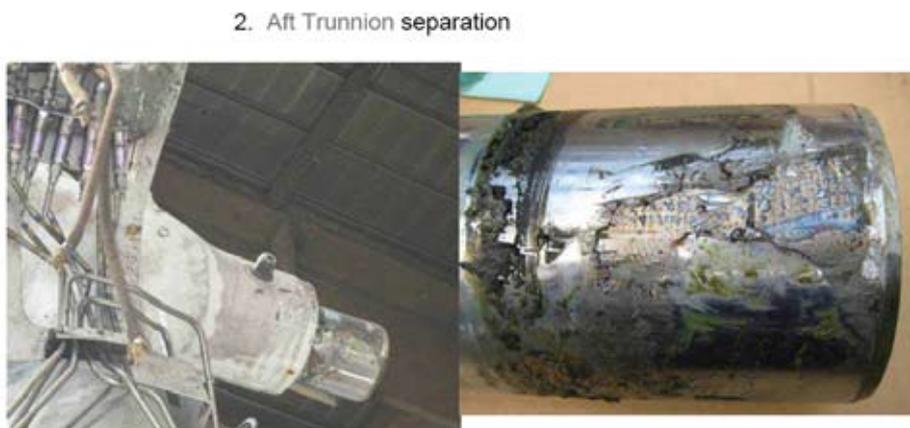
2. Aft trunnion separation

Note the piece of upper wing skin removed by the separation of the upper and lower housings. This impact had pried open the wing tank.

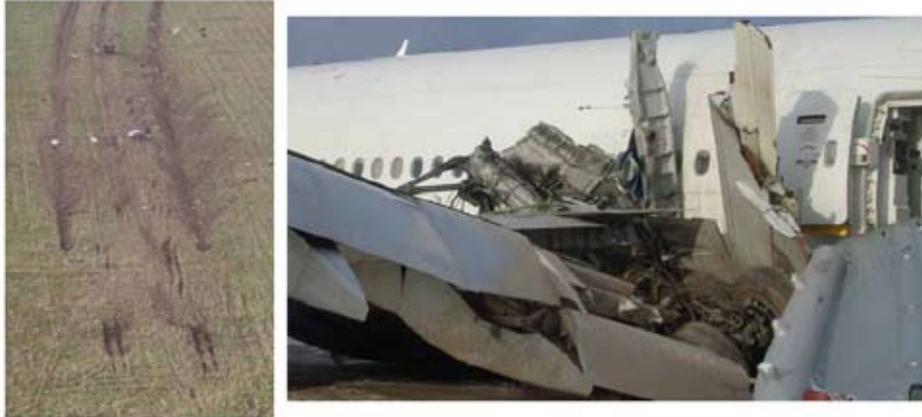
3. Aircraft continued to slide with landing gear attached.

3. Rolling with airplane to rest

4. Final Configuration: Gear beam inboard end damaged but still attached, drag and side brace both folded but still attached.

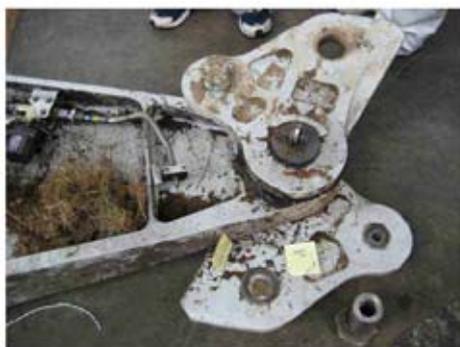
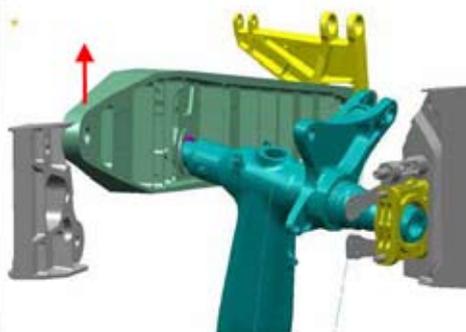
- 1. Initial impact: Gear beam outboard end fuse pins fail and gear beam forced upwards
- Side brace folded and gear beam forced inboard
- Gear beam rotated upwards and contacted the aft trunnion pin
- Forward trunnion lower housing (H block) fuse pins failed

1. Initial Impact
Gear Beam fused upwards

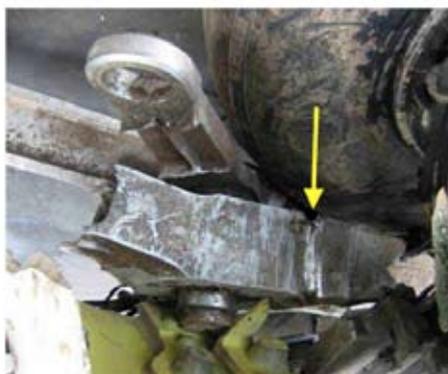
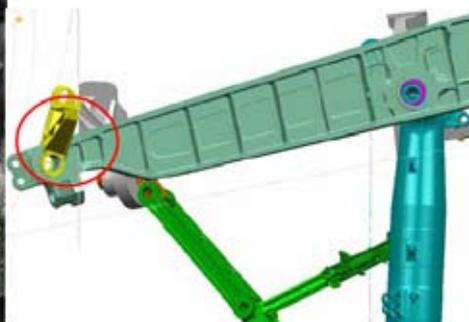
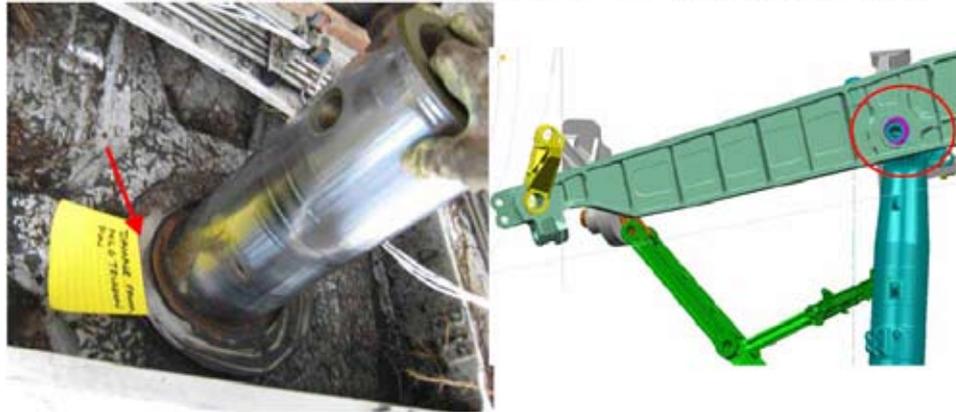
Gear Beam forced Inboard, reaches rotation limit and drives through swing link

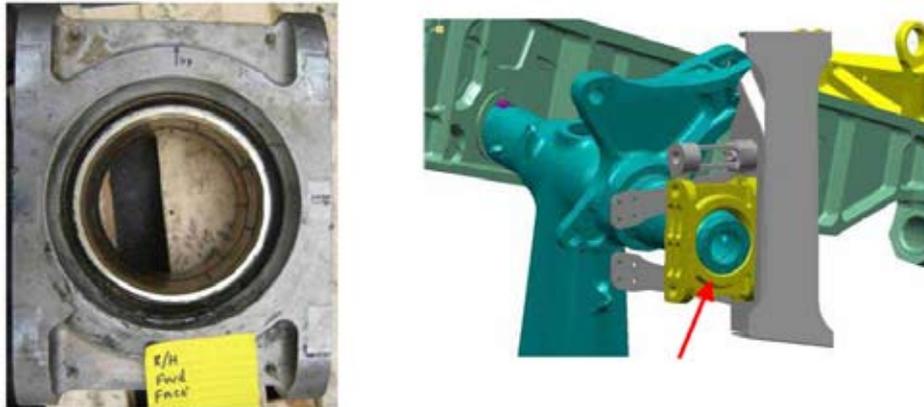
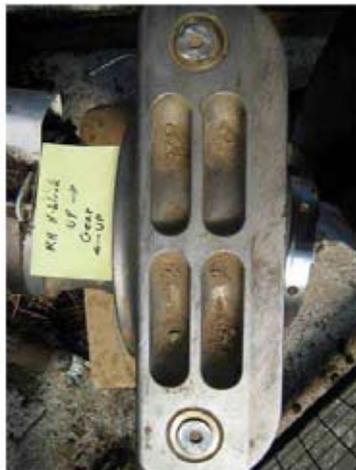
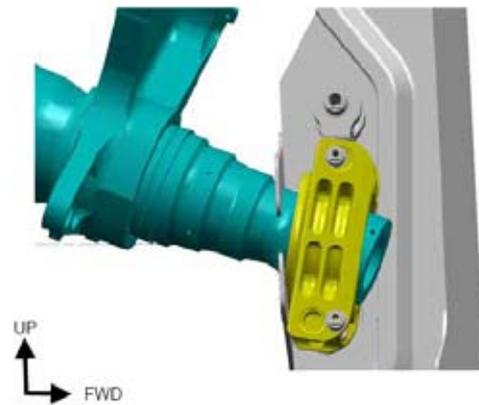
Fwd Trunnion reaches pivot limit on 'H-block' Housing

1. Initial Impact
Forward Trunnion fused

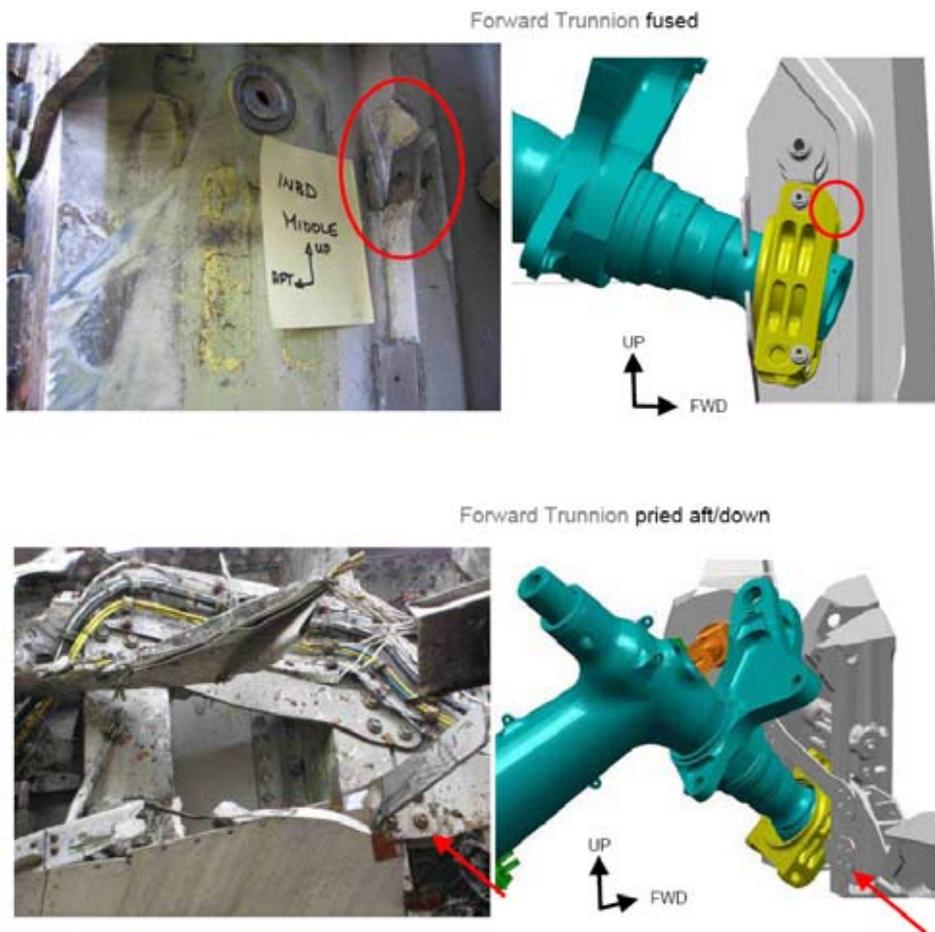
2. Subsequent motion: Forward trunnion levered aft and down

Aft trunnion separated and/or gear beam separated at side brace attachment

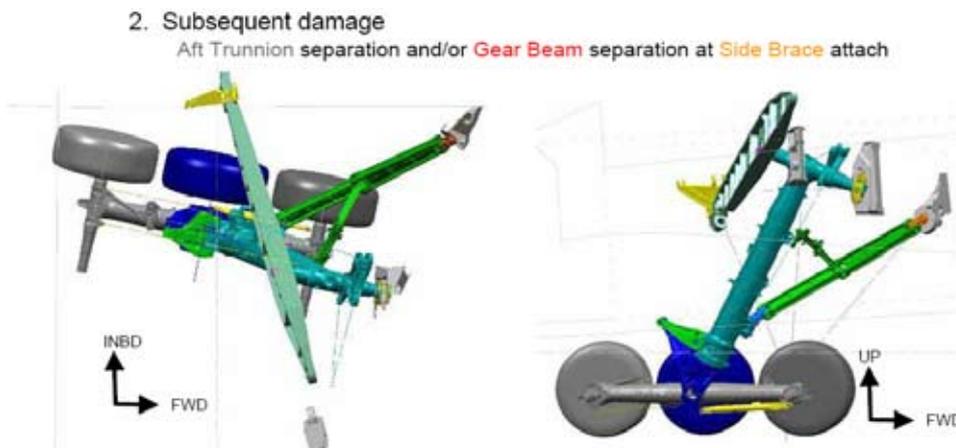
3. Subsequent ground slide: Truck beam fractured

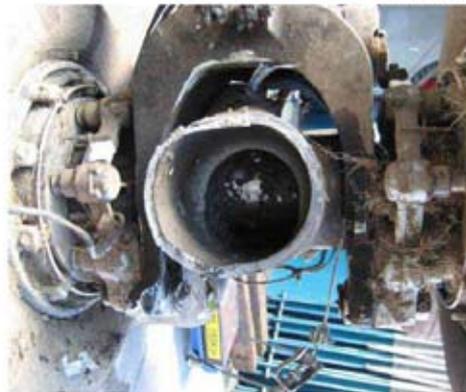
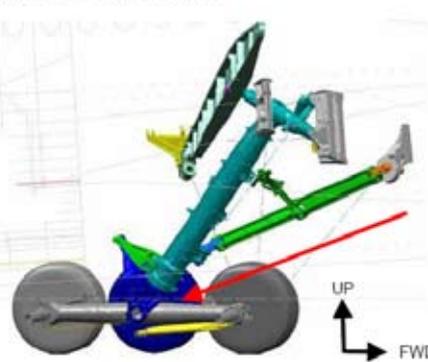
Rear spar web and backup fitting failure and drag brace separation

Truck Beam reaches pitch up limit on Shock Strut/Inner Cylinder and fractures

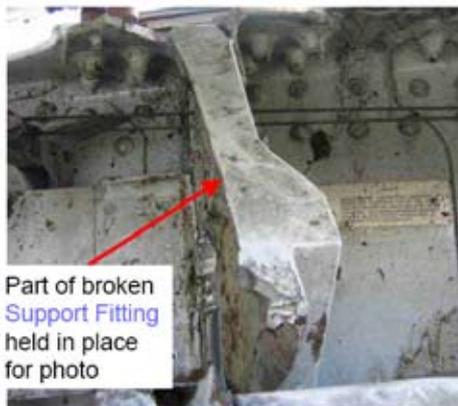
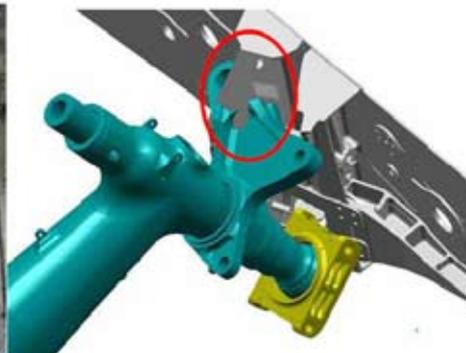
3. Shock Strut / Retract Arm Jams on and destroys upper part of inboard Trunnion Support Fitting

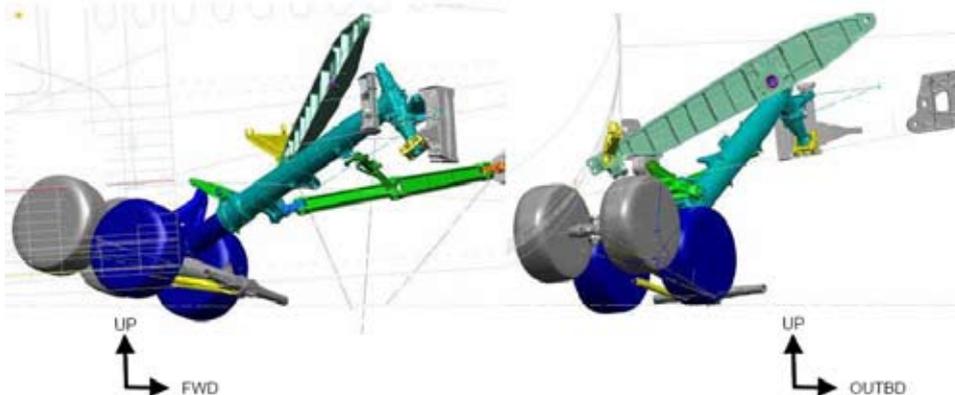
4. Collateral damage: Forward truck beam punctured fuselage skin

Right MLG struck horizontal stabilizer

3. Gear twists on Shock Strut axis and Aft tires impinge on body.

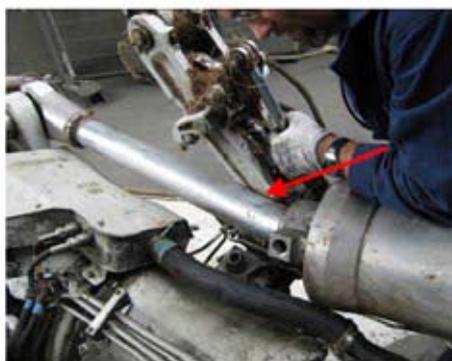
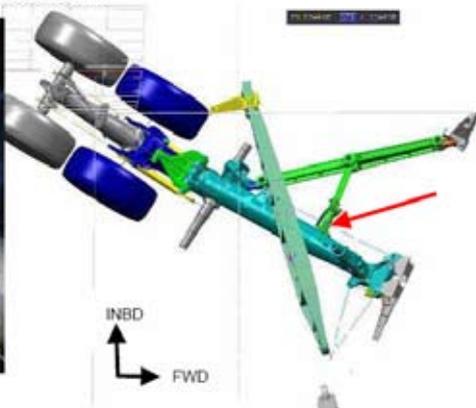
Gear continues twisting until Retract Actuator drives through Drag Brace Lock Link. Drag Brace separation – occurs sometime after this

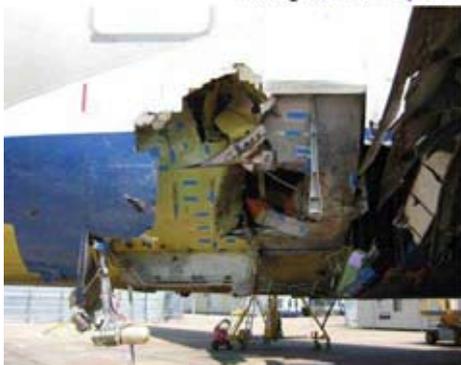
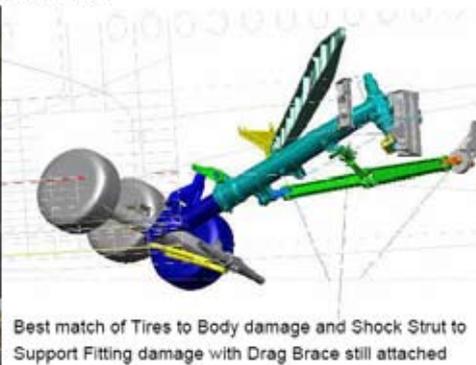
4. Aft Body impact completed after failure of Drag Brace Fitting to Rear Spar attachment

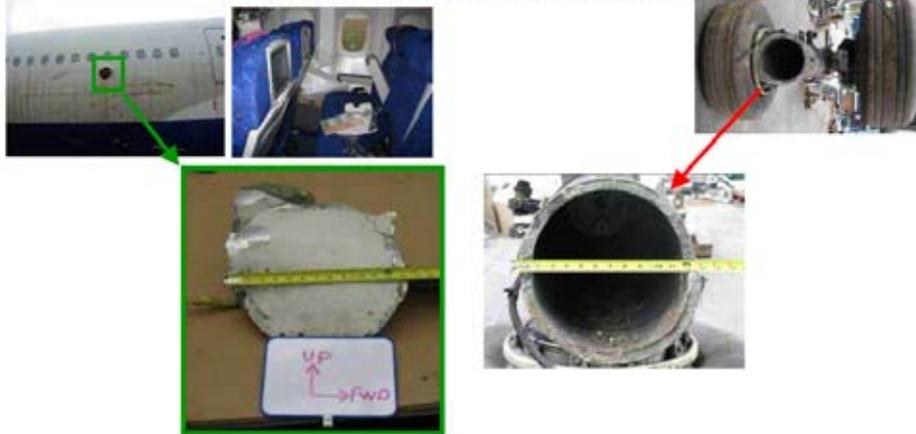
4. Fwd truck beam punctures fuselage skin

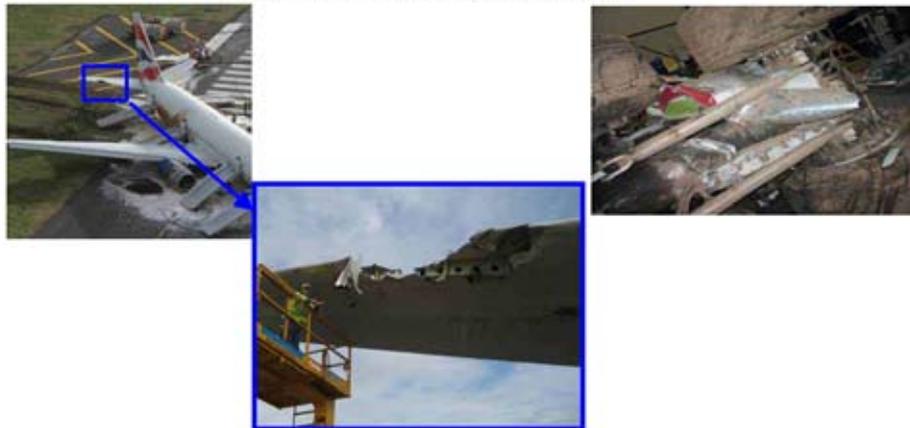
4. Right MLG strikes horizontal stabilizer

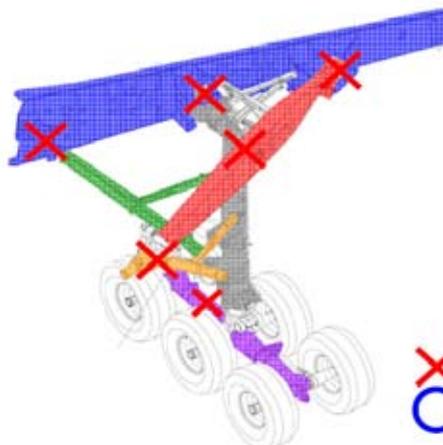
5. Final Configuration

- 6. Final Configuration
- Gear Beam separated
- Oleo and Trunnion separated
- Side Brace separated
- Truck Beam fractured
- Drag Brace separated

- X Joint Separated
- O Joint Remained Attached

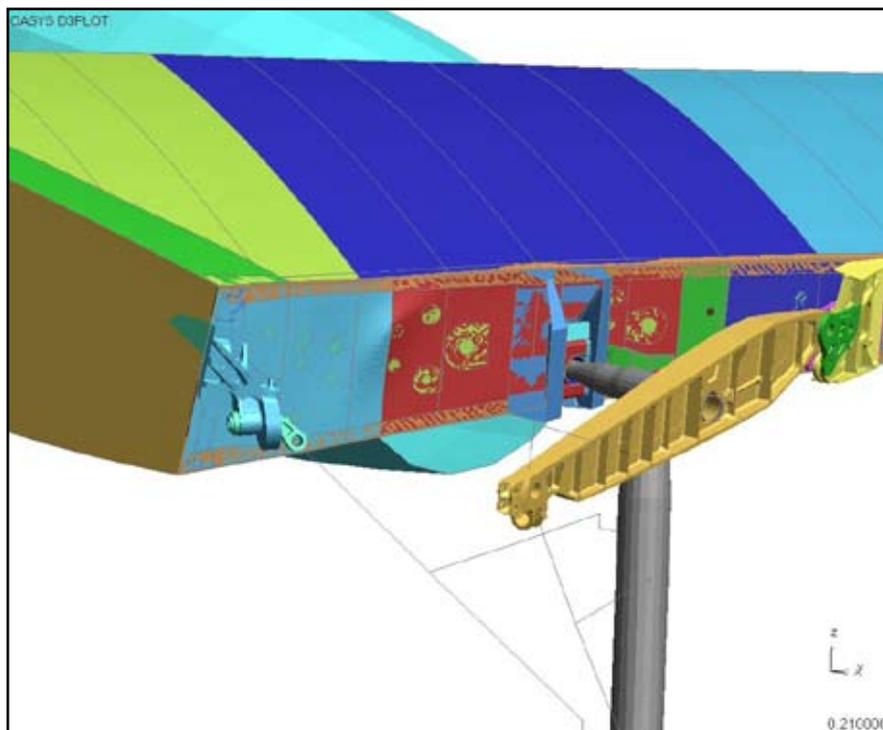
**Figure 67**

It was evident that the behaviour of the model on soft ground was different to that on a hard runway (Run B) in that only one fuse pin failed (the lower pin in the right outboard gear beam).

In the absence of any other fuse pin failures, loads could continue to be transferred into the rear spar. This led to distortion of both rear spars and is illustrated in Figure 67 which shows the right spar. A similar effect was seen in the left rear spar.

Right wing rear spar buckling – Run C (TIME = 0.21 SECS)

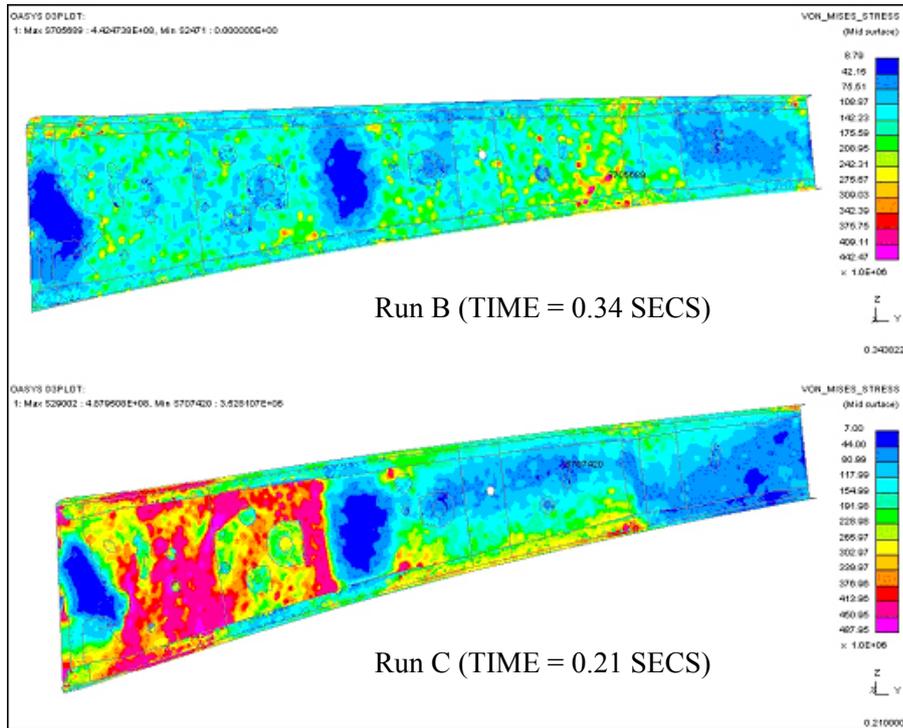
Figure 68 shows a comparison of the Von-Mises stress¹ in Run B (hard runway) and Run C; the red colours indicate higher stresses.

Right wing rear spar buckling Von-Mises stress

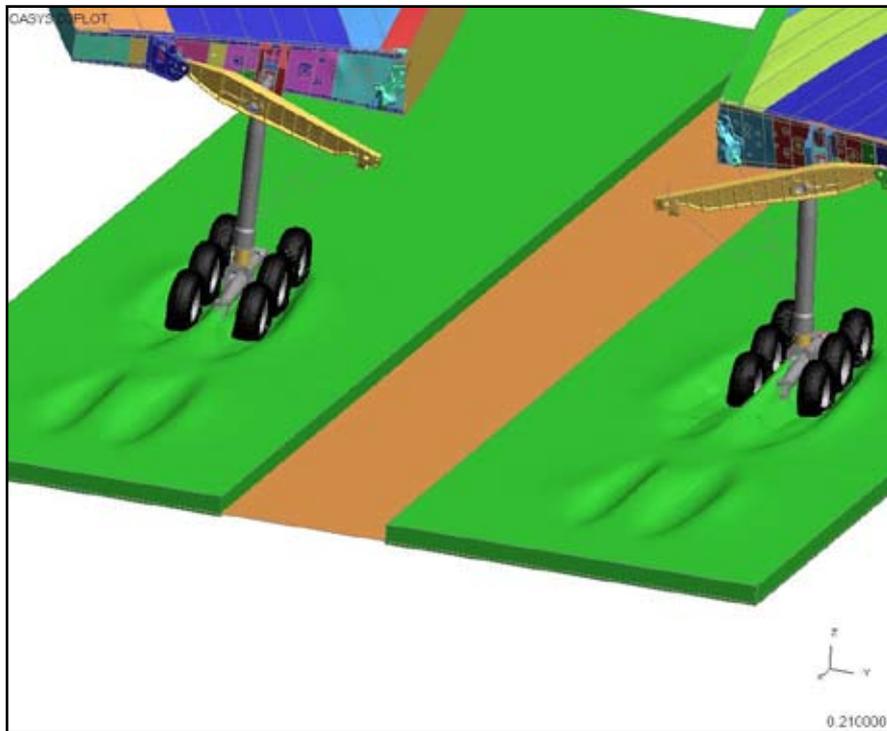
The Figure 69 shows the soft ground deformation.

Soft ground deformation Run C (TIME = 0.21 SECS)
