No: 8/92

Ref: EW/A92/5/1

Aircraft Type and Registration: Boeing 747-212B, G-TKYO

Nature of Damage: Damage to left inboard flaps and wing trailing edge upper fixed panel

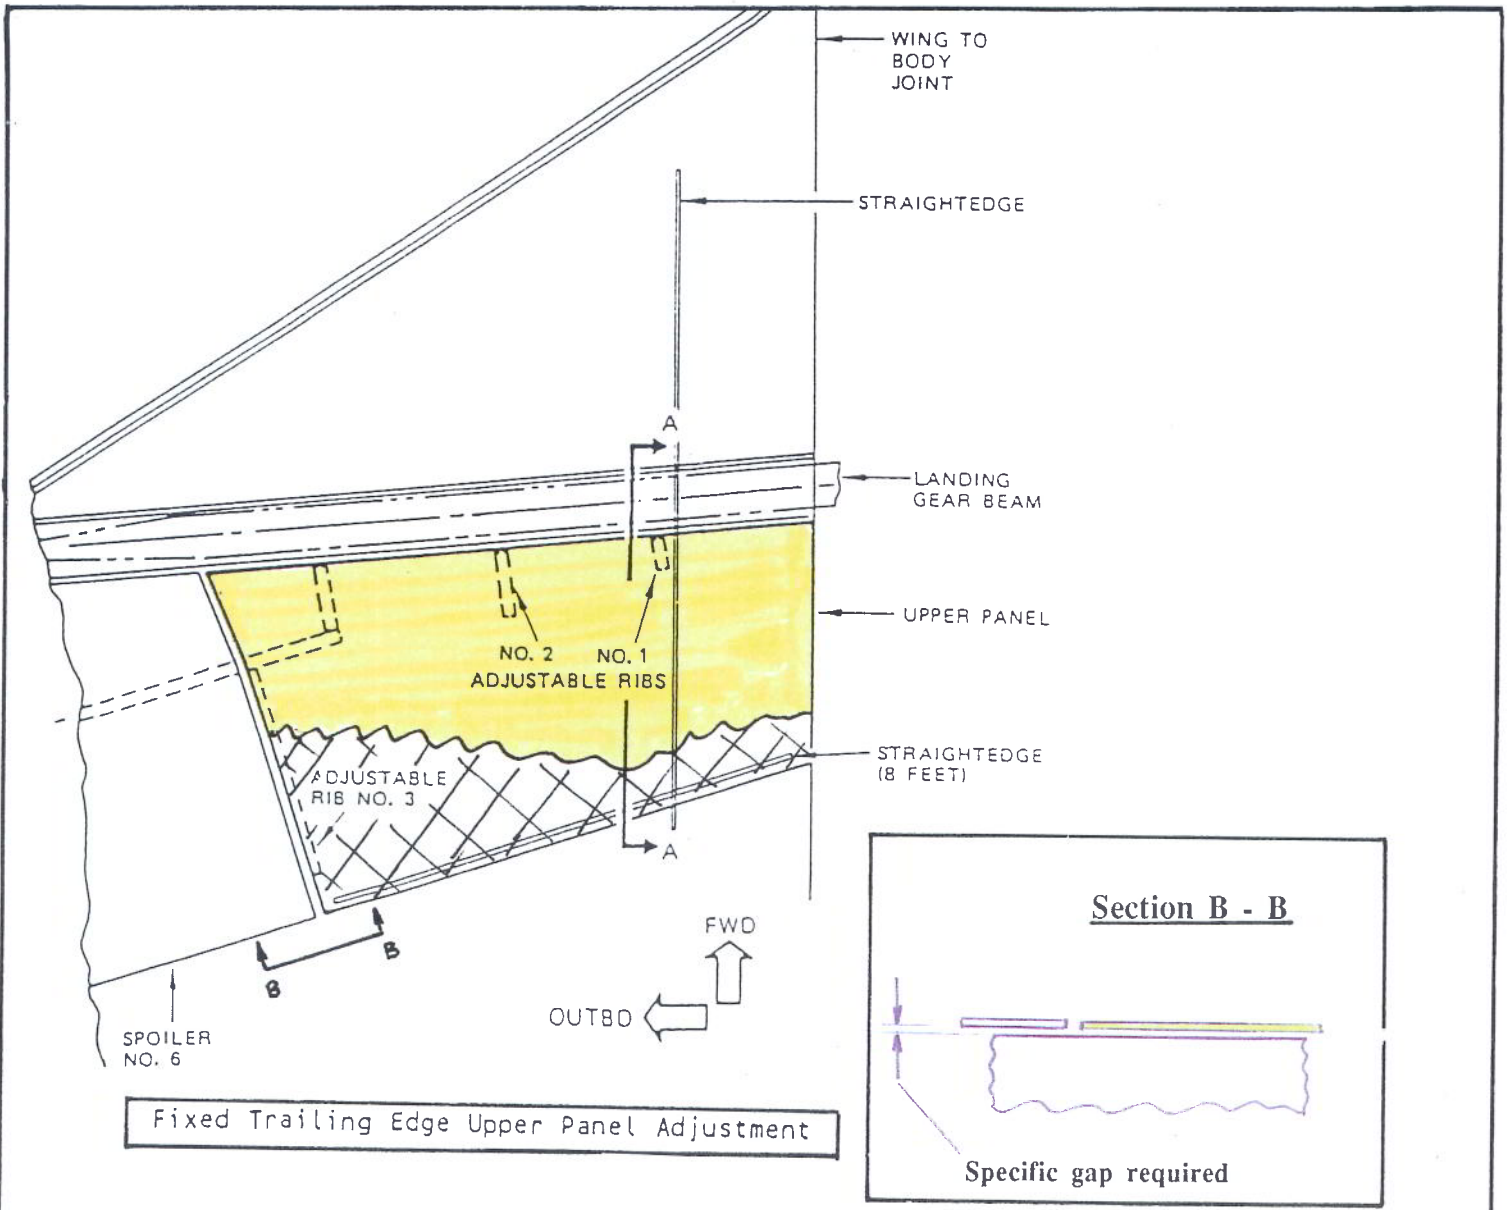
Figure 5 shows the left side panel, after the aircraft had been repaired, rigged in accordance with the revised Service Bulletin and flown back to London Heathrow, with the flaps in the fully retracted position. A measure of contact is evident between the inboard end of the fixed panel and fore-flap but little, if any, at its outboard end (as required). Figure 6 illustrates the rigging requirements.

Flaps fully in, after repair/re-rig
