**INCIDENT**

**Aircraft Type and Registration:** DC-9-32, G-PKBM

**Date & Time (UTC):** 16 November 1993 at 1718 hrs

**Location:** Stand B4, London Heathrow Airport

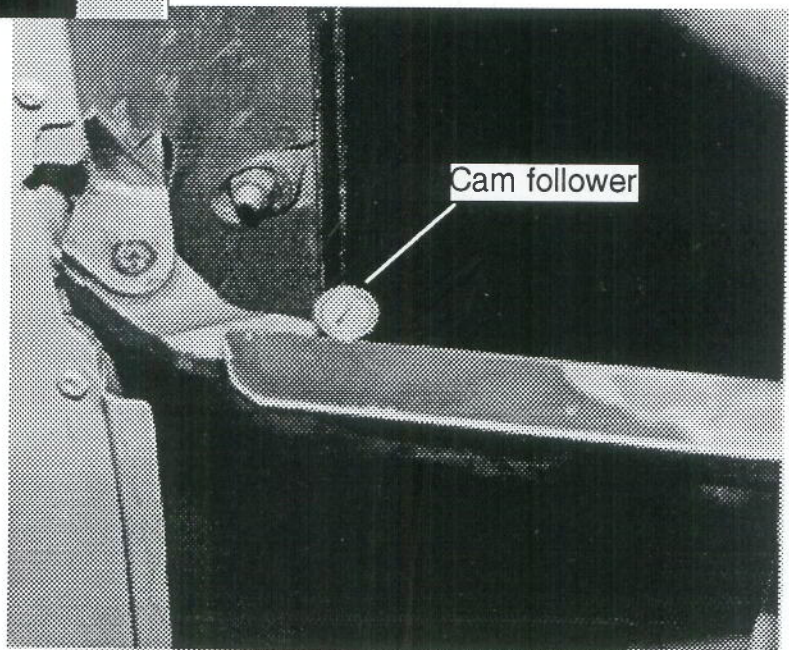
Operation of the door mechanism demonstrated that if the door were opened quickly it was possible to achieve slight overtravel at the end of the forward travel. This could result in the door bouncing back and cause the bayonet bar to end up with its blind side against the spigot, thus preventing the door opening further.

Close-up of cam follower and bayonet showing correct relative positions before separation.

Bayonet positioned on the wrong side of the cam follower, preventing door from opening.
