ACCIDENT

Wing:	Paramania Revolution 23	
Paramotor unit:	Modified H & E Paramotores R120 series	
Year of Manufacture:	2005	
Date & Time (UTC):	8 July 2007 at 1950 hrs	
Location:	Middle Barn Farm, Bexhill, East Sussex	
Type of Flight:	Private	
Persons on Board:	Crew - 1	Passengers - None
Injuries:	Crew - 1 (Fatal)	Passengers - N/A
Nature of Damage:	Substantial	
Commander's Licence:	None required	
Commander's Age:	42 years	
Commander's Flying Experience:	5 years (paramotors)	
Information Source:	AAIB Field Investigation

Synopsis

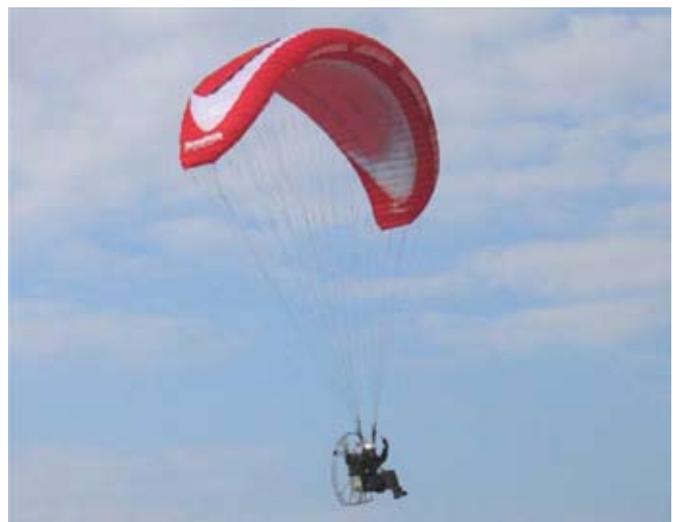
Figure 1

A complete paramotor (Figure 1) consists of a wing (canopy) and a system of suspension lines and risers (shrouds), akin to a paraglider, and a lower ‘paramotor unit’ assembly, accommodating the pilot and powerplant. In the accident aircraft the wing and paramotor units came from separate manufacturers and the paramotor unit had been modified.

Paramotor aircraft - typical
