AIRCRAFT ACCIDENT REPORT 3/2014

**Report on the accident to
Agusta A109E, G-CRST
Near Vauxhall Bridge, Central London
on 16 January 2013**

Air Accidents Investigation Branch

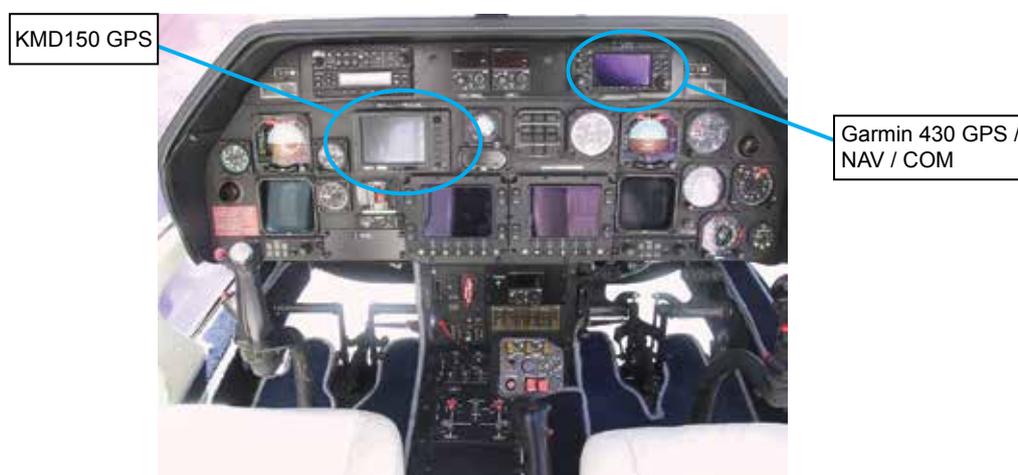
Figure 5 shows a photograph of the cockpit of G-WRBI, taken in March 2009 by the aircraft owner, who stated that it was representative of the cockpit fit of G-CRST at the time of the accident.

G-WRBI cockpit fit (picture courtesy of Castle Air)

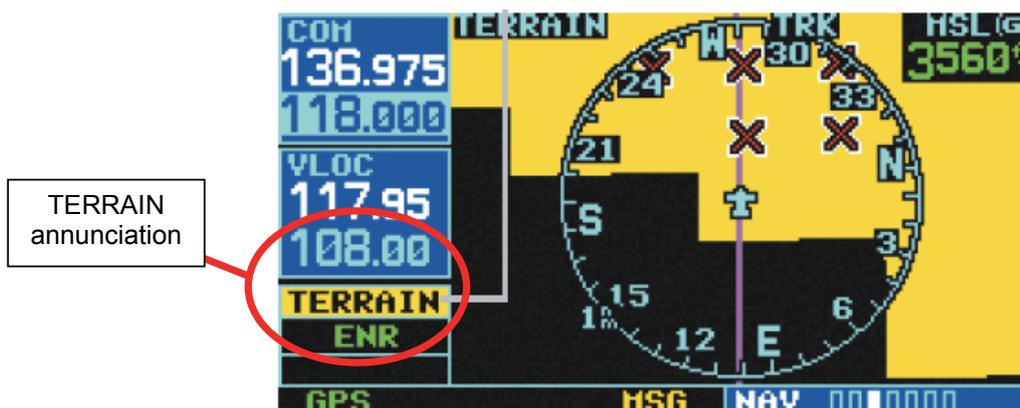
Figure 7

In addition, the device can use flight path data to trigger an alert in respect of terrain or obstacles which may present a hazard. If an alert is triggered, the 'TERRAIN' page provides a flashing 'TERRAIN' annunciation⁸ in the lower left-hand corner 'annunciator field' (Figure 7). There is an option to inhibit this annunciation although the symbols in Figure 6 will still be available. When activated, this will be displayed on the 'annunciator field' as 'TER INHB'.

Garmin 430 TERRAIN page showing TERRAIN annunciation

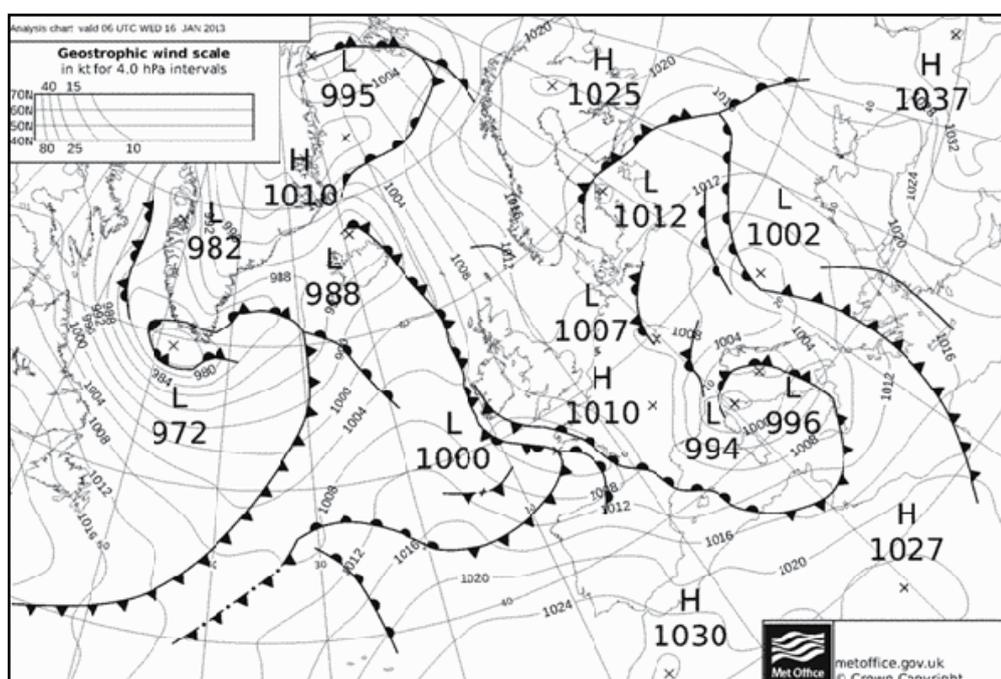
The surface pressure analysis chart is shown at Figure 8 and the forecast weather chart, valid for the time of flight and issued at approximately 2130 hrs the previous evening, is shown at Figure 9. The forecast for area C, the area within which the flight was planned to be flown, was for: isolated areas of freezing fog with a visibility of 200 m; occasional areas of three- to seven-eighths stratus cloud cover with a base of between 200 ft and 600 ft amsl and tops up to 1,500 ft amsl. Locally, in areas of freezing fog, the base of cloud was expected to be on the surface. The freezing point was forecast to be between the surface and 1,000 ft agl (occasionally 2,000 ft agl).

Surface analysis chart valid at 0600 UTC on 16 January 2013

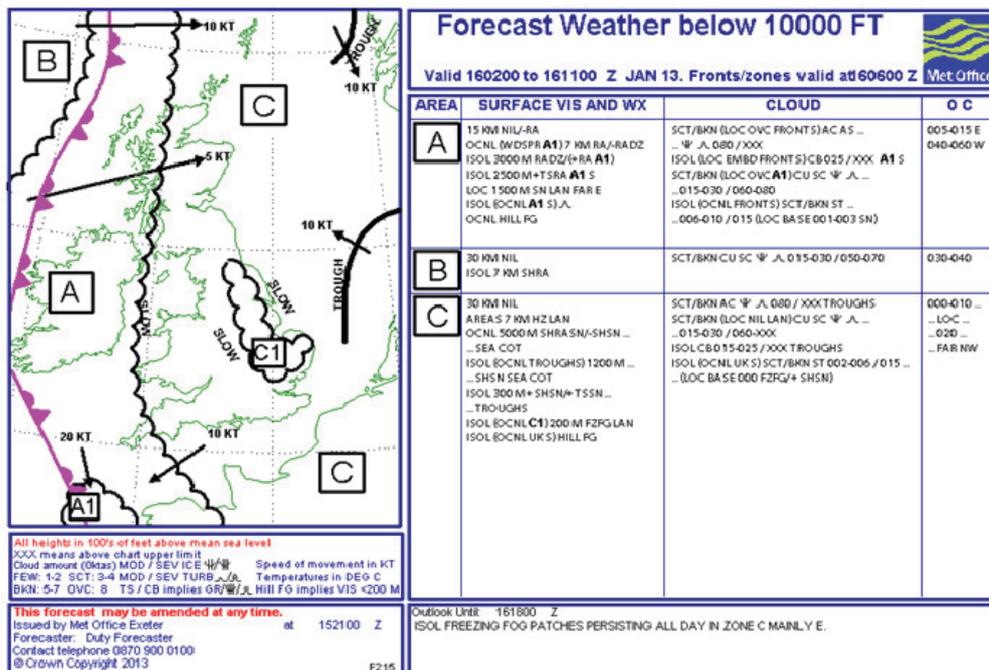
Figure 9

Forecast weather below 10,000 feet

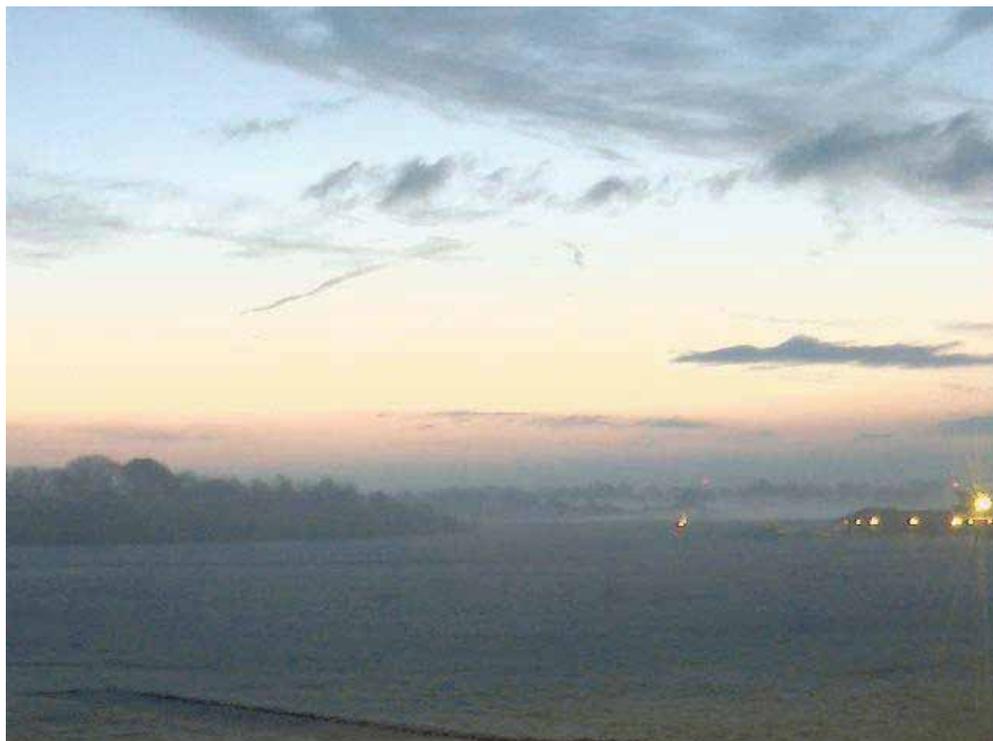
Information from the Redhill Aerodrome Common Automatic Weather Station ATIS on 16 January 2013 showed that, between 0720 hrs and 0804 hrs, the wind at the aerodrome was variable in direction at 1 kt, the temperature was between -5°C and -6°C, and the visibility was between 1,300 m and 5,000 m. Throughout the period, the system was reporting “no cloud detected” (NCD). Figure 10 is an image showing the weather conditions at Redhill Aerodrome at 0730 hrs.

Image of the weather at Redhill Aerodrome at 0730 hrs
on 16 January 2013

The pilot was subject to operational and commercial pressures and was required to consider their associated risks when making the decision to operate the flight. The weather conditions at Redhill Aerodrome had begun to clear (see Figure 10) and the pilot would have been able to return there if the weather at Elstree Aerodrome reflected the forecast. He therefore had a safe contingency plan before departure. However, the weather forecast indicated that a large

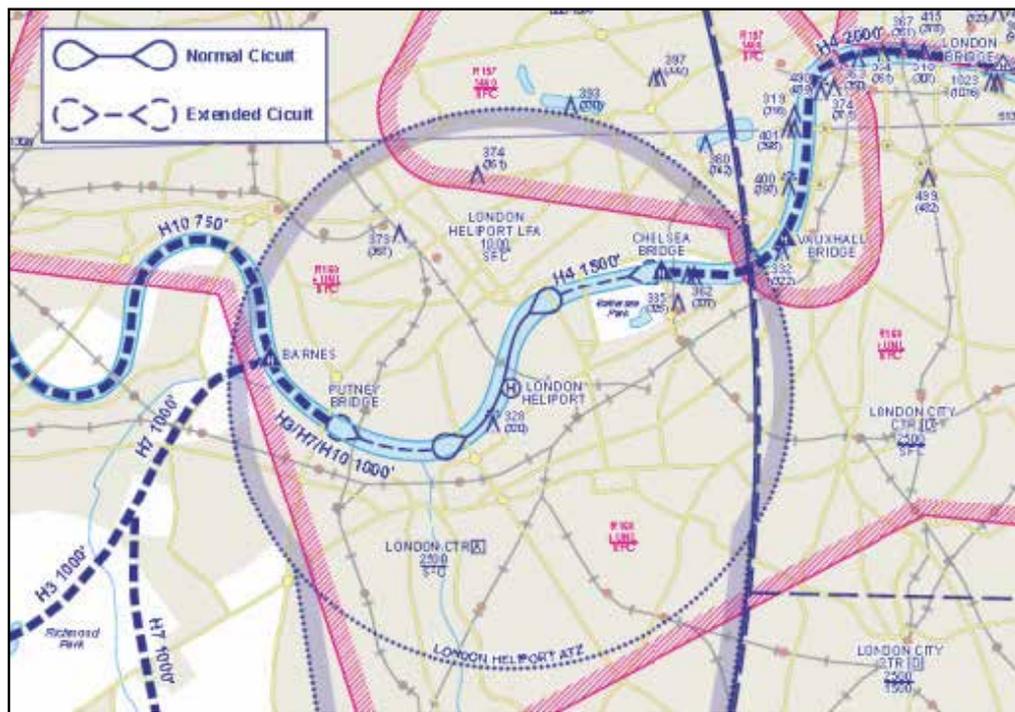
Figure 11

The traffic circuit is a non-standard shape established over the River Thames between Chelsea Bridge and Putney Railway Bridge and is flown at 1,000 ft amsl. The crosswind and base legs are reduced to turns which should be made, as far as practicable, over the river and above 500 ft agl.

Map of circuit procedures at the London Heliport
(UK AIP: AD 2-EGLW-4-1)

St George Wharf lies just outside London Heliport ATZ and does not impinge upon its takeoff and climb surfaces (Figure 11). Nevertheless, in August 2008, the heliport operator sent an e-mail to the Aerodrome Standards Department (ASD)¹⁸ at the CAA in relation to this development to try and gain clarification on the interests of the heliport (protecting the ATZ and takeoff and climb surfaces) and the wider CAA interest of protecting helicopters transiting the ATZ or flying along the designated helicopter routes. In January 2009, the heliport operator sent an e-mail to the CAA in relation to en route safeguarding. The operator commented that, in conditions of reduced cloud base, the development at St George Wharf appeared to raise a conflict between standard operating altitudes on helicopter route H4 and a pilot's obligation to adhere to Rule 5, the Low-Flying Rule. There was no further evidence available in respect of either of these emails to indicate whether or not any conclusion was reached in relation to the matters raised.

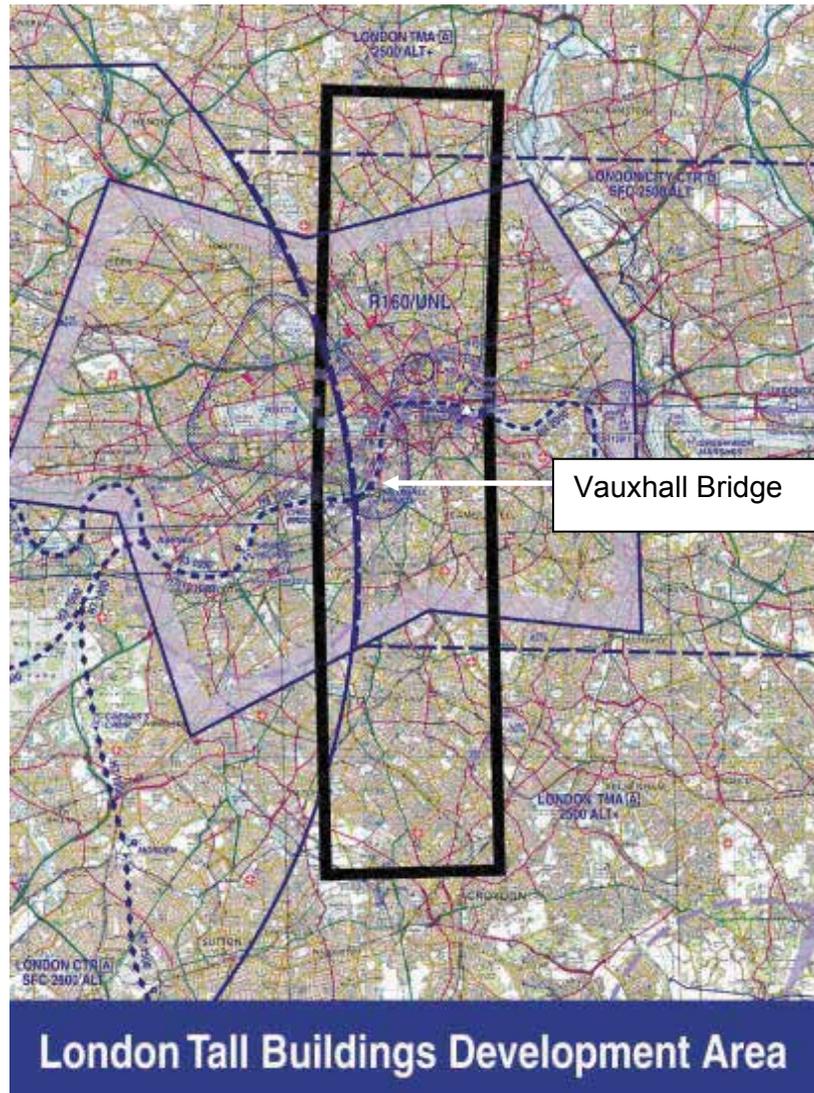
Figure 18

Appendix C of CAP 738, *London Tall Buildings Policy*, discusses safeguarding policy for London airspace and defines an area known as the London Tall Buildings Development Area (see Figure 18). The CAA will support an objection by London Heathrow or City Airports to a proposed development within this area when the development's height would be in excess of 1,000 feet amsl.

London Tall Buildings Development Area (within the black boundary)
