INCIDENT

Aircraft Type and Registration:	Dornier 328-110, D-CPRW	
No & Type of Engines:	2 Pratt & Whitney PW 119B turboprop engines	
Year of Manufacture:	1998	
Date & Time (UTC):	18 January 2006 at 1255 hrs	
Location:	On approach to Runway 24R at Manchester Airport	
Type of Flight:	Public Transport (Passenger)	
Persons on Board:	Crew - 3	Passengers - 17
Injuries:	Crew - None	Passengers - None
Nature of Damage:	None	
Commander's Licence:	Airline Transport Pilot's Licence	
Commander's Age:	46 years	
Commander's Flying Experience:	4,600 hours (of which 400 were on type) Last 90 days - 148 hours Last 28 days - 51 hours	
Information Source:	AAIB Field Investigation

Synopsis

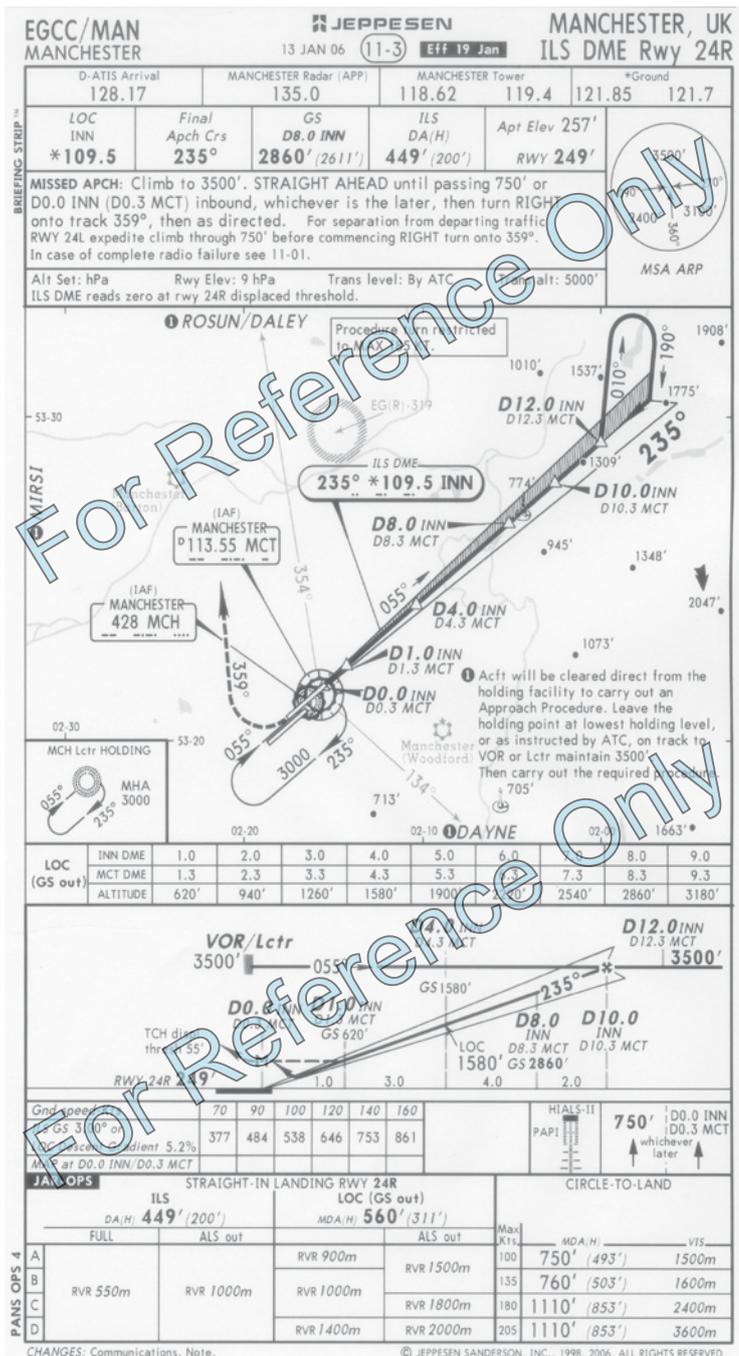
Figure 3

The crew of D-CPRW were using current Jeppesen approach charts. The relevant approach chart for Runway 24R, Figure 3, shows the Final Approach Fix at 10 DME, based on the ILS, at an altitude of 3,500 ft amsl; the runway elevation is 249 ft.
