INCIDENT

Aircraft Type and Registration:	Airbus A321-231, G-EUXL	
No & Type of Engines:	2 International Aero Engine V2533-A5 turbofan engines	
Year of Manufacture:	2007 (Serial no: 3254)	
Date & Time (UTC):	20 December 2011 at 1542 hrs	
Location:	Near London Heathrow Airport	
Type of Flight:	Commercial Air Transport (Passenger)	
Persons on Board:	Crew - 7	Passengers - 116
Injuries:	Crew - None	Passengers - None
Nature of Damage:	None	
Commander's Licence:	Airline Transport Pilot's Licence	
Commander's Age:	44	
Commander's Flying Experience:	8,570 hours (of which 3,445 were on type) Last 90 days - 68 hours Last 28 days - 18 hours	
Information Source:	AAIB Field Investigation

Synopsis

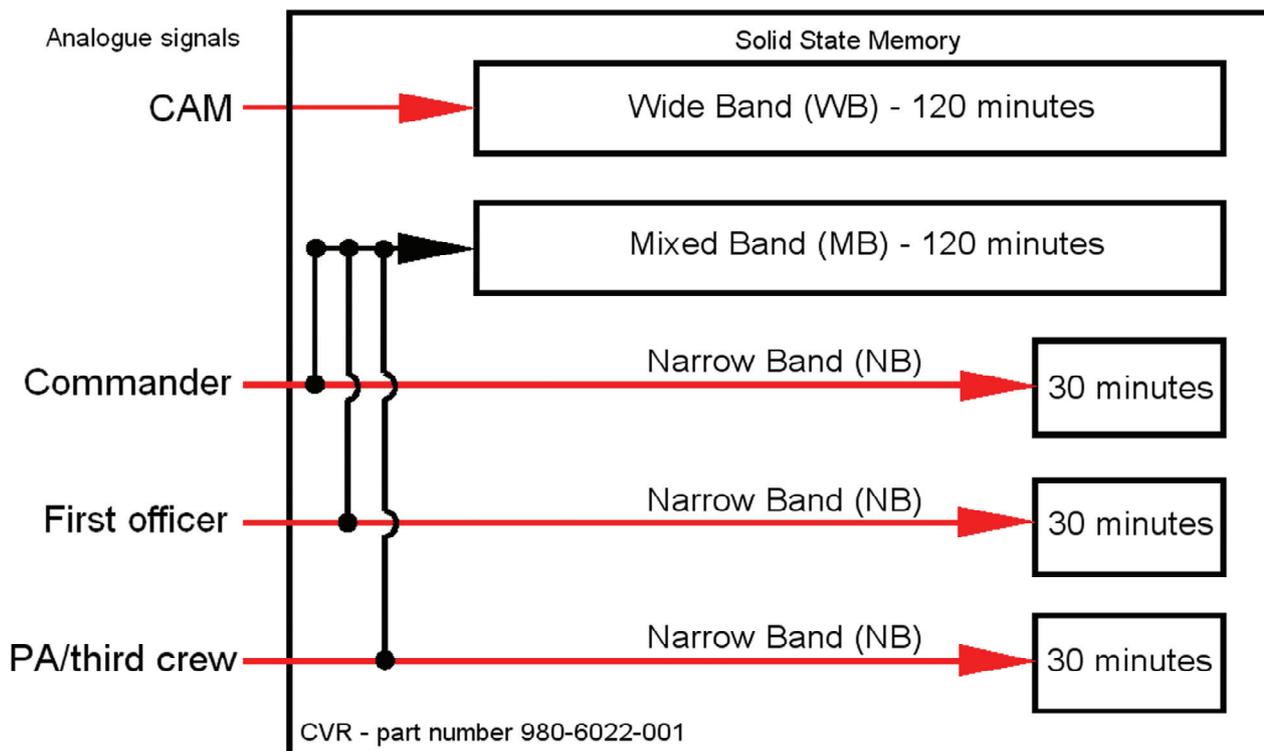
Figure 3

communications are recorded to two 120-minute duration channels, and the most recent 30 minutes of the commander's, co-pilot's and PA/third crew member's communications to three separate channels (see Figure 3).

The CVR manufacturer refers to the CAM channel as the wide band (WB) channel, the combination of the commander's, co-pilot's and PA/third crew member's communications as mixed band (MB) and the three 30-minute channels as narrow band (NB). These terms are referenced for brevity where required.

The initial recording process consists of the analogue-to-digital conversion of the four audio signals. The commander's, co-pilot's and PA/third crew member's communications channels are also combined at this stage to generate the MB channel. The digital data for each of the five channels is then passed to a single integrated circuit (IC), referred to as the 'data packer'². This component is central to the correct operation of the recorder. Under software control, the Data Packer component collects and packs the digital data into packets prior to it being written to the solid state memory. The data packer IC also forms part of the unit's Built-In Test (BIT) function.

CVR channel architecture
