## ACCIDENT

<b>Aircraft Type and Registration:</b>	Medway Microlights Raven X, G-MYVW	
<b>No &amp; Type of Engines:</b>	1 Rotax 447 piston engine	
<b>Year of Manufacture:</b>	1995	
<b>Date &amp; Time (UTC):</b>	9 June 2006, between 1332 hrs and 1412 hrs	
<b>Location:</b>	North of Cliffe, Kent	
<b>Type of Flight:</b>	Training	
<b>Persons on Board:</b>	Crew - 1	Passengers - None
<b>Injuries:</b>	Crew - 1 (Fatal)	Passengers - N/A
<b>Nature of Damage:</b>	Aircraft destroyed	
<b>Commander's Licence:</b>	Student Pilot	
<b>Commander's Age:</b>	41 years	
<b>Commander's Flying Experience:</b>	40 hours (of which 18 were on type) Last 90 days - 7 hours Last 28 days - 7 hours	
<b>Information Source:</b>	AAIB Field Investigation

## Synopsis

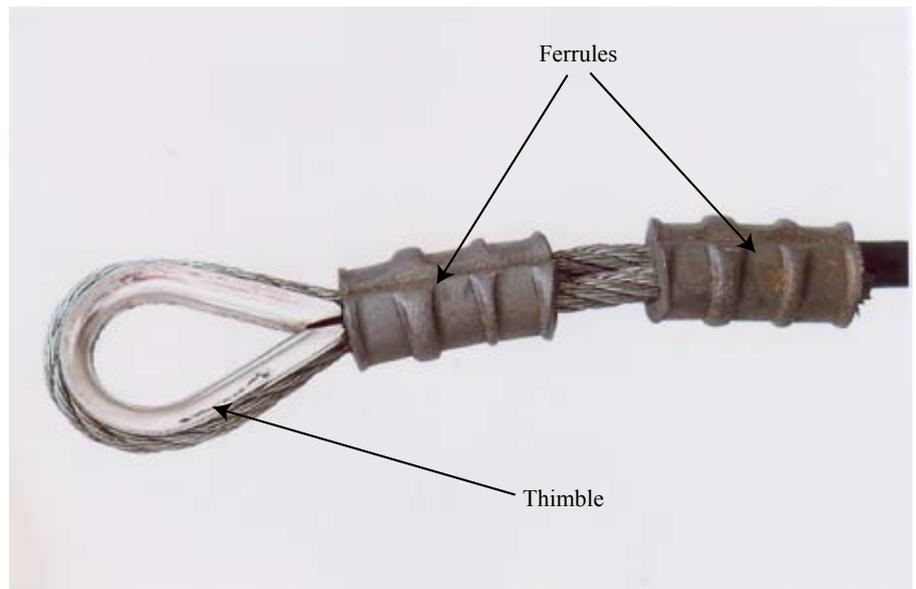
**Figure 3**

The microlight was transported to the AAIB facility for further examination. This did not reveal any pre-impact anomalies but the failed rear flying cables were selected for detailed examination, since the failure mode of the swaged fittings did not appear to be that of a properly-made swage. Essentially, the terminations of the cables are constructed by doubling the cable back on itself around a looped fitting known as a 'thimble' (see Figure 2). Two copper ferrules are then crimped around the two strands of cable, normally using a hand tool which squeezes the ferrules down to a smaller dimension. This dimension is checked using a simple 'go / no-go' gauge – if the joint has been properly swaged, and using the

In the case of G-MYVW, the rear flying cables had pulled through the swage fittings at one end (see Figure 3), leaving just a thimble attached to each side of the ‘A’ frame.

Broken rear cable from G-MYVW
