**INCIDENT**

<b>Aircraft Type and Registration:</b>	Aerospatale AS355F1, G-FFRI	
<b>No &amp; Type of Engines:</b>	2 Allison 250-C20F turboshaft engines	
<b>Category:</b>	2.2	
<b>Year of Manufacture:</b>	1982	
<b>Date &amp; Time (UTC):</b>	19 July 2004 at 0945 hrs	
<b>Location:</b>	Near Lasham Airfield, Hampshire	
<b>Type of Flight:</b>	Public Transport	
<b>Persons on Board:</b>	Crew - 1	Passengers - None
<b>Injuries:</b>	Crew - None	Passengers - N/A
<b>Nature of Damage:</b>	Damage to right engine drivetrain and coupling housing tube	
<b>Commander's Licence:</b>	Airline Transport Pilot's Licence	
<b>Commander's Age:</b>	59 years	
<b>Commander's Flying Experience:</b>	7,200 hours (of which 1,800 were on type) Last 90 days - 60 hours Last 28 days - 18 hours	
<b>Information Source:</b>	AAIB Field Investigation

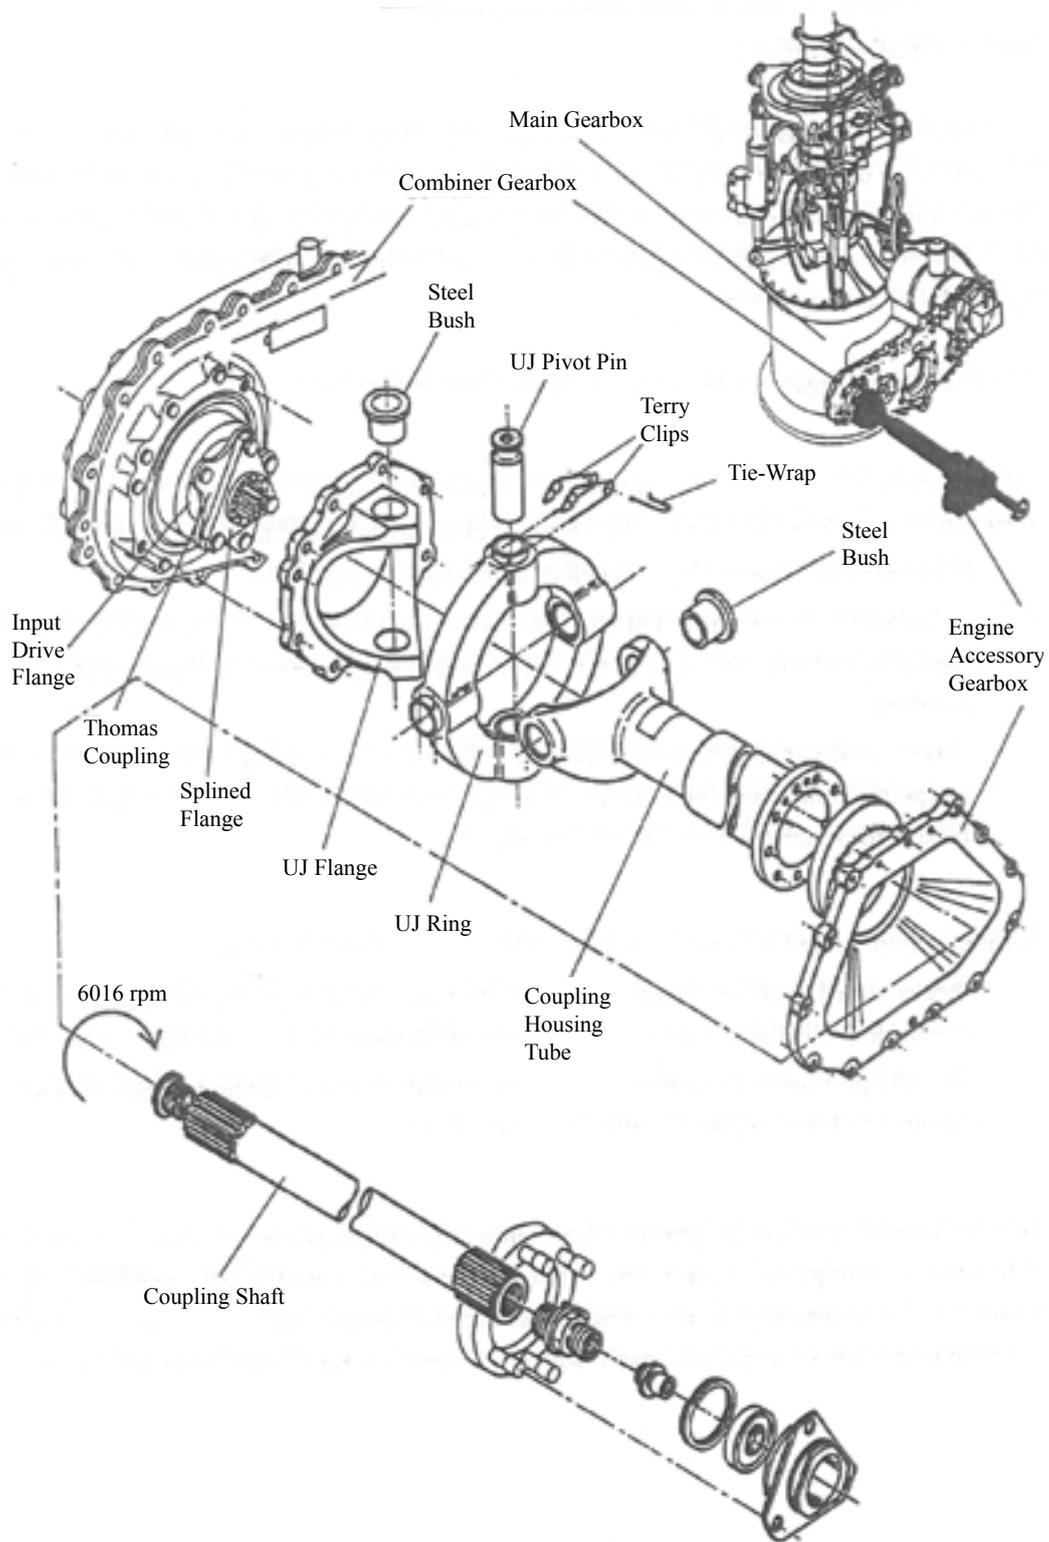
**Figure 1**

The coupling housing tube is a structural part of the engine accessory gearbox (see Figure 1) and is attached to the combining gearbox via a universal, or gimbal, joint. This is because the coupling housing tube is a fundamental part of the engine mounting structure. The engine itself is mounted on a single elastomeric point and the housing tube-to-combining gearbox attachment forms the second element to locate the engine. In the absence of the latter, the engine is free to rock laterally and longitudinally around the single bolt in the elastomeric mount. The No 2 engine of G-FFRI was in this condition since the universal joint had been destroyed by the flailing Thomas coupling/drive shaft. The coupling itself had broken into scores of pieces and was distributed around the Main Rotor Gearbox (MRGB) compartment.

Engine to Main Gearbox Drive Train - exploded view
