ACCIDENT

Aircraft Type and Registration:	Fokker 50, OO-VLQ
No & Type of Engines:	2 Pratt and Whitney 125B turboprop engines
Year of Manufacture:	1989
Date & Time (UTC):	25 August 2005 at 2058 hrs
Location:	Cardiff Airport, South Glamorgan
Type of Flight:	Public Transport (Passenger)
Persons on Board:	Crew - 3 Passengers - None
Injuries:	Crew - None Passengers - N/A
Nature of Damage:	Port wingtip and three feet of leading edge damaged
Commander's Licence:	Dutch Air Transports Pilot's Licence
Commander's Age:	39 years
Commander's Flying Experience:	9,000 hours (of which 5,500 were on type) Last 90 days - 180 hours Last 28 days - 50 hours
Information Source:	Aircraft Accident Report Form submitted by the pilot, reports submitted by the handling agent and further enquiries by the AAIB

Synopsis

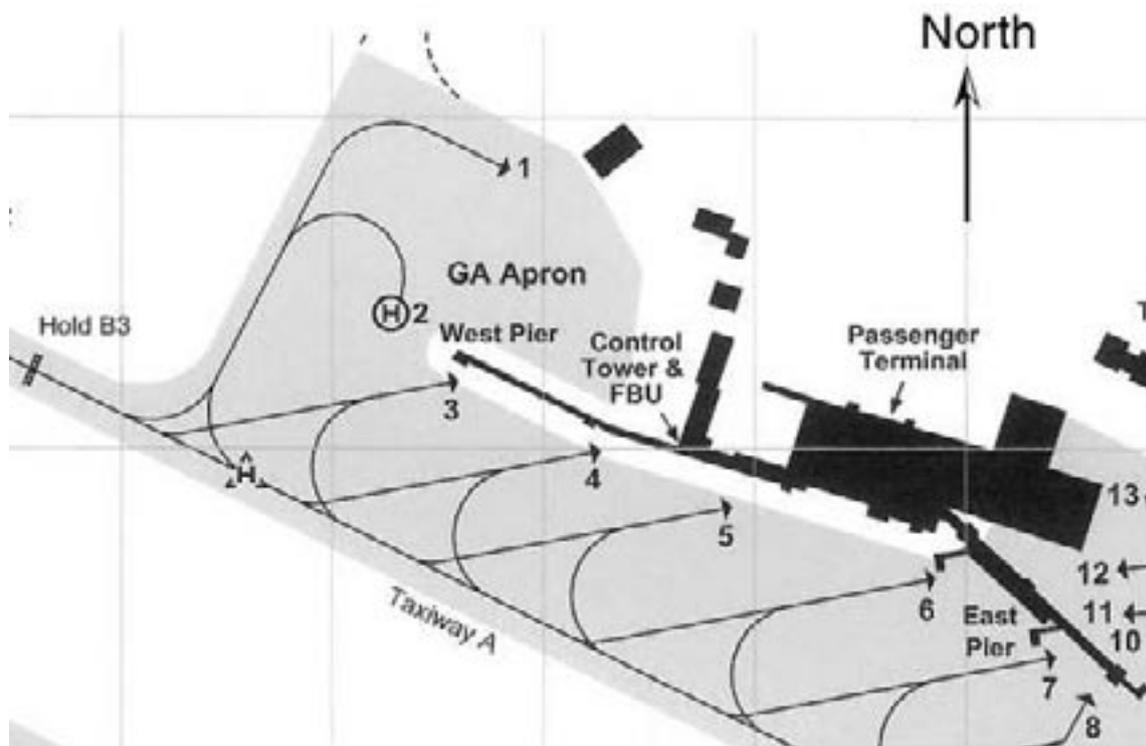
The aircraft dispatcher was standing at the end of the West Pier to wait for the aircraft to come onto Stand 3 (see Figure 2 for a plan of the stands). As the aircraft was being brought along the edge of adjacent Stand 2, he was not unduly alarmed by the approaching aircraft as he thought the marshaller was going to turn the aircraft quite late in order to line it up with the line on Stand 3, as this was common practise. When the aircraft was

Extract from Cardiff Airport AIP chart
