INCIDENCE OF COWLINGS, FAIRINGS AND DOORS OPENING IN FLIGHT

(A) AS 330 PUMA

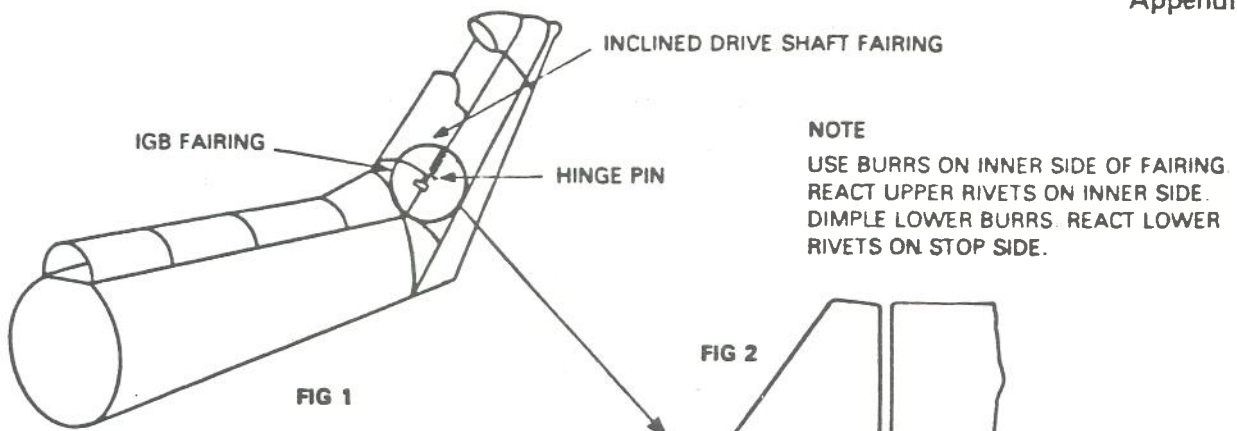
FIG 1

NOTE

USE BURRS ON INNER SIDE OF FAIRING.
 REACT UPPER RIVETS ON INNER SIDE.
 DIMPLE LOWER BURRS. REACT LOWER RIVETS ON STOP SIDE.
