AAIB Bulletin No: 3/95

Ref: EW/C94/12/3

Aircraft Type and Registration: Aerospatiale AS350B2 Ecureuil, G-PLMG

Location: Ballachulish, Scotland

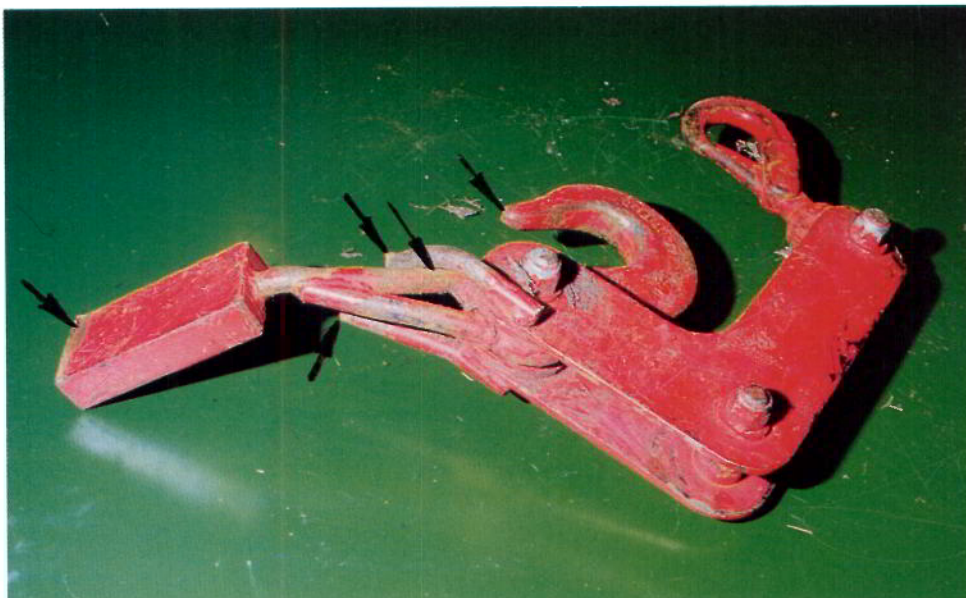
More detailed examination of what initially appeared to be accident damage to the self-releasing hook revealed that this damage was in fact not consistent with the impact, and consequently must have occurred between the point of last departure, when the hook had been used successfully (and must therefore have been serviceable) and the accident. The lower corner of the counterbalance weight was heavily bruised and its mounting arm was bent (in the same direction as the bruise); both of the two keeper rods adjacent to the self-releasing hook were bent and bruised at their ends (the bruising and bending being in the same direction as that of the counterbalance), and there was a bruise and gouge at the *tip* end of the hook. A deep bruise was also visible on the counterbalance arm, where the bent keeper rod had been driven forcibly back against it. Figure 4 shows the deformation of the hook and identifies the sites of the damage. The surface textures of the bruises to the counterbalance weight and the ends of the keeper rods, in particular, were rough and irregular, and not typical of bruises caused by metal-to-metal impacts. Taken overall, the damage formed a pattern consistent with the hook having struck a rock whilst suspended from the aircraft in flight, presumably as the aircraft crested the ridge upon entering the valley in which it crashed. There is little doubt that a strike against a rock in these circumstances would have been capable of knocking the hook back with sufficient energy to cause it to swing rearwards and upwards into the tail rotor disc.
