**WIRES REMOVED FROM N653UA FOR EXAMINATION**

## N653UA - REPAIRED WIRE LIST

AAIB Bulletin No: 10/97

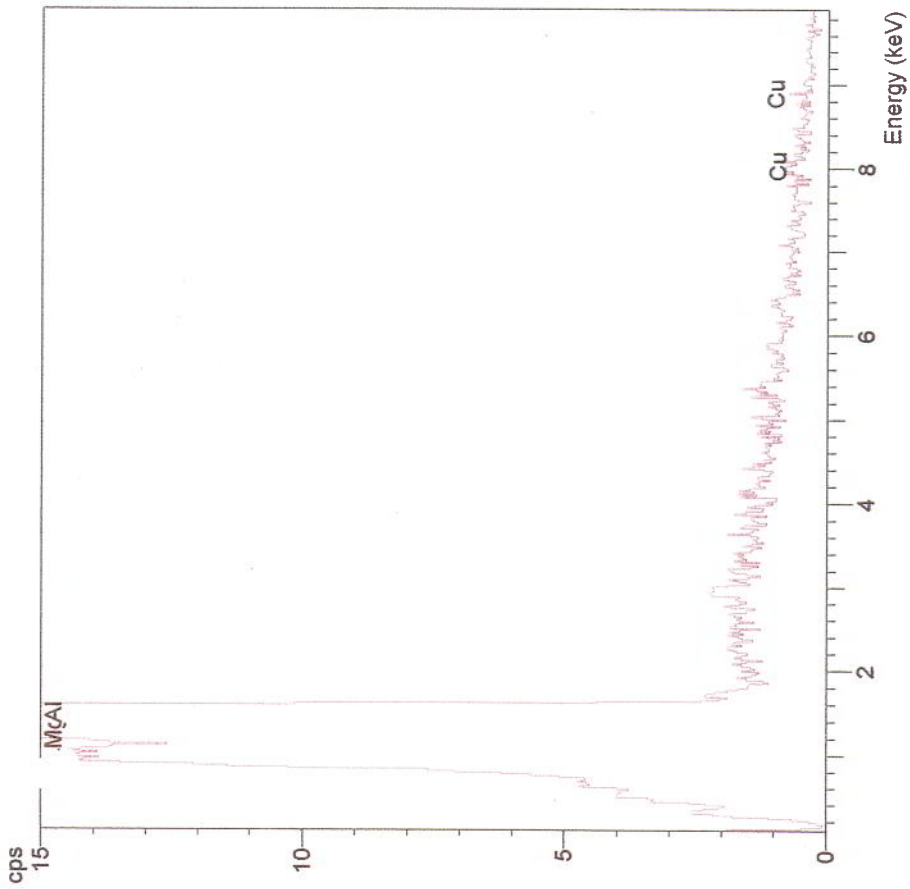
Box covering refrigeration unit  
 Typical EDX spectrum of aluminium alloy  
 from which box is made

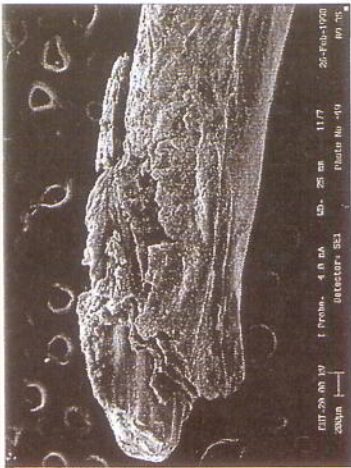
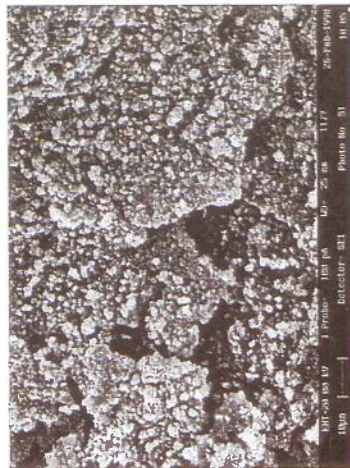
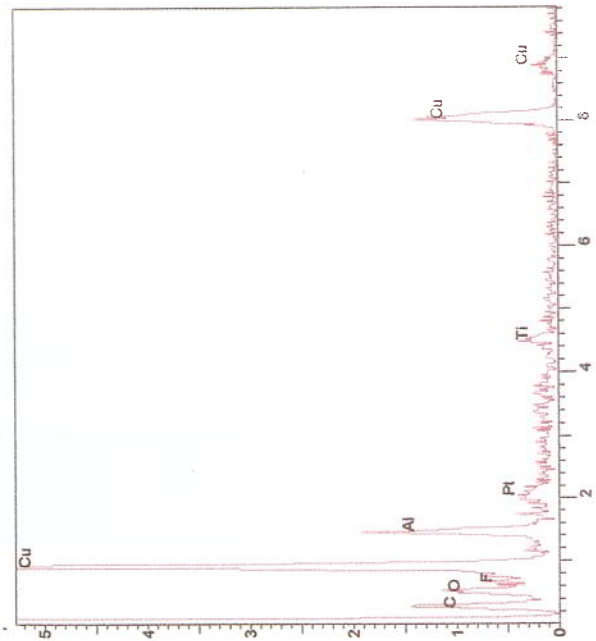
Upper micrograph - location; Lower micrograph - detail

RHS: Element maps of aluminum nodules on wire 11/8

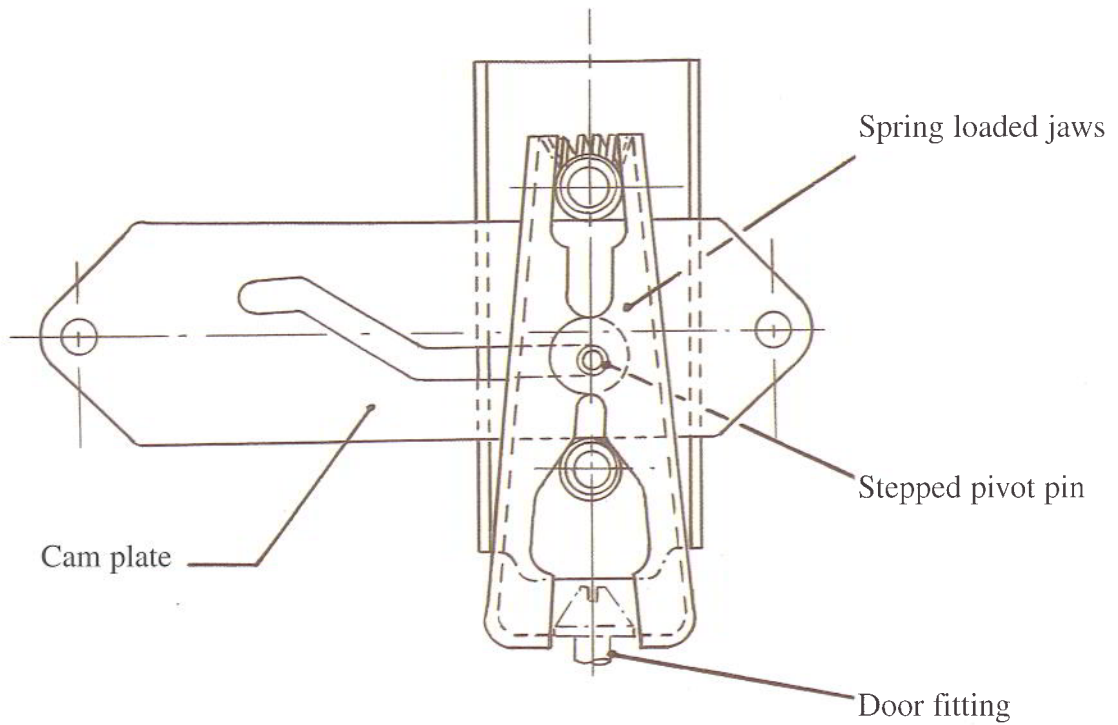
OFF-WING SLIDE COMPARTMENT DOOR LATCH DETAILS

Latch No 3 from left side of aircraft, as found, and jammed mid-travel. Note evidence of fretting around operating rod attachment holes and on cam plate (\*), and displaced pivot pin.

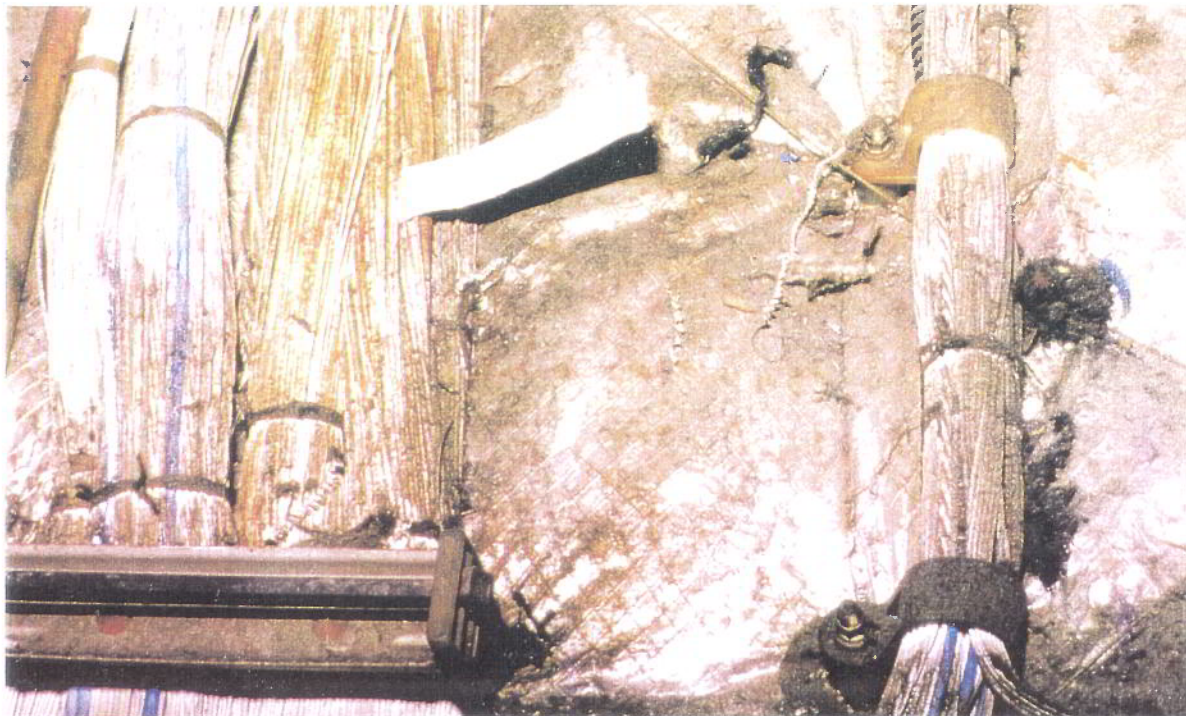
TYPICAL EXAMPLES OF CONDUCTIVE DEBRIS

Contamination of wiring looms by drilling swarf, found in a retired B747, above, and an A300, below.

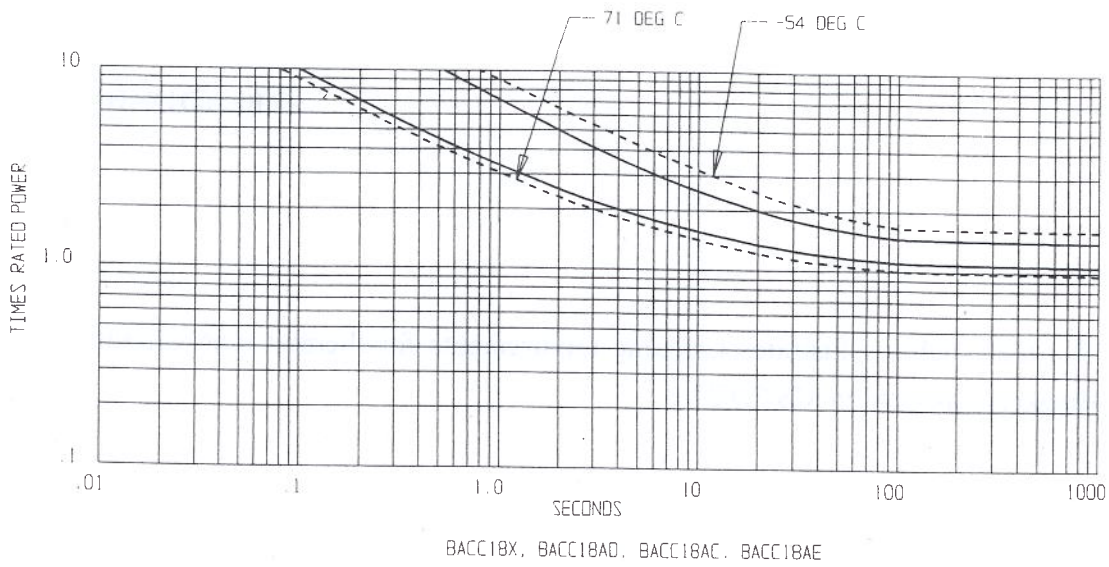
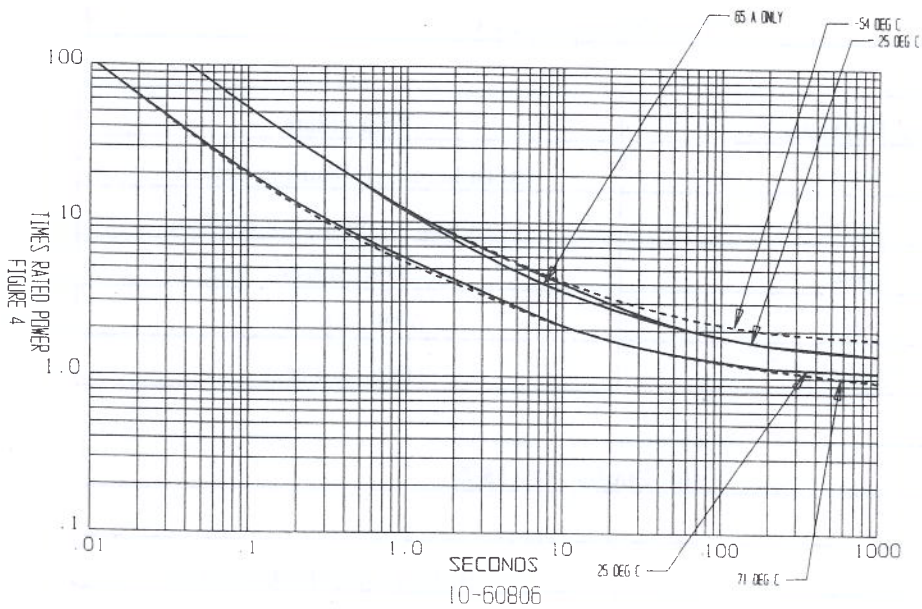
*Stated Response Characteristics of  
Circuit Breakers Found Tripped on  
N653UA*

Location	Circuit Breaker/Pt No	Rating
Fwd Equipment Ctr P33 panel	Bus Sect 2 Gnd Service BACC18X20	10A
Flt Deck Overhead panel P11	T/R Ind BACC18Z1R	1A
	R Eng T/R Ind Altn BACC18Z1R	1A
Flt Deck P6-4 Panel	Pitot Heat - L Aux Phase C BACC18Z5R	5A
	Pitot Heat - F/O Phase B BACC18Z5R	5A
	Passenger Service Outlet BACC18AC10	10A
	Altn Slat Outbd Pwr BACC18AC10	10A
	Altn Flap Pwr BACC18AE15	15A
	Altn Slat I/B Pwr BACC18AC3	3A
	R TRU 10-60806-1020	20A
