No: 11/92

Ref: EW/C92/6/1

Aircraft Type and Registration: Douglas Aircraft Company MD-11, N1754

Date & Time (UTC): 4 June 1992 at 1052 hrs

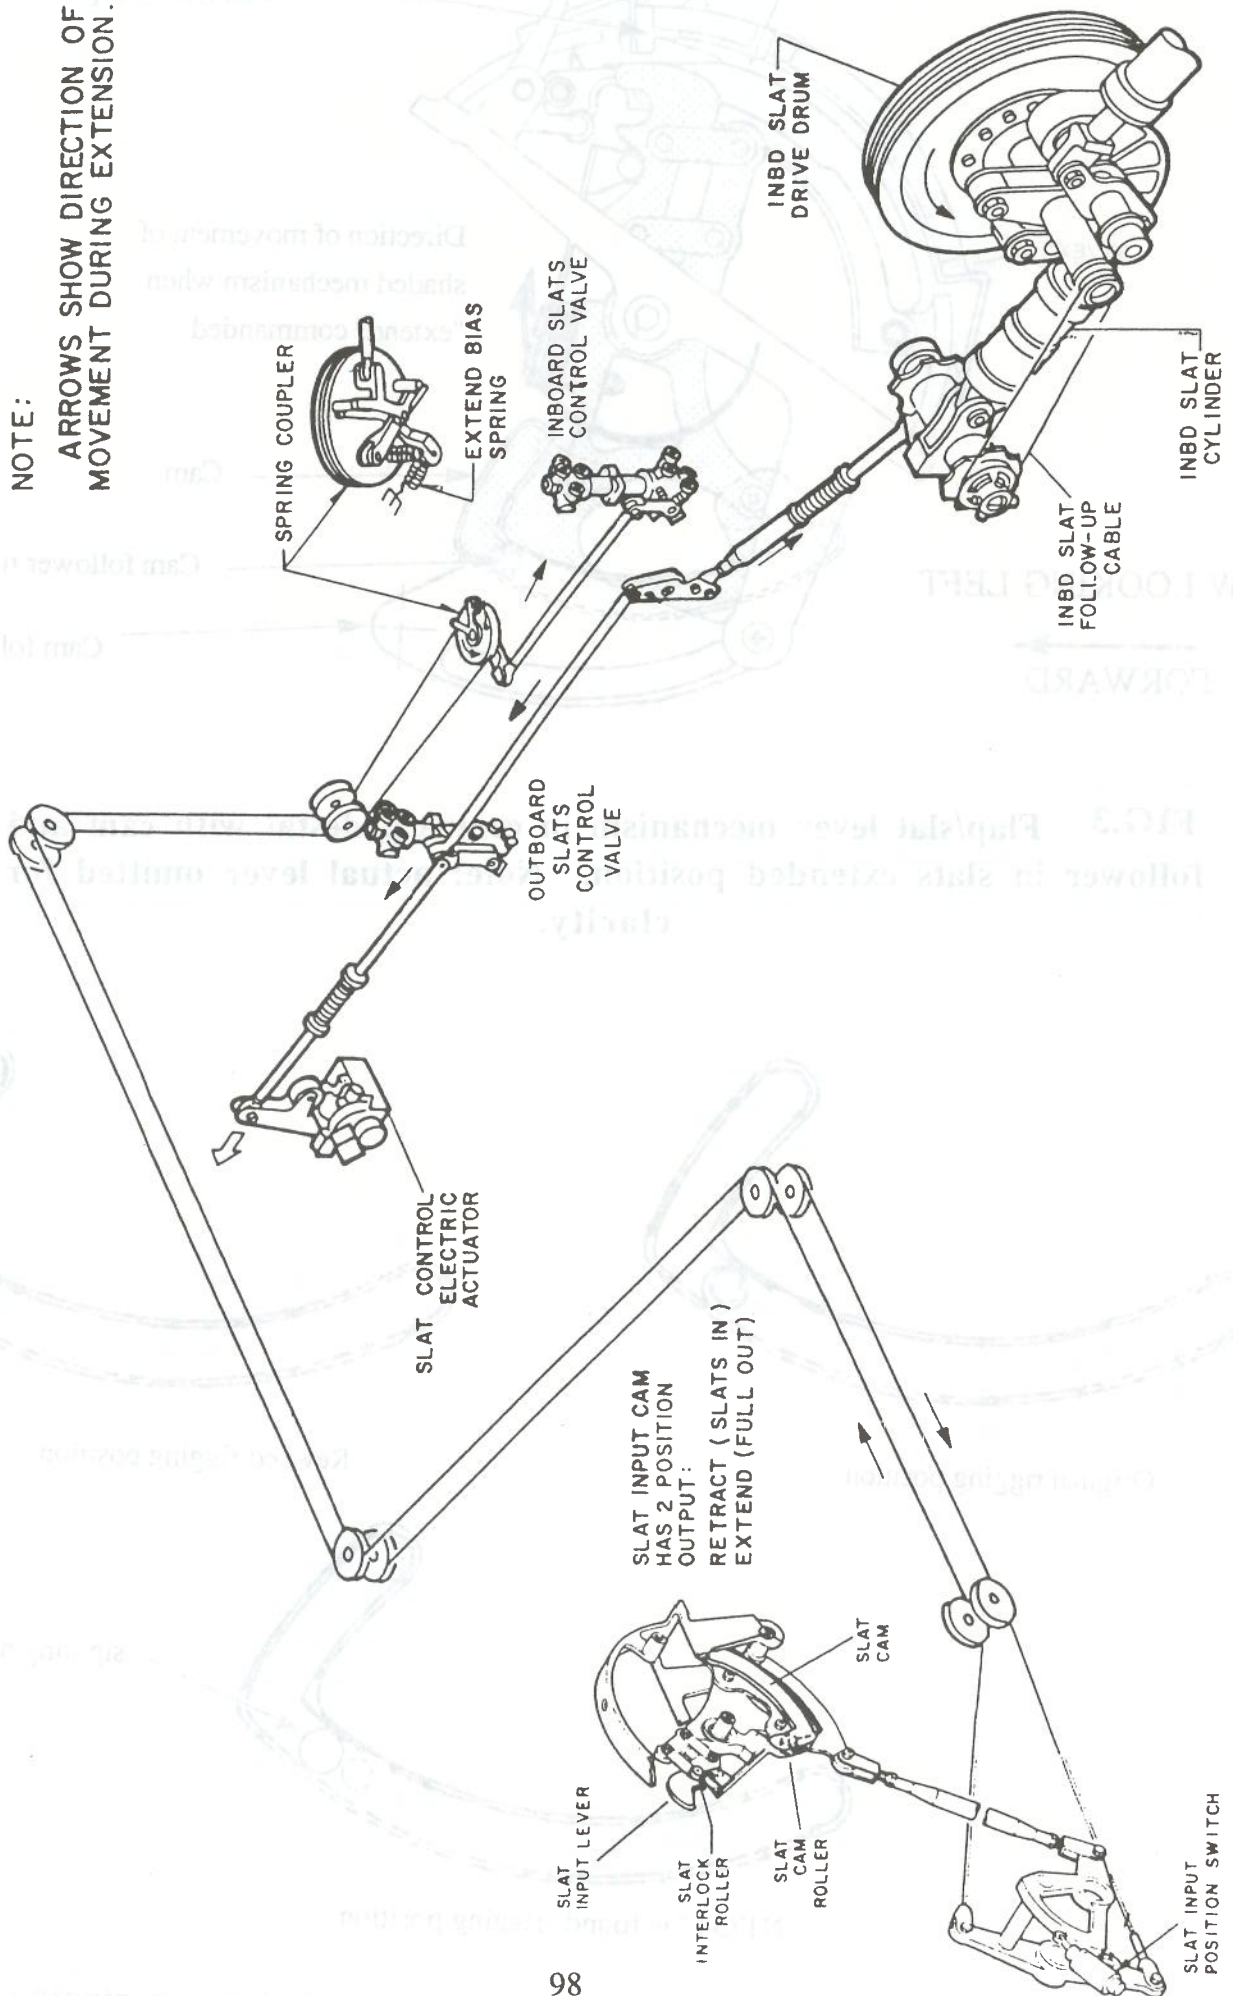
FIG.2 Schematic layout of MD-11 leading edge slat operating system

The design of the MD-11 flap/slat system is broadly similar to the earlier DC-10 aircraft from which it was derived. It is essentially a simple hydro-mechanical system in which movement of a combined flap/slat lever on the centre pedestal initially extends the slats and, with further movement, progressively extends the trailing edge flaps. Cables running aft from the lever mechanism move the inboard slats control valve via a spring coupler (see Figure 2). When the inboard slats are partially extended, a follow-up mechanism on the inboard slat drive drum opens the outboard slat control valve and the outboard slats extend. During retraction, the inboard slats retract first, followed by the outboard slats. It can be appreciated that there is no electrical signalling involved in the normal operation but, associated with the stall protection system, is an "Autoslat" feature which extends the *outboard slats only* should the flight control computers sense an impending stall. This system is, however, inhibited at the high Mach number or IAS at which this aircraft was operating.
