APPENDIX A

G-BEWL Seating Arrangement and Injury Severity Scores (ISS)

Brent Spar helideck showing impact marks and damage

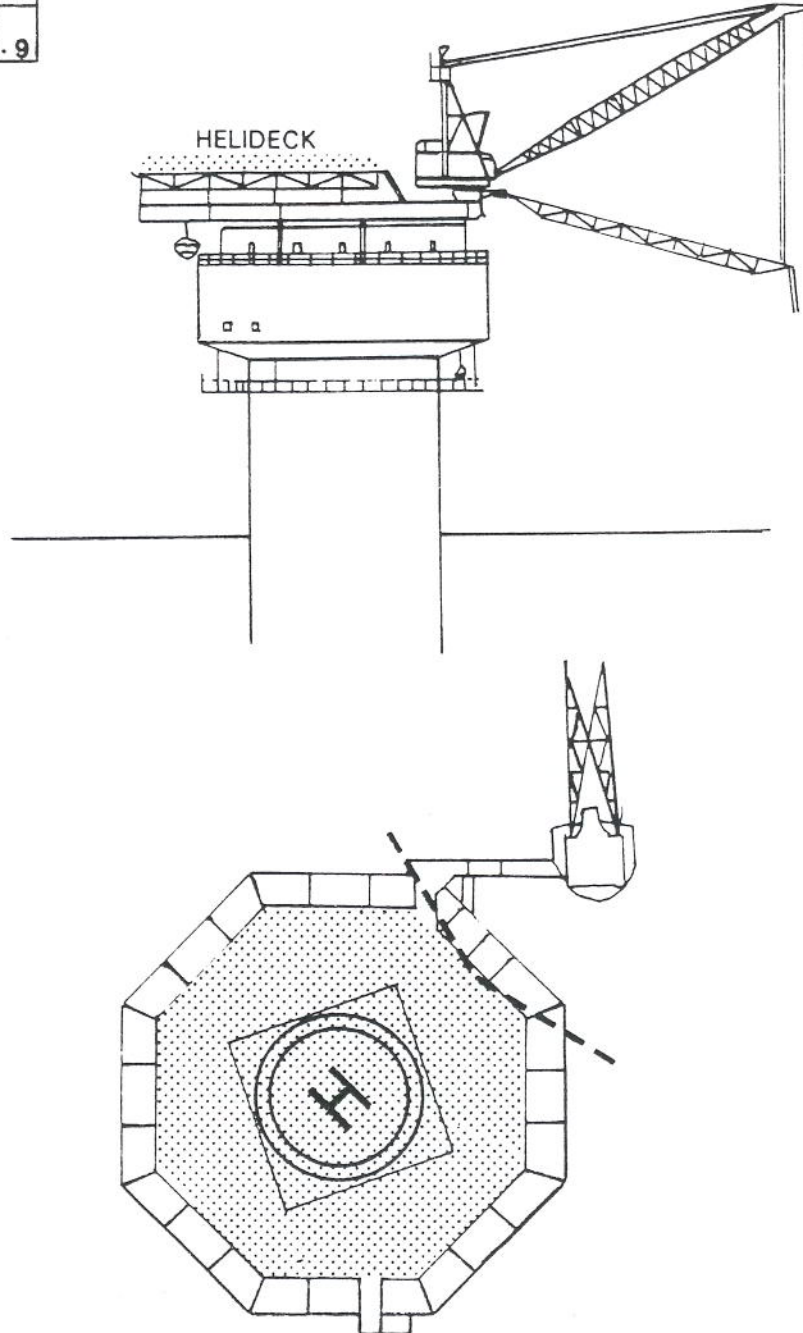
Helideck 19.8m diameter

1. Helideck unrestricted up to B214ST/ AS332L. S61N may operate subject to CAA operating conditions.
2. Helideck rotatable through 360° when tanker loading taking place.

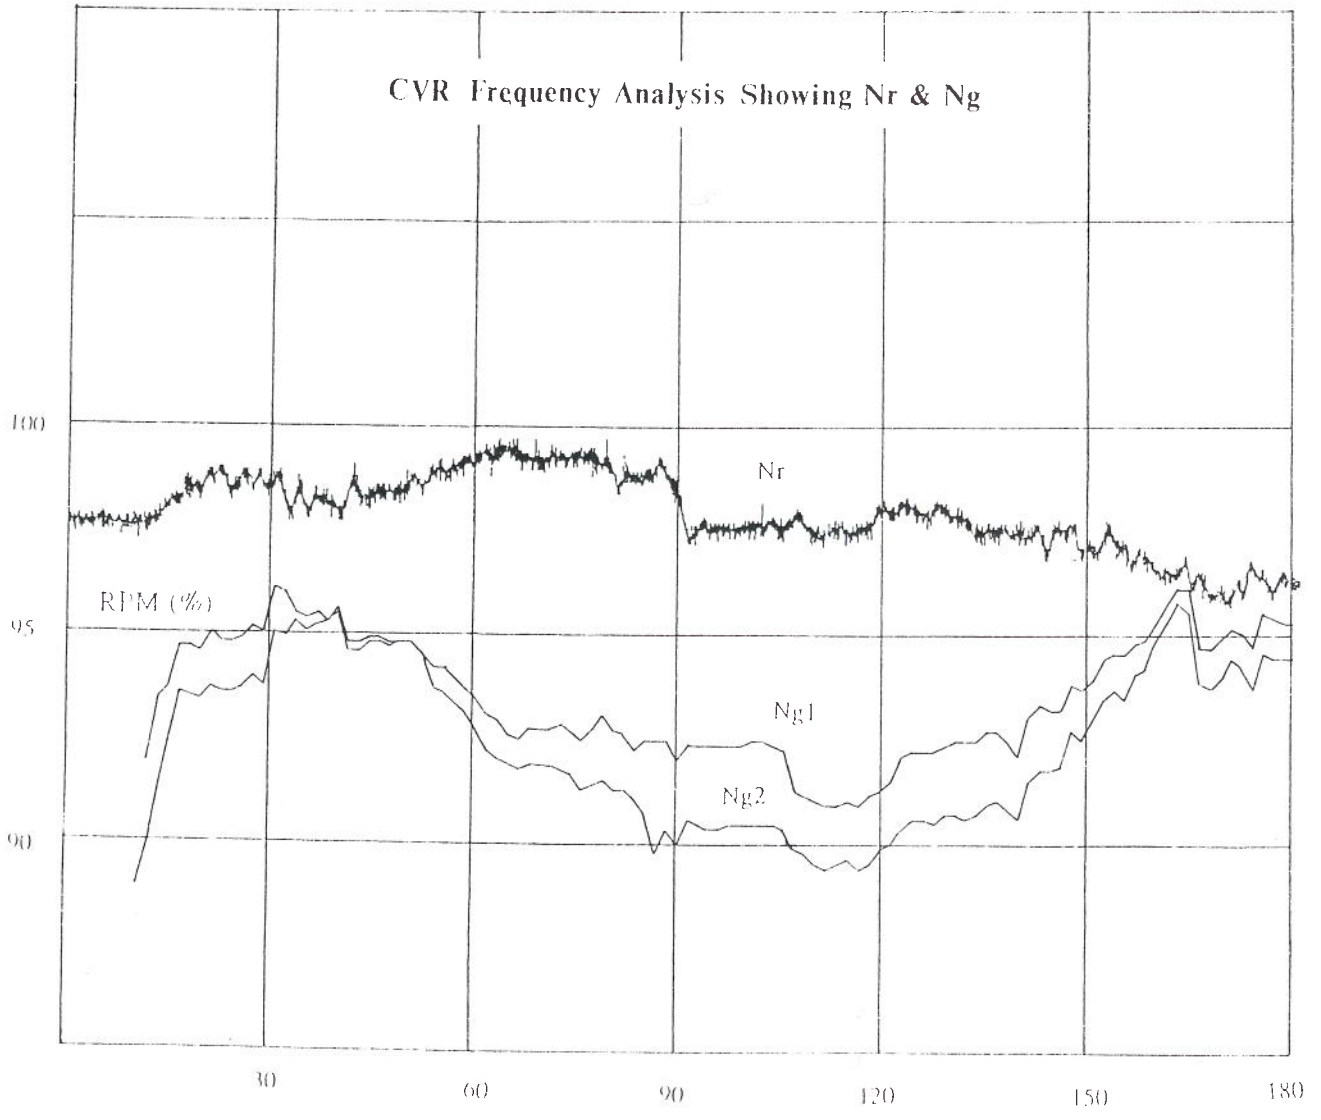
CVR Frequency Analysis Showing Nr & Ng

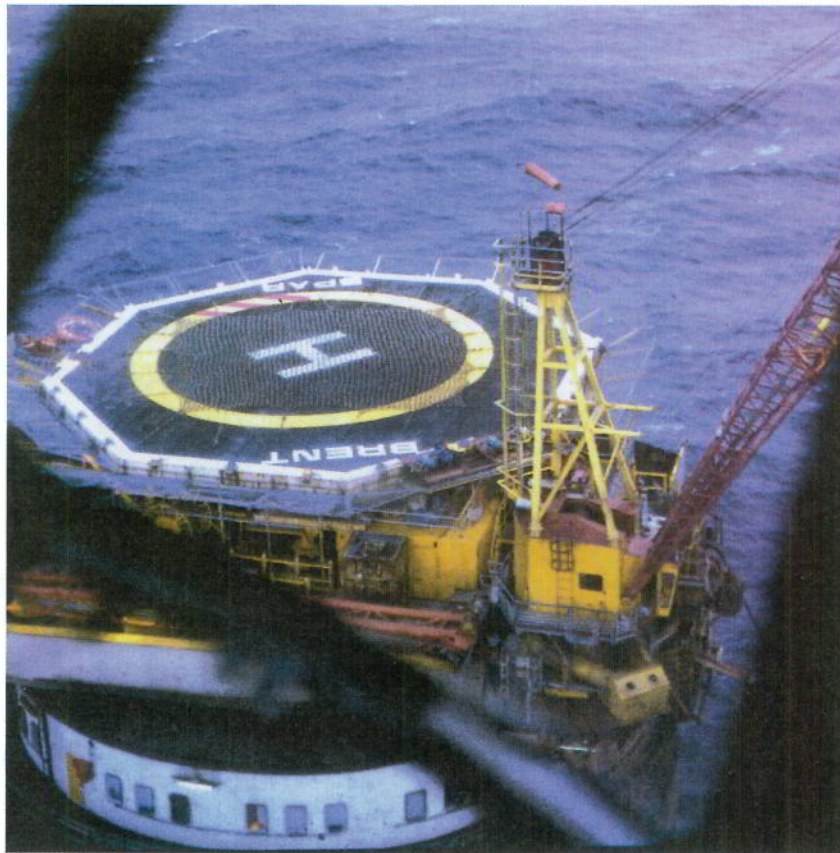
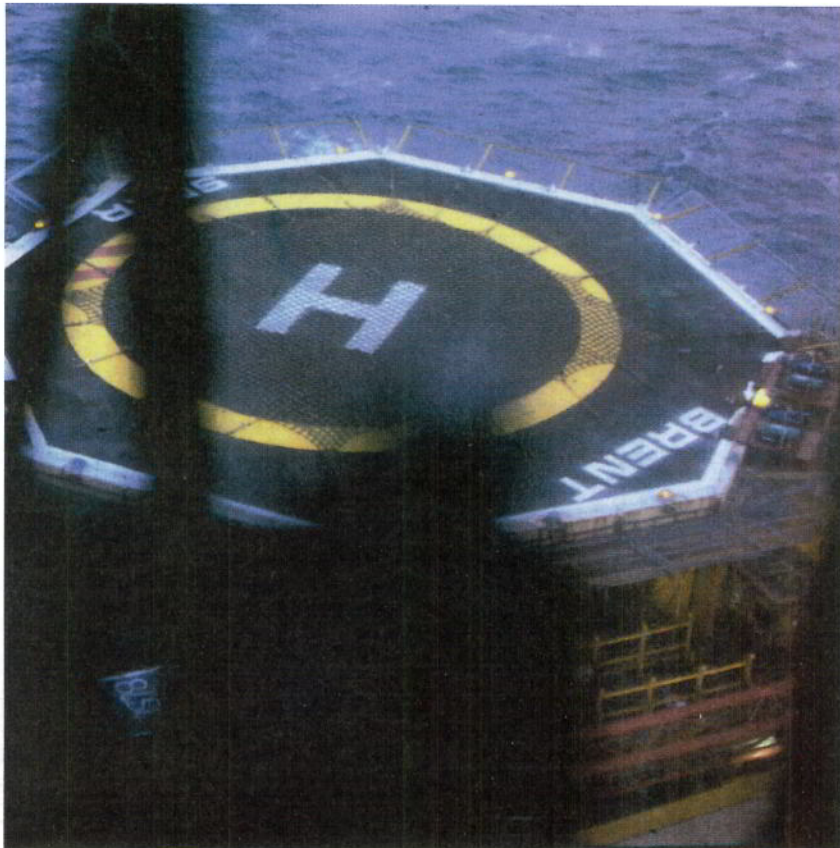
The second is that the commander may have believed that there was more margin for manoeuvre around the aiming circle than actually existed, and may not have been fully aware of the nature and implications of the restrictions on landing imposed by the orientation of the H and the orientation of the 150° obstacle sector and the 45° prohibited landing sector of the aiming circle.

Right-hand pilot's eye view of Brent Spar landing area.
