INCIDENT

Aircraft Type and Registration:	Boeing 737-377, G-CELF
No & Type of Engines:	2 CFM56-3B1 turbofan engines
Year of Manufacture:	1988 (Serial no: 24302)
Date & Time (UTC):	2 August 2013 at 0617 hrs
Location:	On departure from Leeds Bradford Airport
Type of Flight:	Commercial Air Transport (Passenger)
Persons on Board:	Crew - 5 Passengers - 119
Injuries:	Crew - None Passengers - None
Nature of Damage:	Broken generator harness and over-heated battery charger
Commander's Licence:	Airline Transport Pilot's Licence
Commander's Age:	56
Commander's Flying Experience:	8,130 hours (of which 3,300 were on type) Last 90 days - 66 hours Last 28 days - 34 hours
Information Source:	AAIB Field Investigation

Synopsis

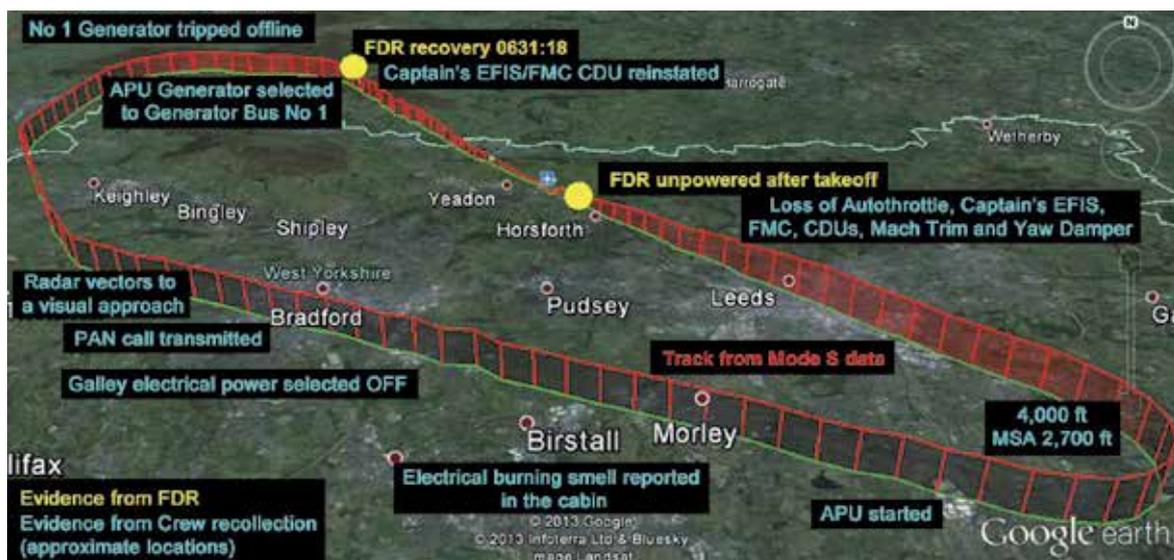
Limited sets of flight parameters were transmitted to ATC's radar, throughout the flight, via Mode S transponder returns. These covered a period of 26 minutes and 30 seconds. Figure 1 shows the recorded aircraft track.

Aircraft track from Mode S transponder data, with approximate positions of events from crew recollections

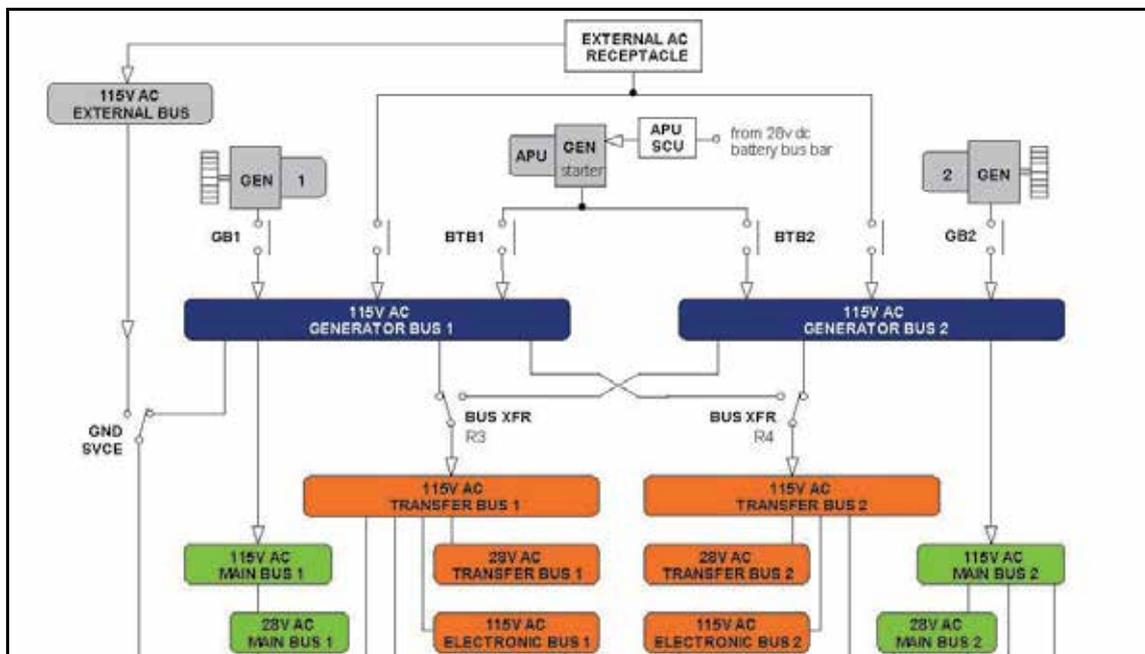
Figure 4

Top level electrical system schematic for the Boeing 737-300 (orange denotes busses carrying essential loads and green denotes busses carrying non-essential loads; schematic courtesy of B737MRG)

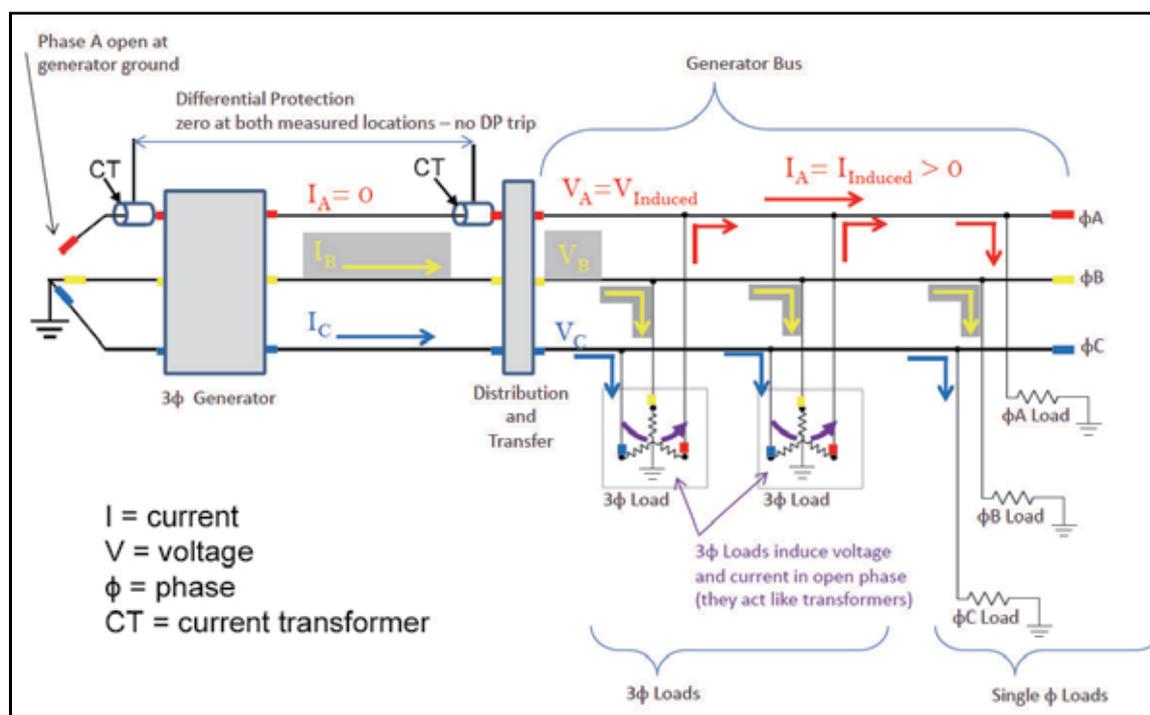
Figure 5

There are a number of electrical components on the aircraft that require 3-phase power for operation, such as hydraulic pumps, fuel pumps and transformers. Other lower power components, such as the EFIS screens, instruments and auto-throttle operate using single-phase power. When the phase 'A' generator cable broke at the T191 stud, there would have been a drop in voltage in the phase 'A' line. However, the voltage on phase 'A' would not have dropped to zero because the 3-phase loads, still powered by phases 'B' and 'C', would have induced current and voltage on phase 'A'. This occurs because 3-phase loads are connected across the phases rather than from each phase to ground. This effect is illustrated in Figure 5. There is no current flow in the phase 'A' line between ground and the generator bus, so the current transformers at the generator and generator bus measure the same current and therefore the differential current protection is not tripped. On the Boeing 737-300 there is no measurement of differential current between phases. Inside the generator bus there is current flow in the phase 'A' line due to the voltage induced from the 3-phase components.

Operation of a 3-phase system with phase 'A' open circuit at the generator ground

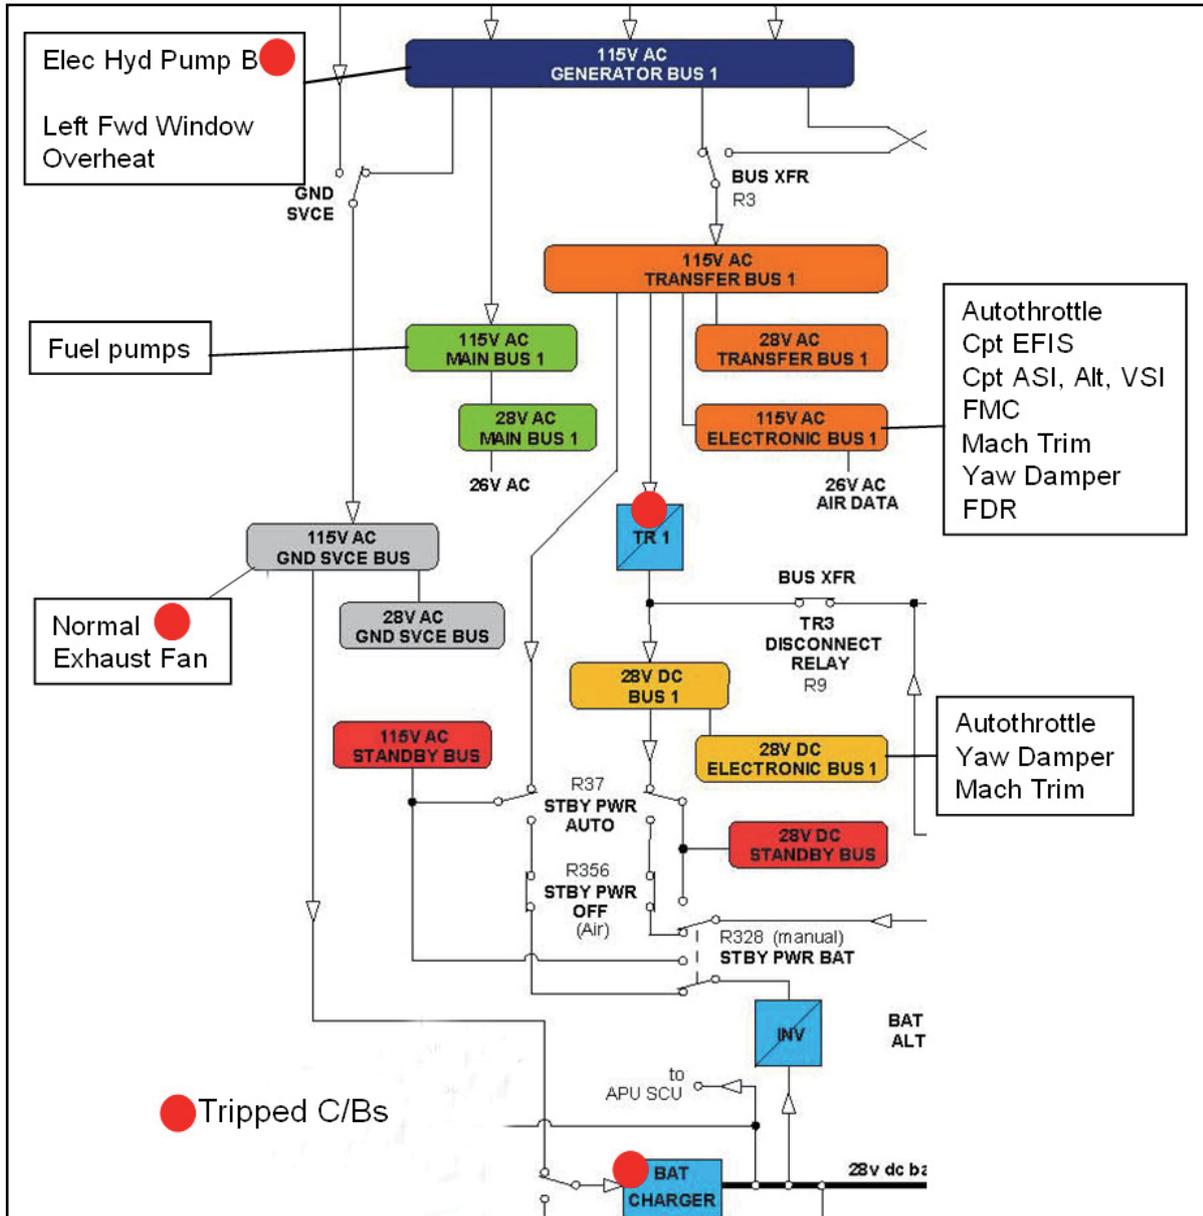
As each C/B for a 3-phase device tripped, the induced voltage on phase 'A' reduced. Eventually, once enough 3-phase devices had tripped offline, the phase 'A' induced voltage probably dropped sufficiently that the under-voltage protection tripped off the generator during the final approach. Figure 6 shows an expanded diagram of the No 1 Generator Bus system, highlighting the components which are fed from the different busses, and the C/Bs which tripped in the incident.

Consequently, once the No 1 generator tripped offline, the Bus Transfer (XFR) relay automatically switched to the Alternate position, causing the No 2 generator bus to power the No 1 transfer bus. This restored power to the essential single-phase AC equipment operating on phase 'A'. This explains why the captain's instruments were restored after the No 1 generator tripped offline. The captain also manually selected the APU to feed the No 1 generator bus at about the same time, which restored power to all loads powered by Generator Bus 1. The TR1 C/B remained tripped but a closed TR3 disconnect relay⁴ (Figure 6) allowed the No 2 side to feed the No 1 DC busses.

Electrical system schematic detail for Generator Bus 1 (red dots denote equipment with tripped circuit breakers; schematic courtesy of B737MRG)
