Air Accidents Investigation Branch

**Report on the accident to
Aerospatiale (Eurocopter) AS332 L2 Super Puma,
registration G-REDL
11 nm NE of Peterhead, Scotland
on 1 April 2009**

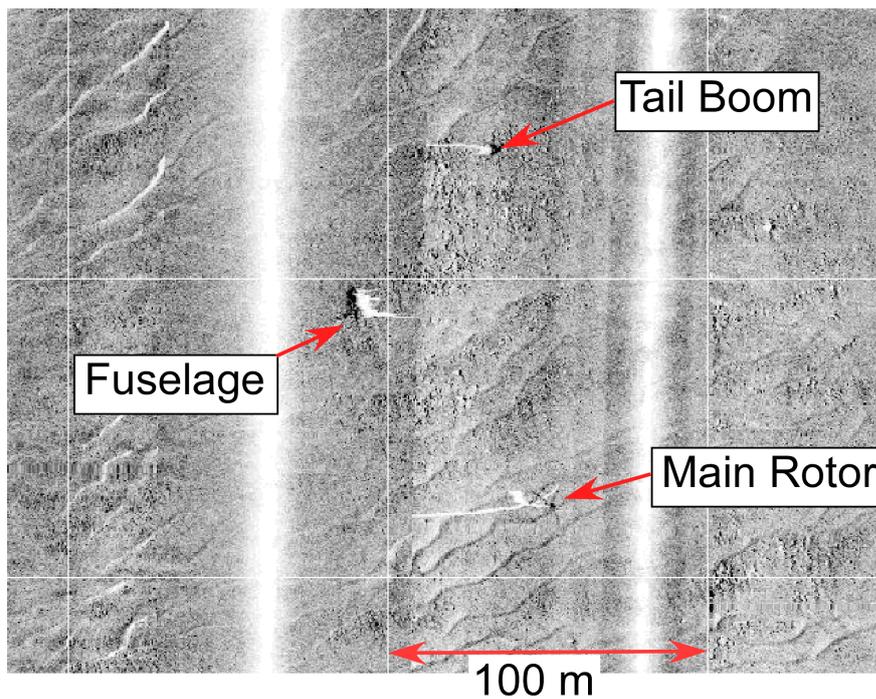
Figure 2
Sidescan sonar picture of main wreckage items

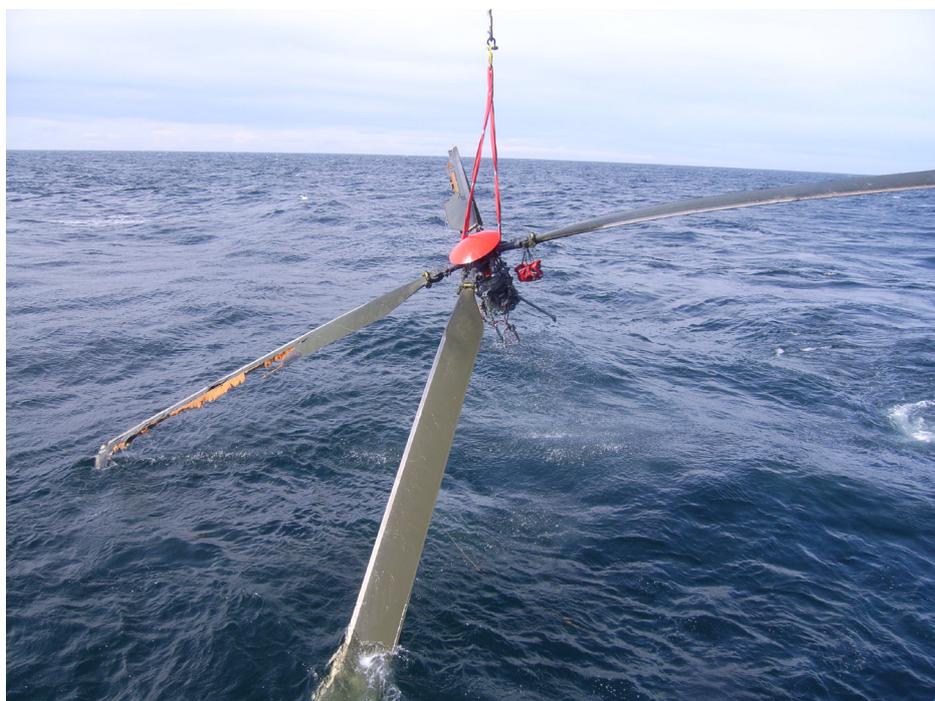
Figure 3
Main rotor head recovery

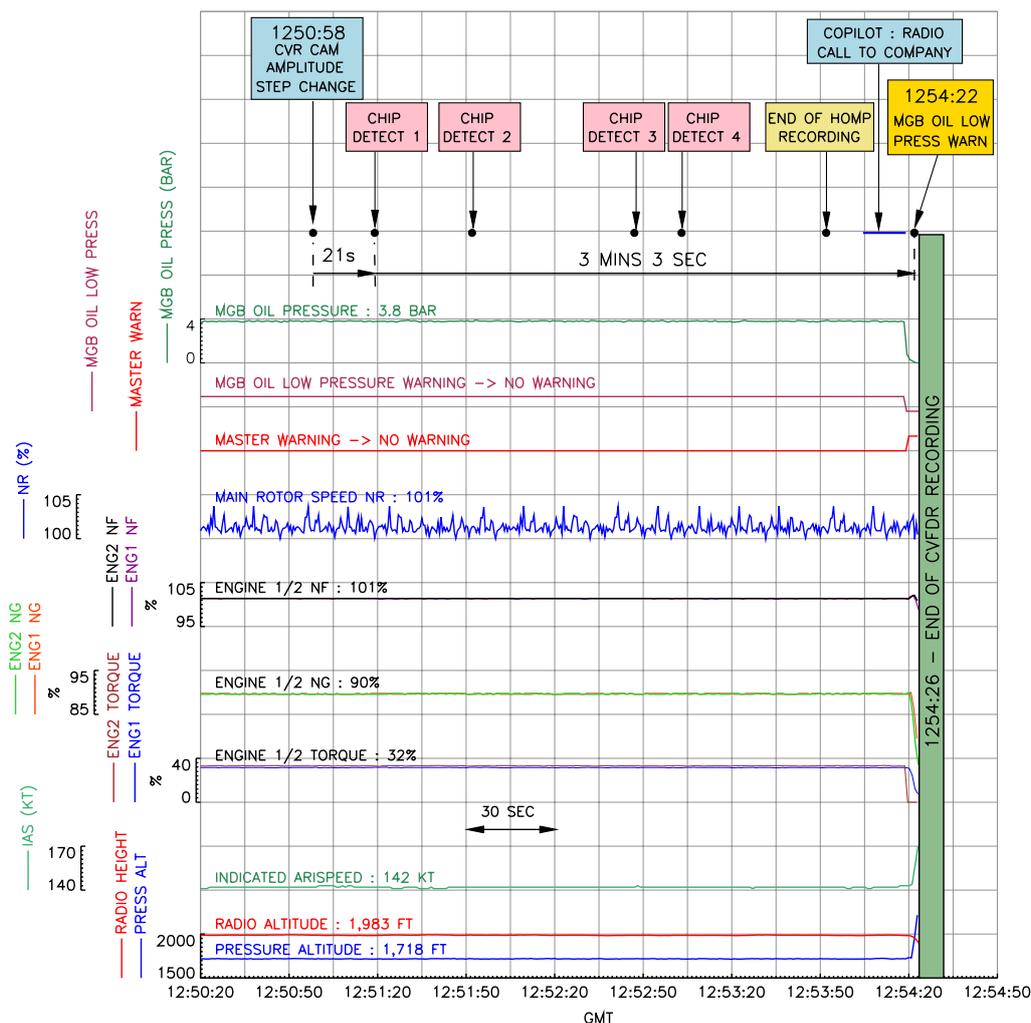
Spectral analysis of the CAM recording revealed an amplitude step change, in a frequency consistent with damage to the second stage epicyclic ring gear, occurring at 1250:58 hrs, (see Figure 16). This change in acoustic signature was inaudible on all the recorded channels. At approximately 1251:19 hrs an epicyclic chip detection warning was recorded on HUMS. Over the next minute and 43 seconds, three further chip detector warnings were recorded.

Figure 16
G-REDL recorded flight data

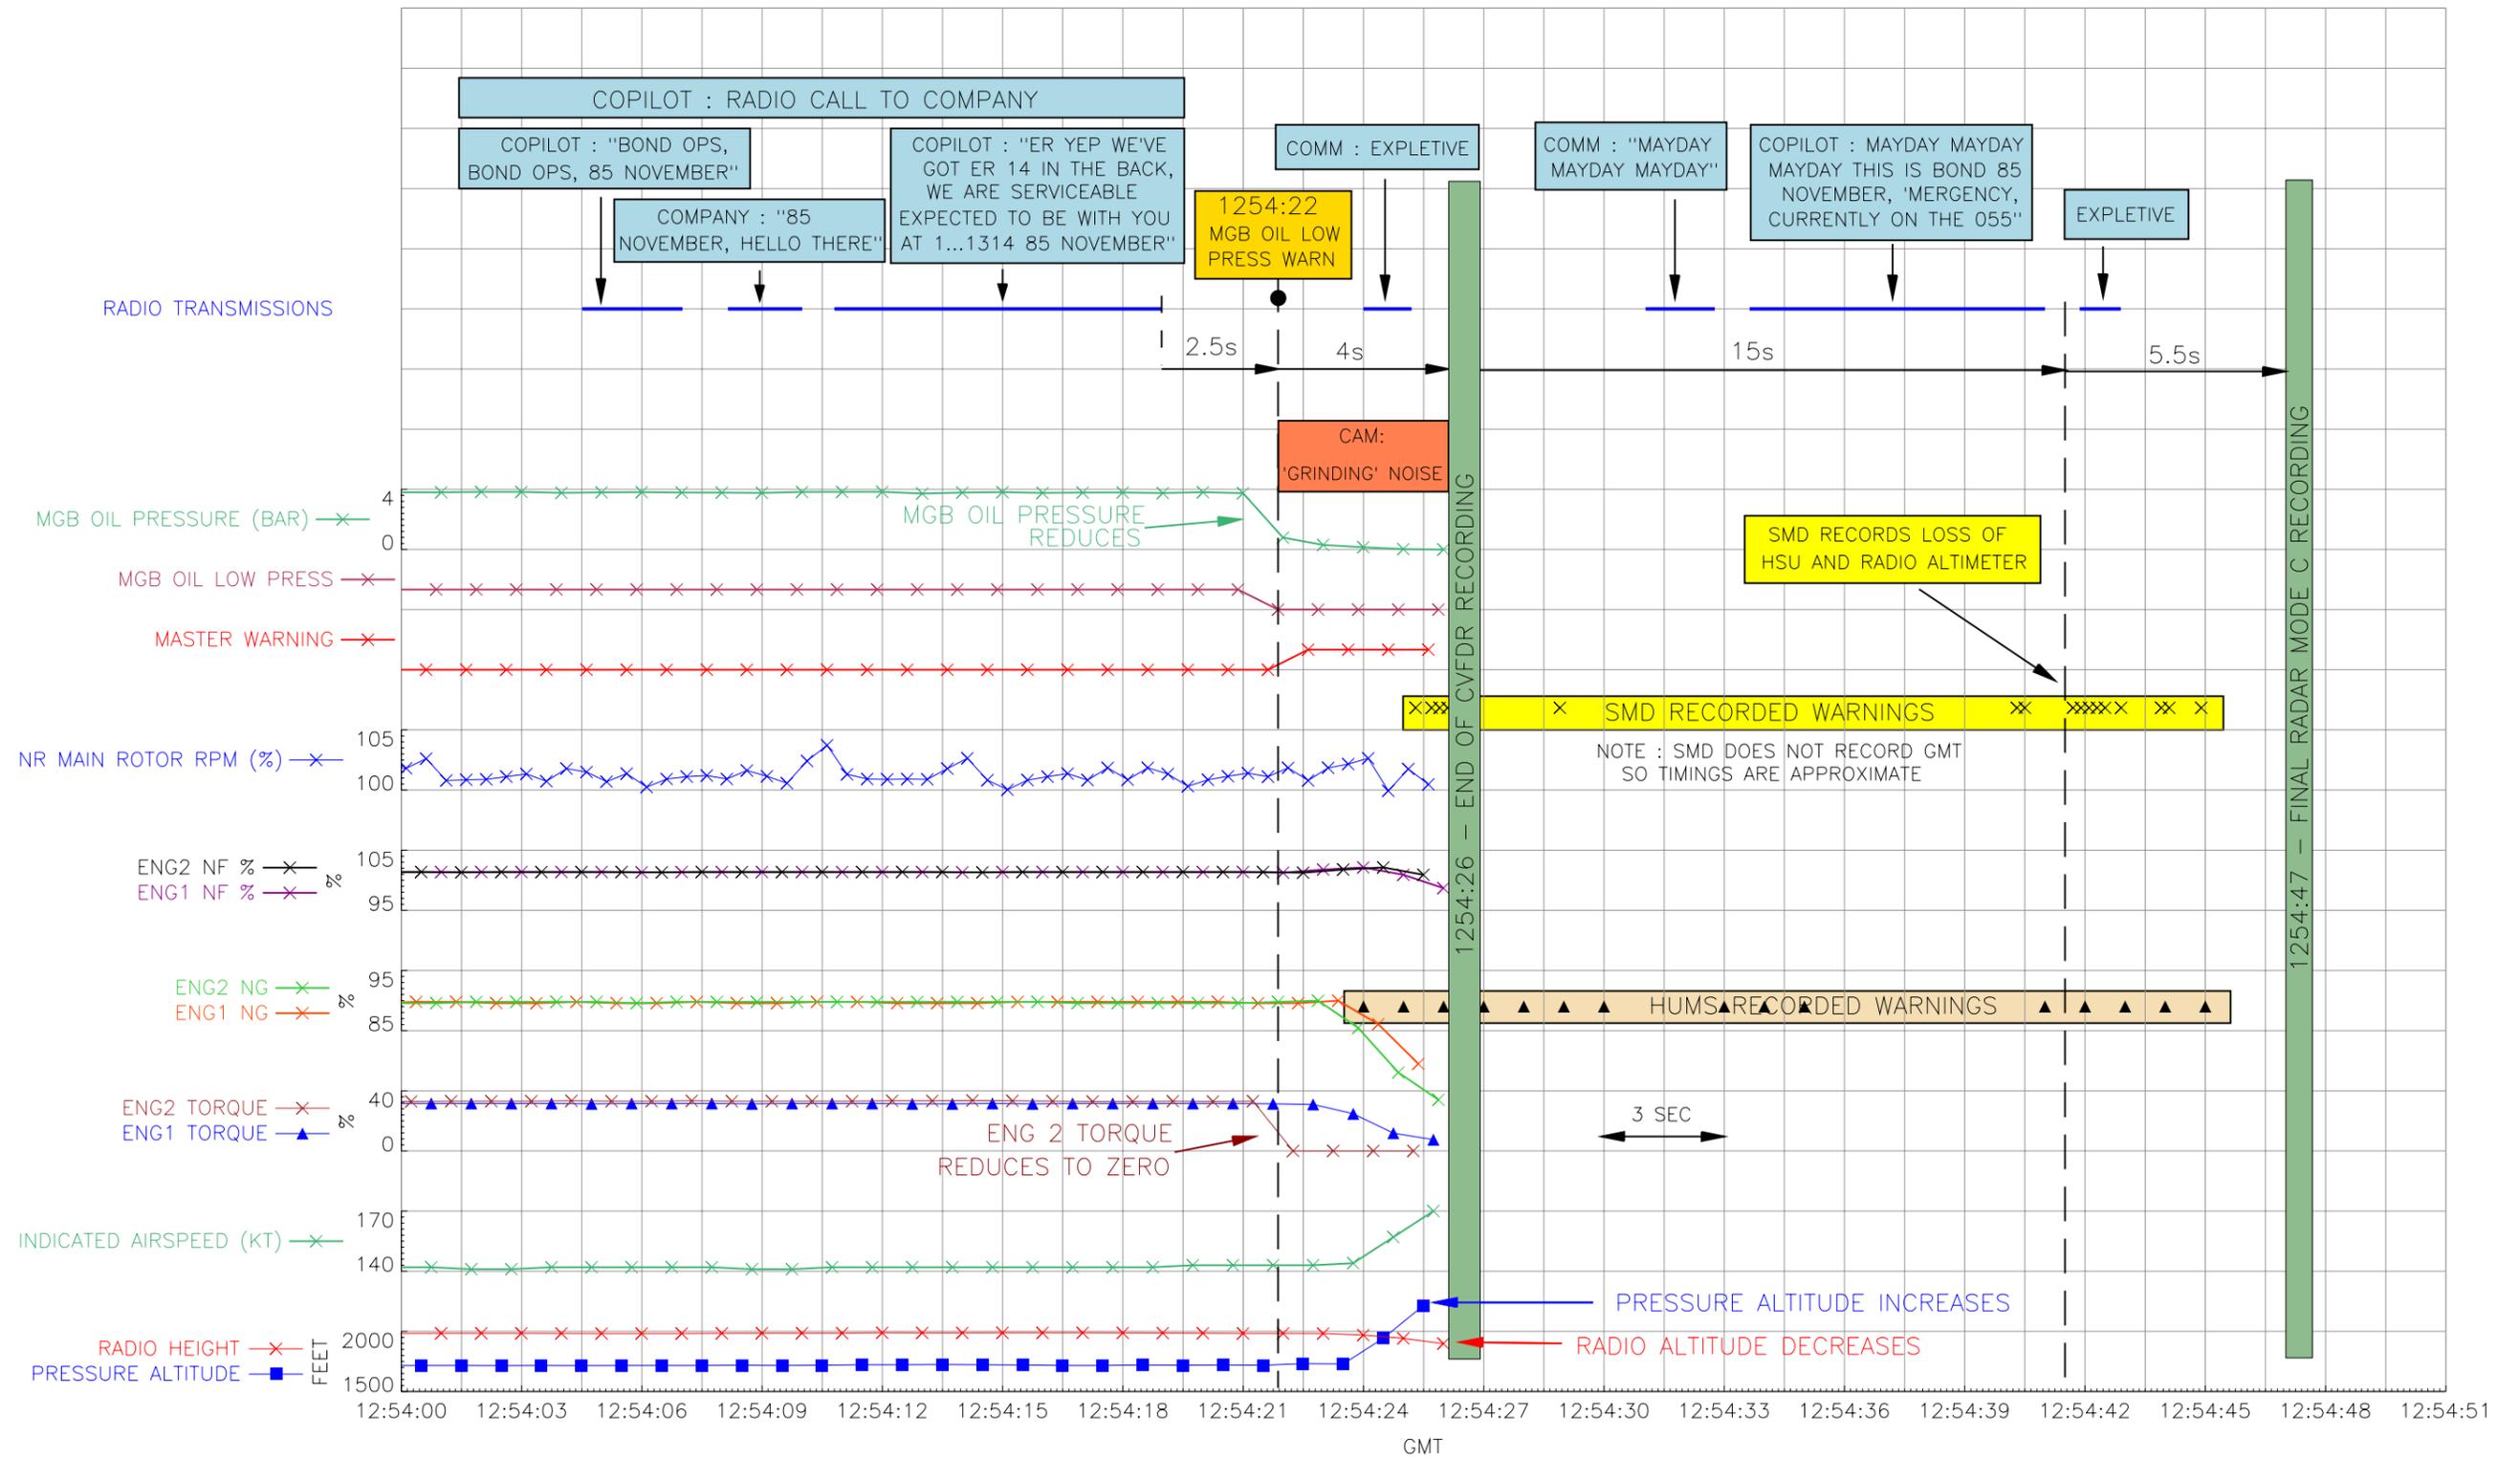
The recorded MGB oil pressure reduced from 3.8 bar to 0.8 bar within one second and the data confirmed that the helicopter immediately deviated from cruise flight conditions. Half a second later, the recorded right engine torque reduced from 33% to zero, (see Figure 17). Apart from this recorded loss of torque, engine operation during the final part of the recording was normal, and the recorded main rotor rpm remained at between 100% and 103%.

Figure 17
G-REDL recorded flight data

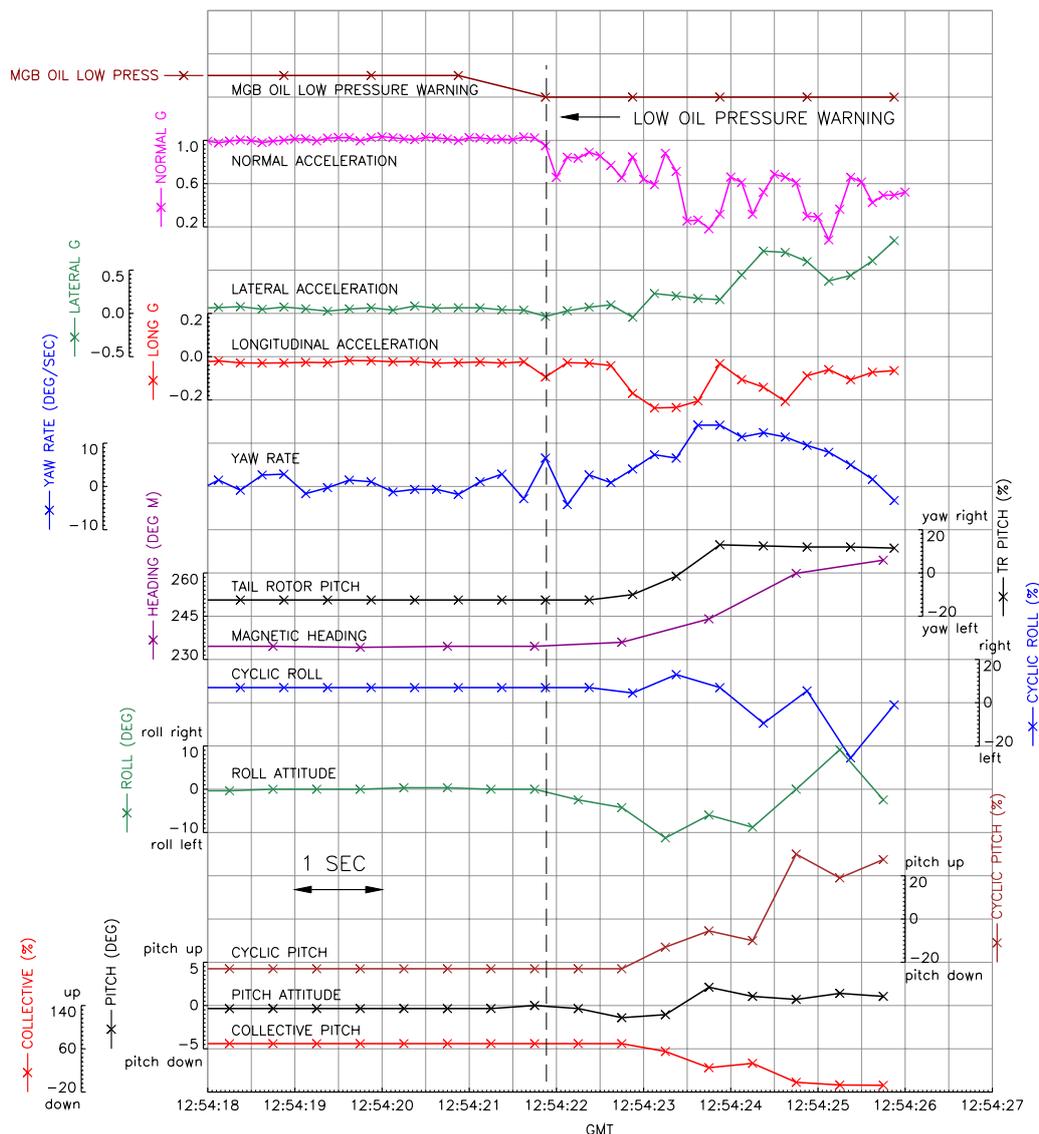
Figure 18

Directly after the loss of MGB oil pressure, the helicopter deviated from its cruise conditions. With only four seconds of flight data, analysis of the helicopter response was limited. During these four seconds, the helicopter initially rolled left to -11.3° before rolling right to 9.1° within two seconds. Magnetic heading increased by 30 degrees with pitch attitude reducing to -1.4° pitch down before increasing to no more than 2.1° pitch up. Recordings of flight control inputs show a reduction in collective pitch to zero, and commands to pitch up, yaw to the right and roll right then left, (see Figure 18).

The recorded flight data was provided to the manufacturer who ran a simulation to analyse the consistency between flight control inputs and the helicopter response during the final seconds of operation, see Appendix F. The analysis was performed in two stages. The first was to input the recorded flight control commands and analyse the simulated helicopter response. The second was to use the recorded helicopter attitudes and determine the required flight control inputs to achieve them. The results indicated that, two seconds after the MGB oil low pressure warning, the helicopter was no longer responding normally to flight control inputs.

Flight control inputs and helicopter response

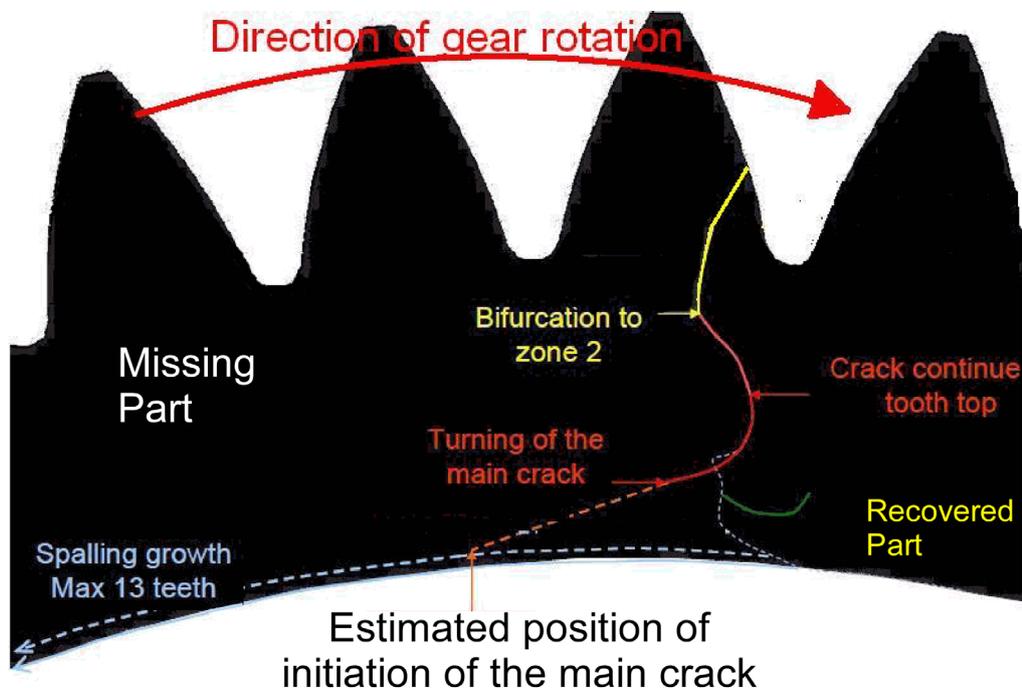
Figure 31

The crack was predicted to progress initially approximately tangentially to the raceway surface, (see Figure 31) but also moving inwards. As it leaves the carburised layer, the increasing tensile stresses cause the crack to turn and follow the line of maximum tensile stress. This was predicted to create a 'dished' shape similar to that seen in Zone 1 of the fracture surface of the 9-tooth section.

As the crack progresses, theory suggests that it should propagate towards the tooth root. However, the model showed that this area, and the tooth flanks, has significant compressive stresses, so the crack tends to follow the tensile stresses in the middle of the tooth, until the gear fractures in overload. The possibility of a bifurcation of the crack was also predicted, creating a feature similar to that observed in Zone 2 of the actual failure.

The conclusion of the stress analysis was that it could explain most of the features of the fatigue morphology observed on the fatigue fracture face of the failed second stage gear. It also suggested that the origin of the fatigue would have been several millimetres away from the fracture face (ie on a segment of the gearwheel which was not recovered).

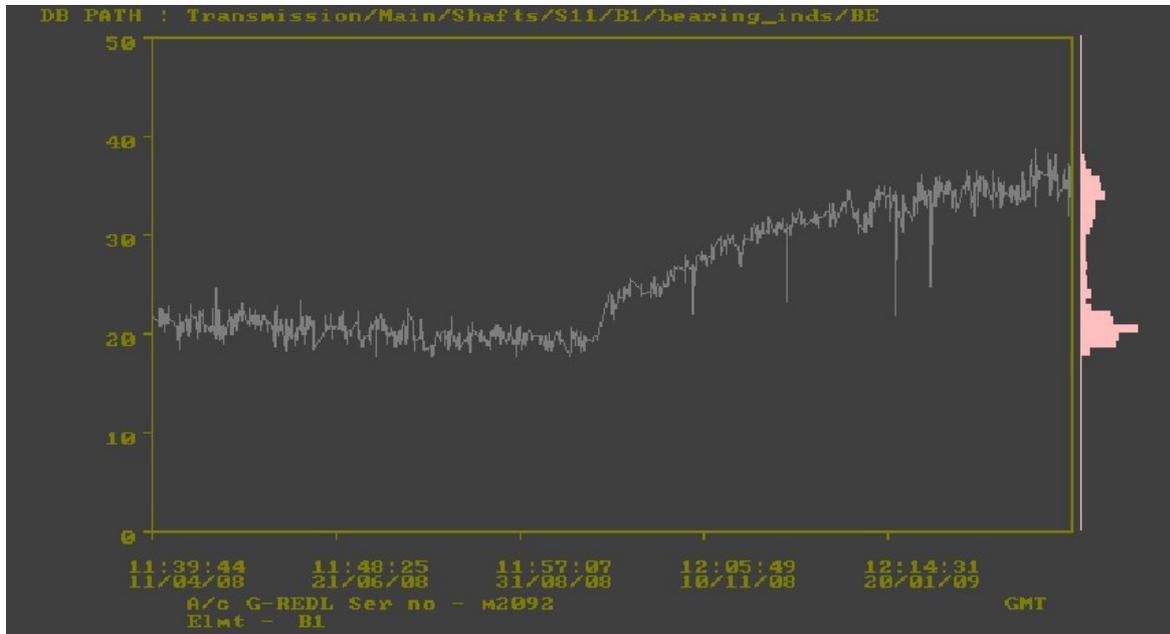
Figure G-1

G-REDL HUMS lower planetary bearings Band Energy

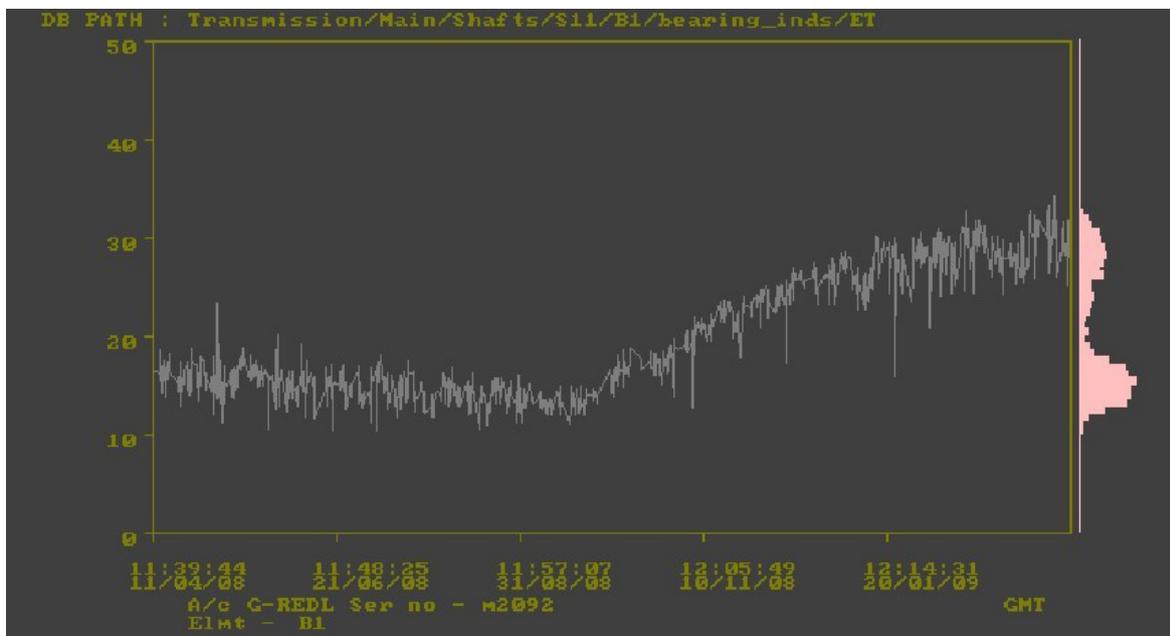
Figure G-2

G-REDL HUMS lower planetary bearings Tonal Energy

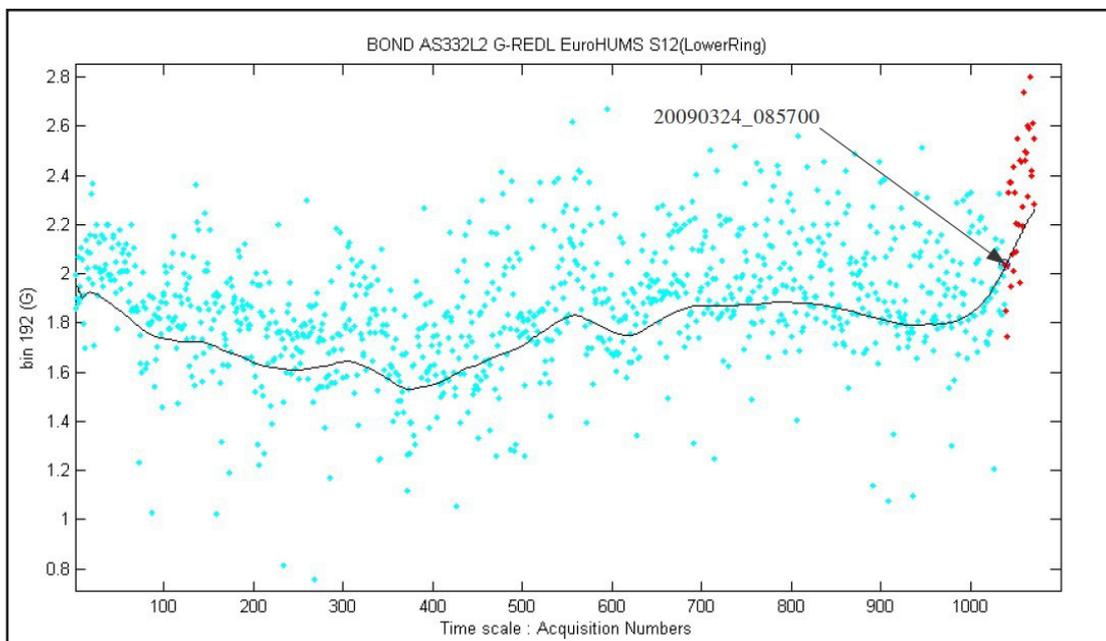
Figure H-2

Lower epicyclic ring gear, lower sideband mesh CI. Arrow points to operations of 24 March 09
 (Source: Eurocopter)

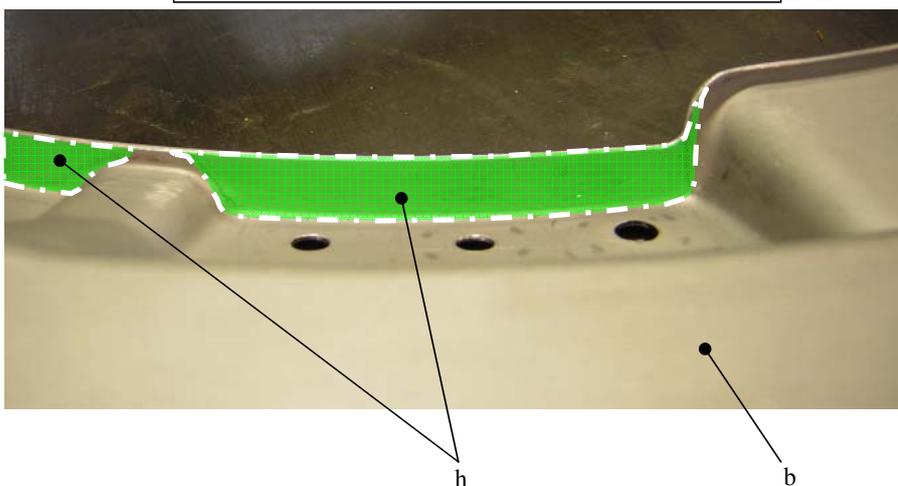
Chip collector (b) before deletion of the flanged edges.

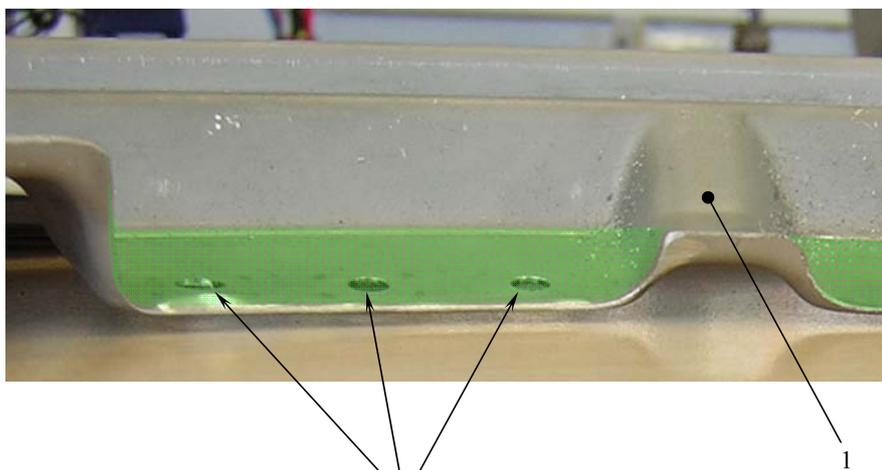
Figure 4

Chip collector (1) after deletion of the flanged edges and the magnetic elements (e)

Clearance holes for the attachment rivets (g) for the magnetic elements (e)

3) Modification of the chip collector (b) as shown in Figure 4:

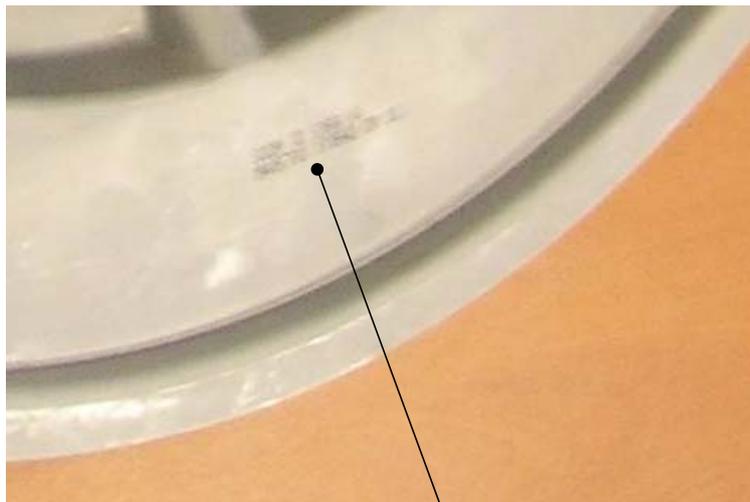
Figure 5

**Mark the new part number in
indelible ink**

4) Re-identify the chip collector (b) in accordance with paragraph 2.C. as per MTC Work Cards 20.08.05.101 and 20.08.05.103 and in accordance with Figure 5:
