**Air Accidents Investigation Branch**

**Report on the serious incident to  
British Aerospace ATP, G-JEMC  
10 nm southeast of Isle of Man (Ronaldsway) Airport  
on 23 May 2005**

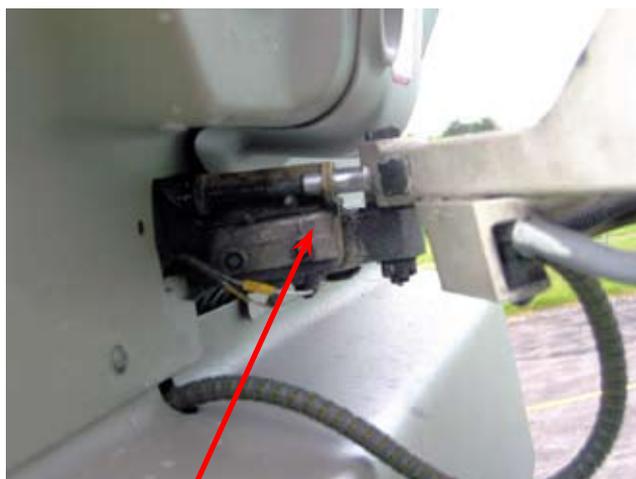
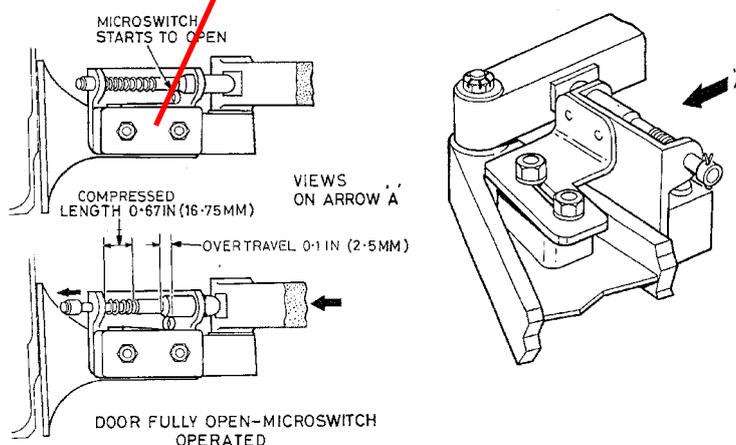
**Figure 8**

A safety microswitch, operated by a spring-loaded plunger, is attached to the door hinge mechanism. The operation of the microswitch is achieved by movement of a plunger, which is in contact with a roller mounted on the switch actuating arm, Figure 8. The plunger is depressed by fully opening the door, bringing the roller into contact with the larger diameter parallel section. This pushes down on the actuating arm, placing the switch in its 'made' state; electrical continuity is achieved, enabling power to be supplied to the airstairs retraction system.

Operation of door safety microswitch

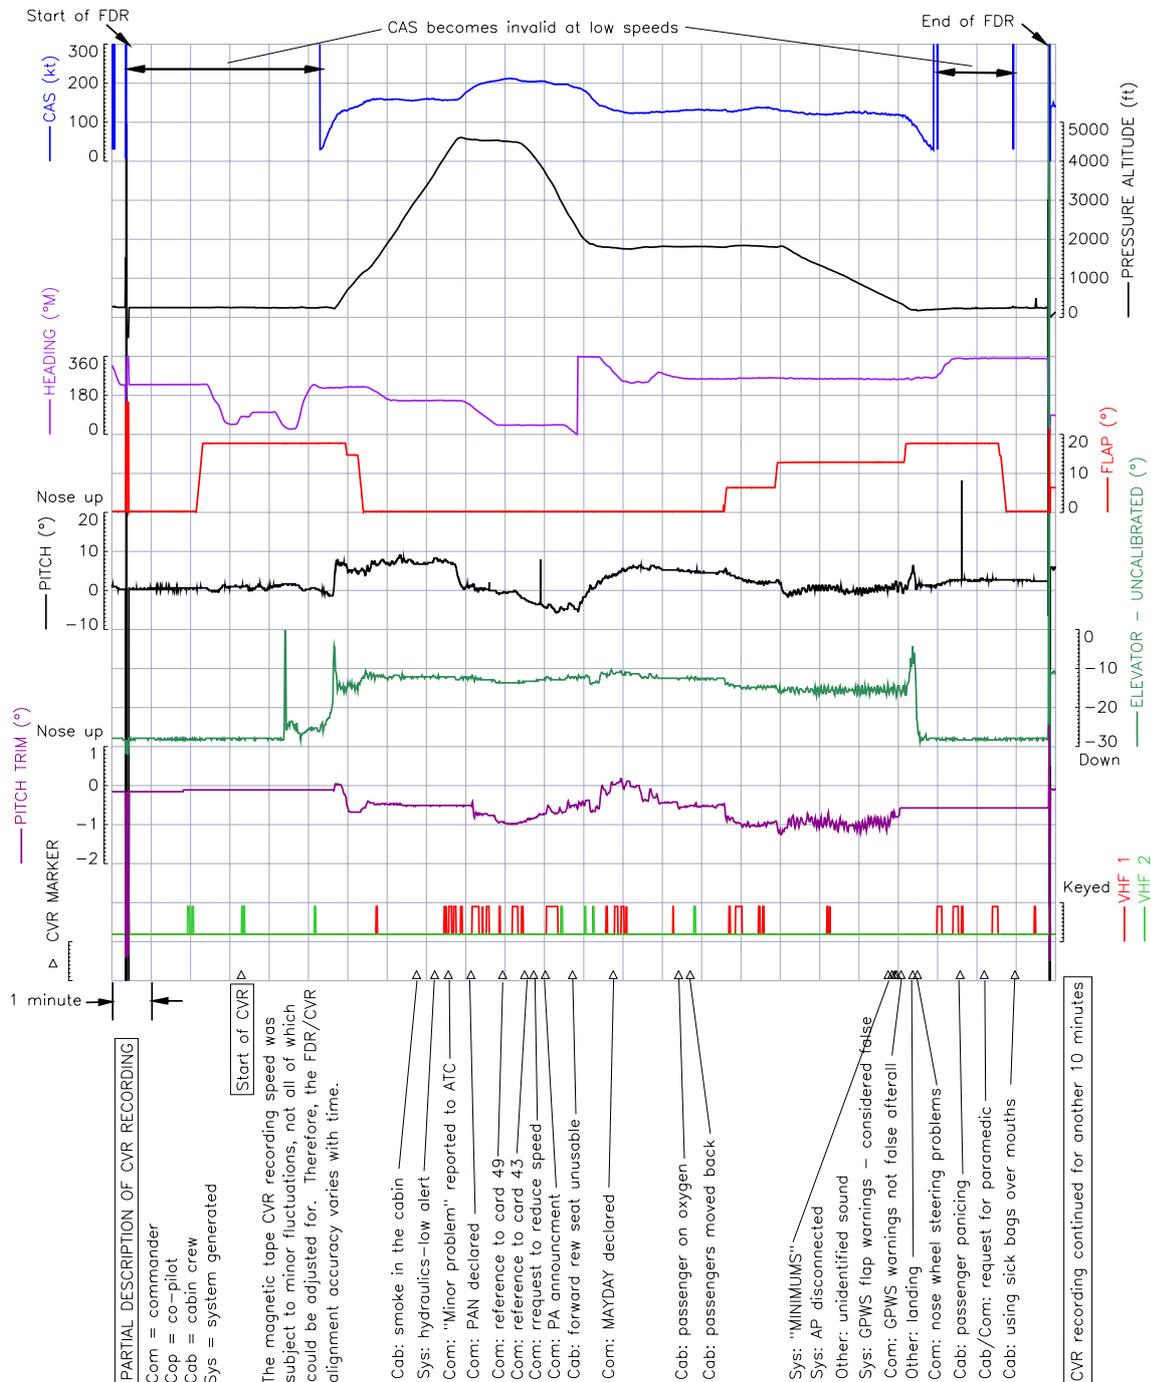
Figure 9

The pertinent FDR recorded parameters are shown in Figure 9, together with relevant extracts from the CVR. The CVR recorded the autopilot disconnect alert, approximately 30 seconds before touchdown, with selection of landing flap occurring shortly thereafter.

Selected FDR recorded parameters shown against pertinent CVR extracts

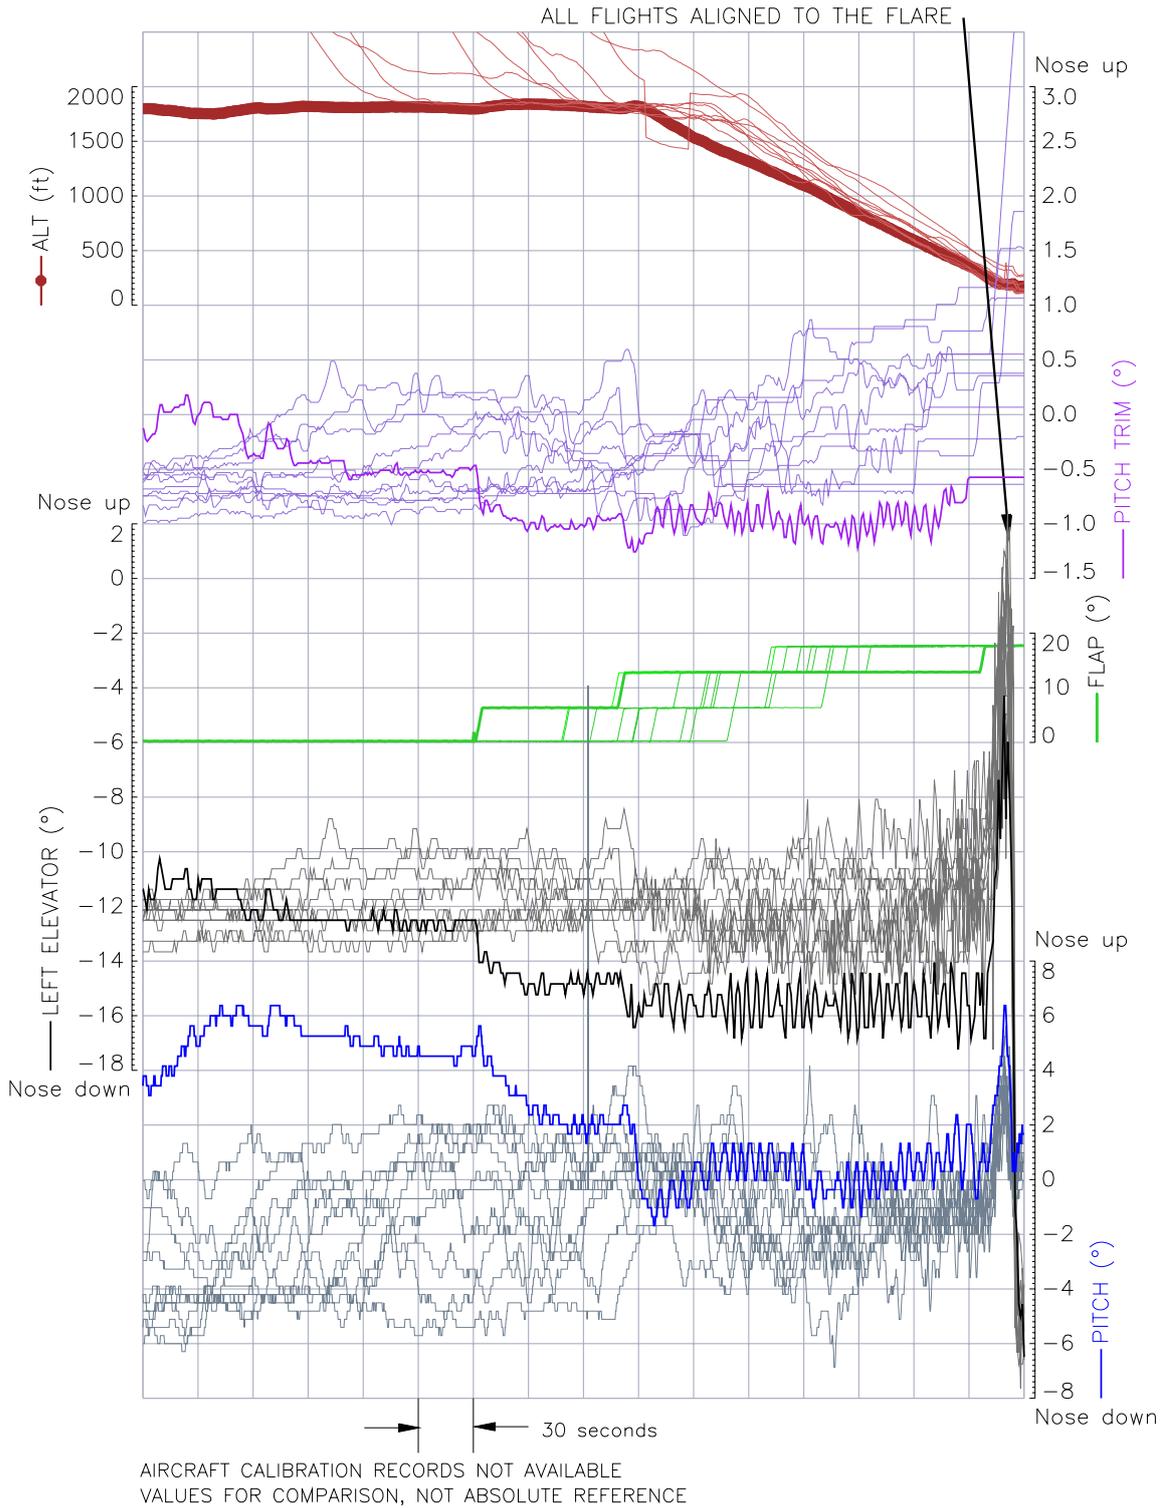
**Figure 10**

A comparison of pitch-related parameters towards the end of the flight is made with those from other landings, in Figure 10. Of note, the aircraft pitch trim setting was significantly more nose-down, the (left) elevator angle was deflected significantly more in the aircraft nose-down sense, and the aircraft's pitch attitude

during the final descent, was amongst the highest recorded of the preceding 46 flights. Also, there was an apparent change in the aircraft's pitch stability at the end of the flight, following selection of Flap 15 in preparation for landing. Had landing flap been selected at the appropriate time on approach, additional nose-up pitch forces would have occurred over a longer period.

Comparison of pitch related parameters against those of previous flights. The bold lines relate to the event flight and the rest relate to previous flights recorded on the FDR
