ACCIDENT

Aircraft Type and Registration:	Boeing 777-222, N786UA	
No & Type of Engines:	2 Pratt & Whitney PW4090 series turbofan engines	
Year of Manufacture:	1997	
Date & Time (UTC):	26 February 2007 at 1000 hrs	
Location:	London (Heathrow) Airport	
Type of Flight:	Commercial Air Transport (Passenger)	
Persons on Board:	Crew - 20	Passengers - 185
Injuries:	Crew - None	Passengers - None
Nature of Damage:	Heat and fire damage to the right main power distribution panel, surrounding structure and components inside the Main Equipment Centre	
Commander's Licence:	Airline Transport Pilot's Licence	
Commander's Age:	52 years	
Commander's Flying Experience: (Hours all approximate)	18,000 hours (of which 2,800 hours were on type) Last 90 days - 215 hours Last 28 days - 65 hours	
Information Source:	AAIB Field Investigation

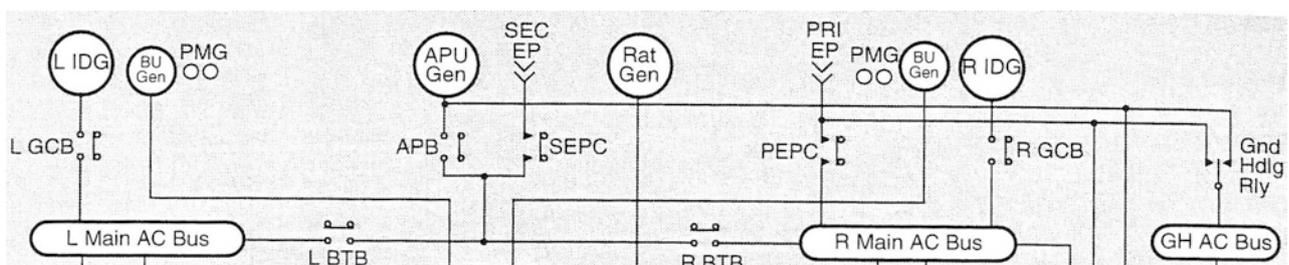
power distribution system is shown in Figure 1. The flow of power is controlled by contactors which open and close; seven contactors are shown in Figure 1 which include the right generator circuit breaker (RGCB) and right bus tie breaker (RBTB). The RGCB, RBTB and Right Main Bus are components of the P200 Electrical Load Management System (ELMS) power panel located in the right forward section of the MEC.

Boeing 777 electrical power distribution schematic
