ACCIDENT

Aircraft Type and Registration:	Piper PA-28-140 Cherokee, G-ATRR	
No & Type of Engines:	1 Lycoming O-320-E3D piston engine	
Year of Manufacture:	1966 (Serial no: 28-21892)	
Date & Time (UTC):	19 May 2013 at 1018 hrs	
Location:	Caernarfon Airport, Gwynedd	
Type of Flight:	Private	
Persons on Board:	Crew - 1	Passengers - 2
Injuries:	Crew - 1 (Serious)	Passengers - 1 (Fatal) 1 (Serious)
Nature of Damage:	Aircraft destroyed	
Commander's Licence:	Private Pilot's Licence	
Commander's Age:	61 years	
Commander's Flying Experience:	90 hours (of which 72 were on type) Last 90 days - 9 hours Last 28 days - 2 hours	
Information Source:	AAIB Field Investigation

Synopsis

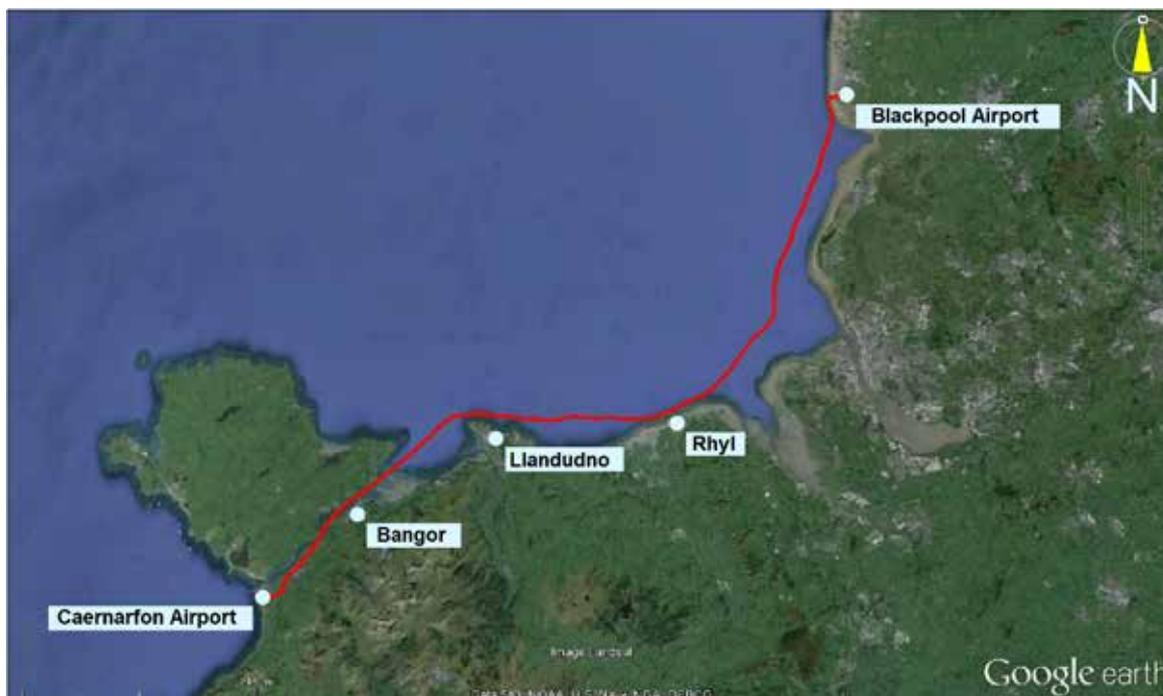
Figure 1

route, maintaining an altitude of between 1,000 ft and 2,500 feet amsl. A GPS-derived track plot of the route is shown as Figure 1.

GPS track - Blackpool to Caernarfon

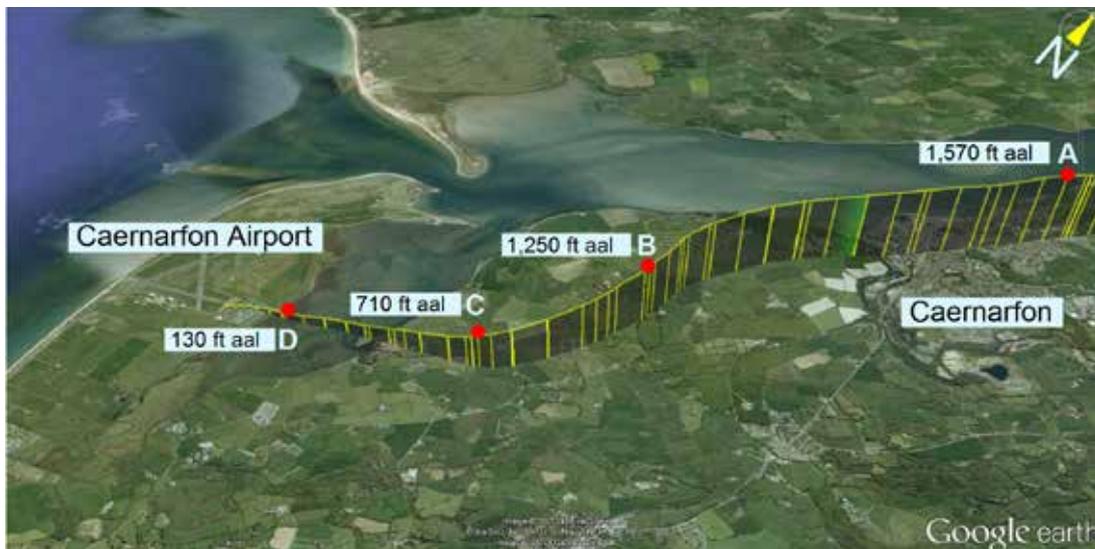
Figure 3

towards the final approach track for Runway 26, initially at about 300 ft/min, then at about 960 ft/min (Point B, groundspeed 103 kt, 2.2 nm from the runway threshold).

GPS track of approach to Caernarfon
