SERIOUS INCIDENT

Aircraft Type and Registration:	Raytheon 390 Premier I, G-FRYL	
No & Type of Engines:	2 Williams International FJ44-2A turbofan engines	
Year of Manufacture:	2004	
Date & Time (UTC):	7 August 2008 at 1800 hrs	
Location:	En route Copenhagen, Denmark to Farnborough, UK	
Type of Flight:	Commercial Air Transport (Non-Revenue)	
Persons on Board:	Crew - 2	Passengers - None
Injuries:	Crew - None	Passengers - N/A
Nature of Damage:	None	
Commander's Licence:	Commercial Pilot's Licence	
Commander's Age:	60 years	
Commander's Flying Experience:	11,830 hours (of which 1,850 were on type) Last 90 days - 140 hours Last 28 days - 30 hours	
Information Source:	AAIB Field Investigation

Synopsis

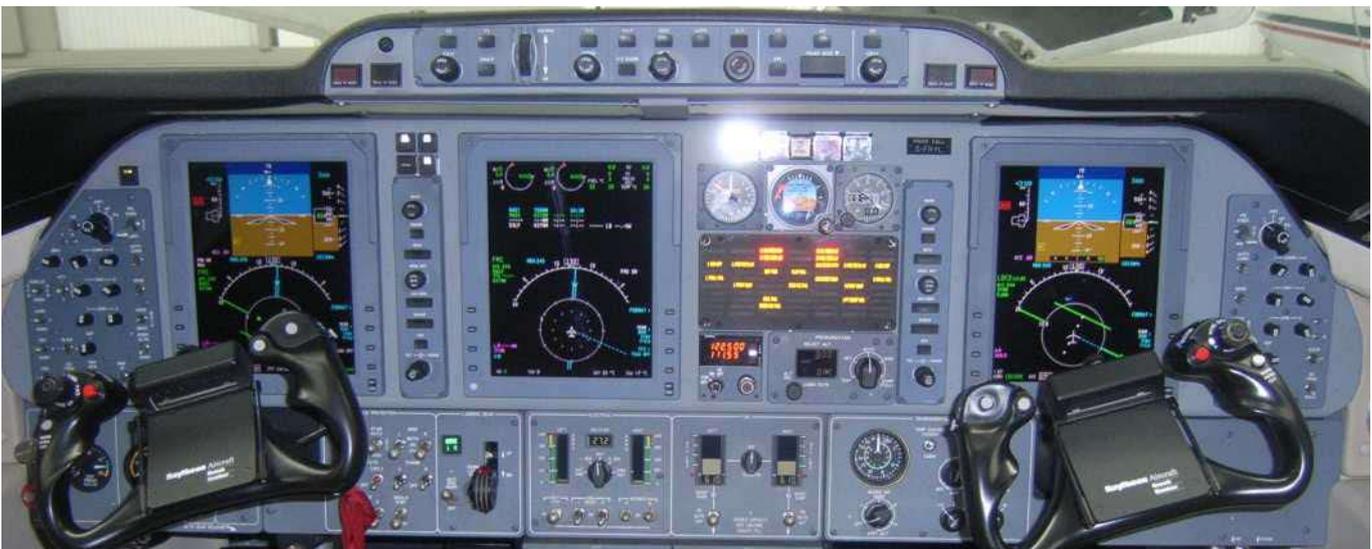
Figure 1

The EFIS consists of three large colour displays, two Primary Flight Displays (PFD1 and PFD2) and a Multifunction Display (MFD), and two display control panels, one for each pilot's display (see Figure 1). The PFDs show attitude, navigation/compass, flight control, air data (altitude, airspeed and vertical speed), and TCAS advisory functions. Air data information is supplied
