## ACCIDENT

<b>Aircraft Type and Registration:</b>	Boeing 737-600, 7T-VJT
<b>No &amp; Type of Engines:</b>	2 CFM 56-7B20 turbofan engines
<b>Year of Manufacture:</b>	2002
<b>Date &amp; Time (UTC):</b>	31 May 2006 at 1200 hrs
<b>Location:</b>	London Gatwick Airport
<b>Type of Flight:</b>	Commercial Air Transport (Passenger)
<b>Persons on Board:</b>	Crew - 6                      Passengers - 18
<b>Injuries:</b>	Crew - None                      Passengers - None
<b>Nature of Damage:</b>	Damage to engine and engine outer casing
<b>Commander's Licence:</b>	Airline Transport Pilot's Licence
<b>Commander's Age:</b>	54 years
<b>Commander's Flying Experience:</b>	10,868 hours (of which 700 were on type) Last 90 days - 195 hours Last 28 days - 45 hours
<b>Information Source:</b>	AAIB Field Investigation

## Synopsis

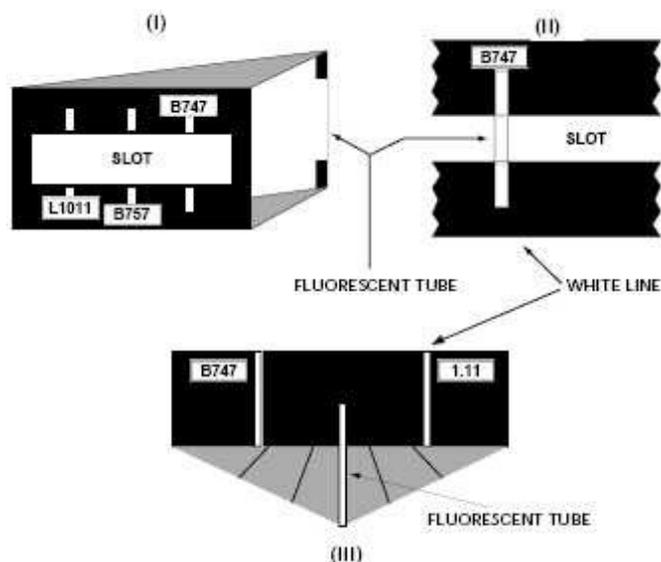
**Figure 2**  
PAPA (typical)

*This aid is positioned to the left side of the Stand centreline and provides stopping guidance by employing a black board marked with white vertical lines bearing aeroplane type identification labels and in which a horizontal slot has been cut, as illustrated at Fig (2) (i). A short distance behind the slot is a vertically-mounted white fluorescent light tube which, when aligned with the required aeroplane type line, indicates the stop-point, as shown at Fig (2) (ii). An alternative layout is illustrated at Fig (2) (iii) where the board is provided without a slot and the tube is mounted in front of it; the method of use is identical.*

On Stand 19, the PAPA, Figure 2, was installed approximately 13 m to the right of the stand centreline but designed for use from the left pilot position. Consequently, it was necessary for the commander to look across the cockpit in order to view it as shown in Figure 3.
