INCIDENT

Aircraft Type and Registration:	Boeing 767-31K, G-DAJC
No & Type of Engines:	2 General Electric Co CF6-80C2B7F turbofan engines
Year of Manufacture:	1994
Date & Time (UTC):	15 August 2010 at 0750 hrs
Location:	Gatwick Airport, West Sussex
Type of Flight:	Commercial Air Transport (Passenger)
Persons on Board:	Crew - 11 Passengers - 324
Injuries:	Crew - None Passengers - None
Nature of Damage:	Electrical overheating of an oven controller module
Commander's Licence:	Airline Transport Pilot's Licence
Commander's Age:	51 years
Commander's Flying Experience:	13,650 hours (of which 8,630 were on type) Last 90 days - 155 hours Last 28 days - 34 hours
Information Source:	Aircraft Accident Report Form submitted by the aircraft commander

Synopsis

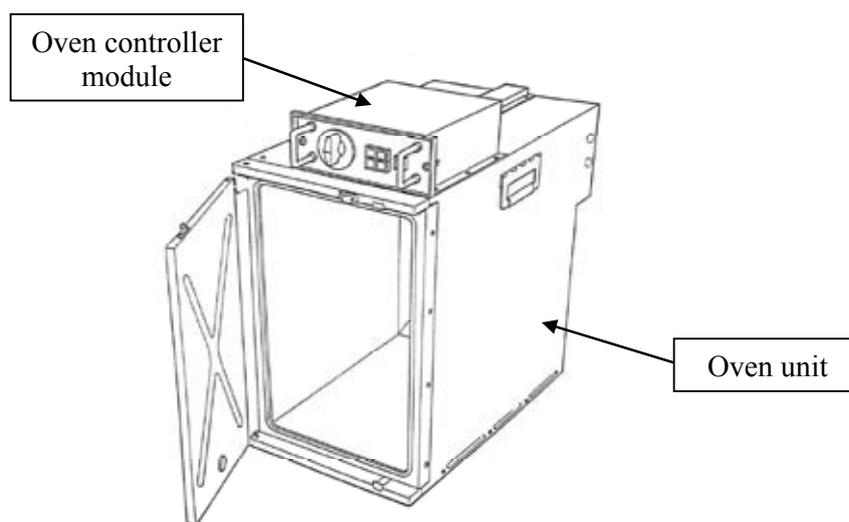
Figure 1
Oven assembly

unit, as shown in Figure 1. The two ovens in the forward galley are supplied with 115 volt AC electrical power and are protected by a circuit breaker, rated at 15 amps, that is accessible to the cabin crew. Each oven controller module is additionally equipped with a circuit breaker rated at 5 amps, installed on the rear of the controller. This circuit breaker is not accessible without removal of the oven from the galley.
