ACCIDENT

Aircraft Type and Registration:	Reims Cessna F406 Caravan II, G-TWIG
No & Type of Engines:	2 Pratt & Whitney Canada PT6A-112 turboprop engines
Year of Manufacture:	1987
Date & Time (UTC):	22 October 2004 at 1033 hrs
Location:	37 miles north-west of Inverness
Type of Flight:	Public Transport (non-revenue)
Persons on Board:	Crew - 1 Passengers - None
Injuries:	Crew - 1 (Fatal) Passengers - N/A
Nature of Damage:	Aircraft destroyed
Commander's Licence:	Airline Transport Pilots Licence
Commander's Age:	35 years
Commander's Flying Experience:	2,735 hours (of which 510 were on type) Last 90 days - 170 hours Last 28 days - 48 hours
Information Source:	AAIB Field Investigation

Synopsis

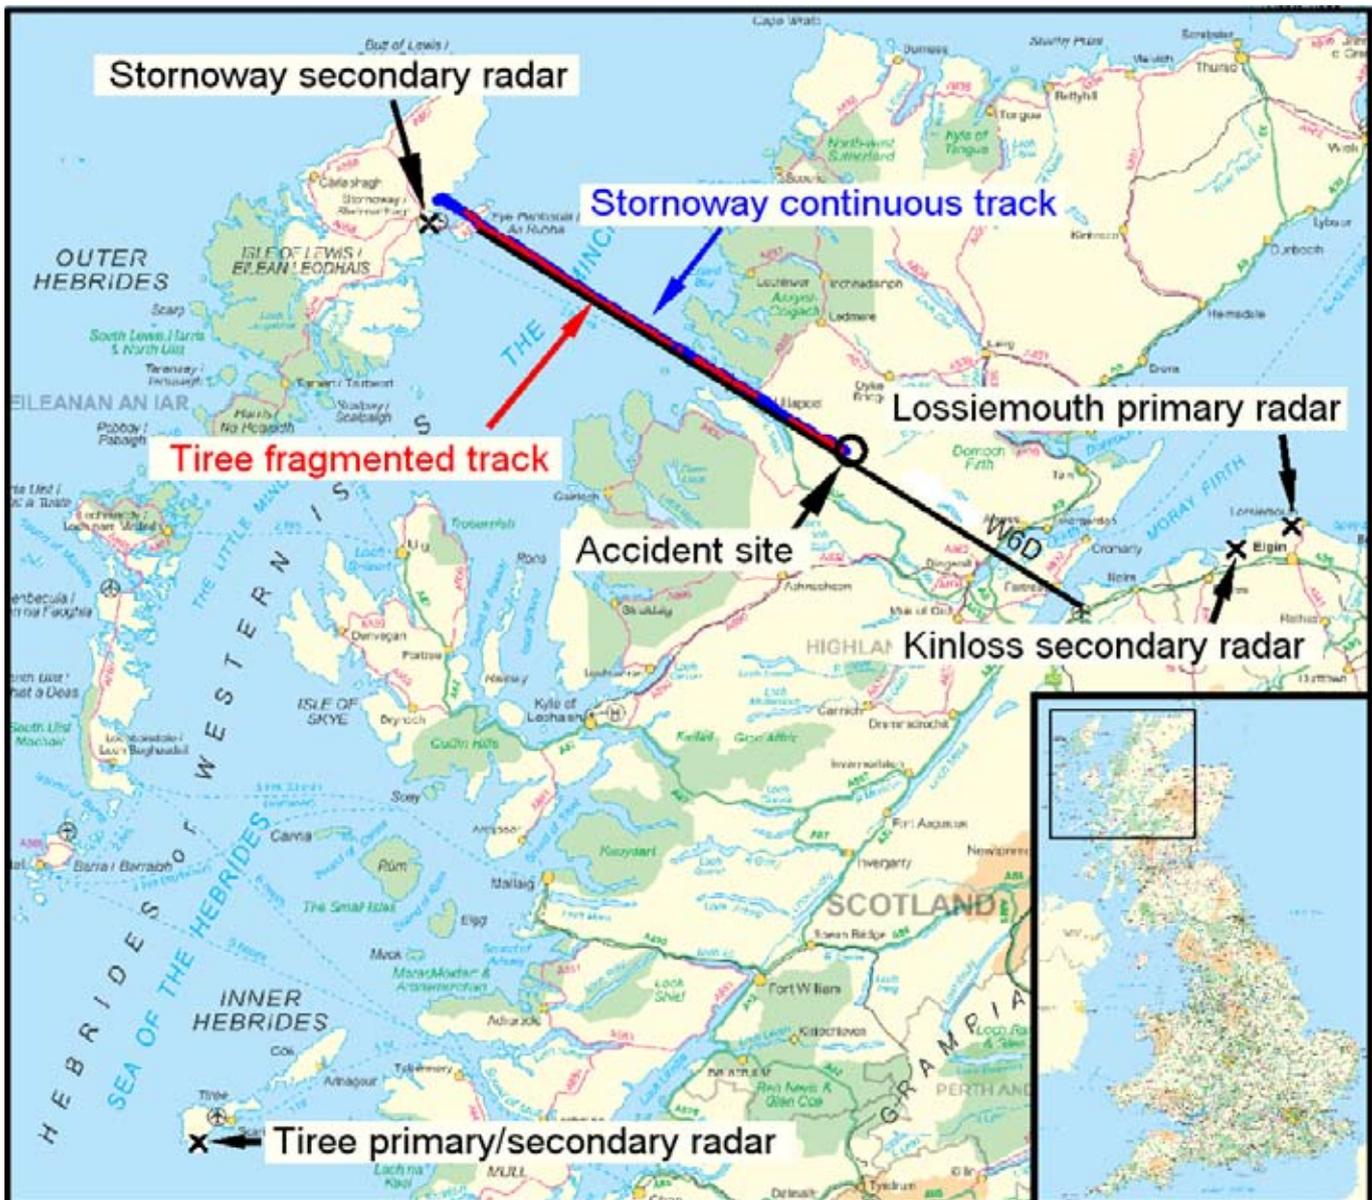
The recorded radar tracks from Stornoway and Tiree are given in Figure 3 together with the type of radar, the location of the radar head, the advisory route being flown and the accident site.

and secondary radar returns, were fragmented due to shadowing by terrain half way between the radar head and the flight path. Another problem with the Tiree data was that the forward motion of the aircraft was aligned with the bearing resolution of the radar which, at these distances, is very poor compared to the range resolution. However, this did make the Tiree source good for assessing the aircraft's across-track motion.

Geographical locations of the accident site, radar tracks, advisory route flown and relevant radar heads
