ACCIDENT

Aircraft Type and Registration:	Piper PA-28-181, Cherokee Archer II, G-BXRG	
No & Type of Engines:	1 Lycoming O-360-A4M piston engine	
Year of Manufacture:	1978	
Date & Time (UTC):	12 November 2011 at about 1527 hrs	
Location:	27 nm west-north-west of Alderney	
Type of Flight:	Private	
Persons on Board:	Crew - 1	Passengers - 1
Injuries:	Crew - 1 (Fatal)	Passengers - 1 (Minor)
Nature of Damage:	Aircraft lost at sea	
Commander's Licence:	National Private Pilot's Licence	
Commander's Age:	79 years	
Commander's Flying Experience:	150 hours estimated (all were on type) Last 90 days - 3:30 hours Last 28 days - 1:20 hours	
Information Source:	AAIB Field Investigation

Synopsis

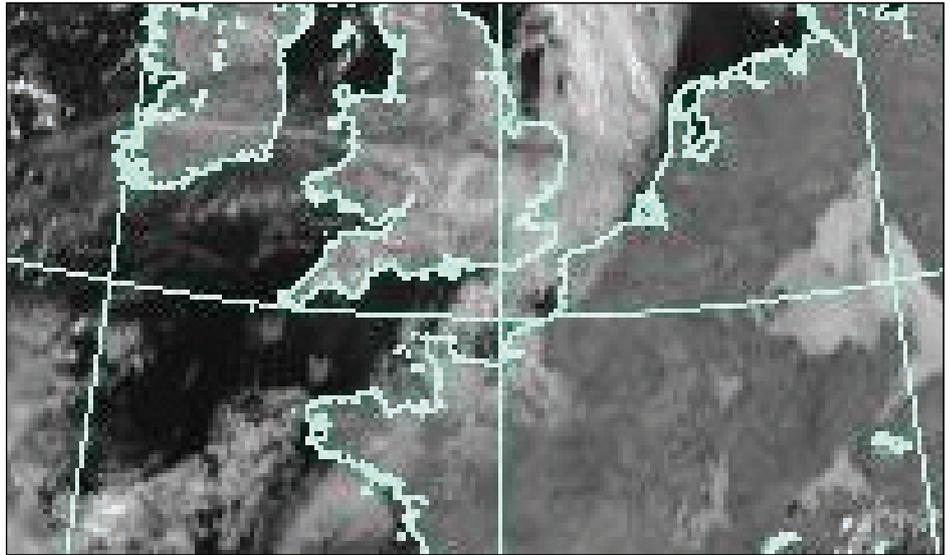
Figure 3

The Met Office’s aviation forecast issued at 0855 hrs (which would have been available to the pilot at Lee-on-Solent) showed a band of weak frontal weather across the area. At 1200 hrs, this would stretch from south-east England across the Channel to northern France and the Channel Islands, moving slowly eastwards (Figure 3). Within the frontal area, the forecast visibility was generally 12 km, but reducing to

3,000 m in mist or light rain and drizzle. Occasional scattered or broken low level stratus cloud was forecast between 200 ft and 1,500 ft, with further broken or overcast cloud layers above.

Visible-spectrum satellite image, taken at 1200 hrs

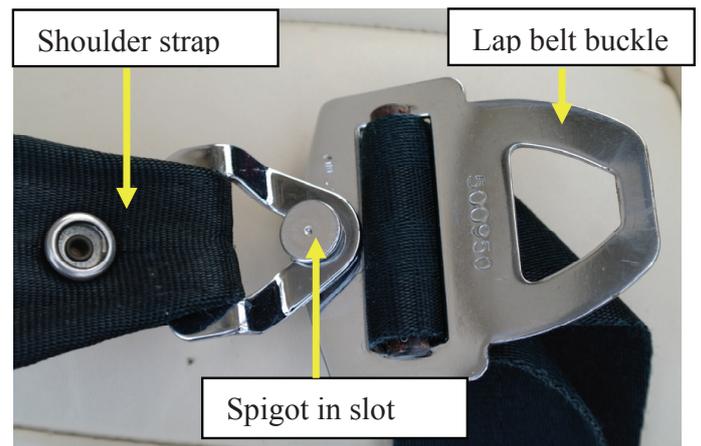
Figure 4
Seat belt buckle

Entry and exit from the cabin is through a door situated on the right side, secured by two latches. The front seats are adjustable fore and aft and are fitted with a three-point harness consisting of a lap belt and shoulder strap. The male portion of the lap belt buckle engages with the female portion of the buckle, which is mounted on a strap secured to the floor between the front seats. The shoulder strap incorporates an inertia reel which is connected to the aircraft structure, just above the side window. The shoulder strap is routed over the shoulder adjacent to the windows and attaches to the lap belt buckle, in the area of the occupant's inboard hip, by a spigot and slot arrangement (Figure 4).

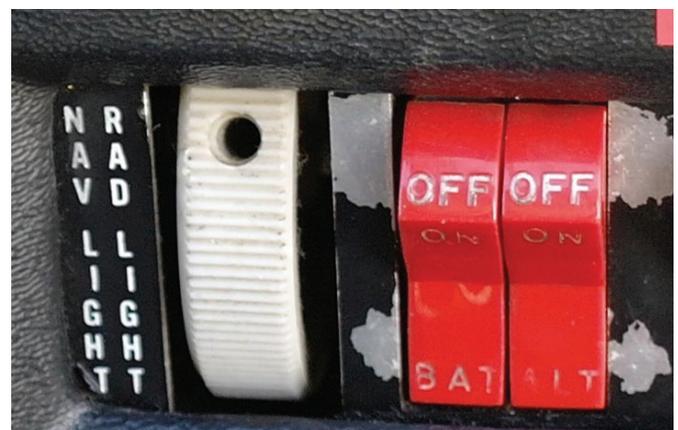
Figure 5
Battery master and alternator switches (red)

The electrical system in G-BXRG included a 14V 60-amp alternator, a 12V battery with a 1-hour rate of 23 amps, a voltage regulator, an over-voltage relay and a battery master switch relay. The battery and alternator are both connected to the aircraft busbar from which electrical power is provided, through circuit breakers (CBs), to the aircraft and avionic systems. The CBs are located at the bottom of the instrument panel in front of the passenger and the battery and alternator are controlled by red switches mounted on the centre instrument panel. Figure 5 shows the switches fitted to

another PA-28-181. The passenger believed that these switches had both been in the ON position during the accident flight.
