ACCIDENT

| Aircraft Type and Registration: | Agusta A109A, G-DNHI | |

Synopsis

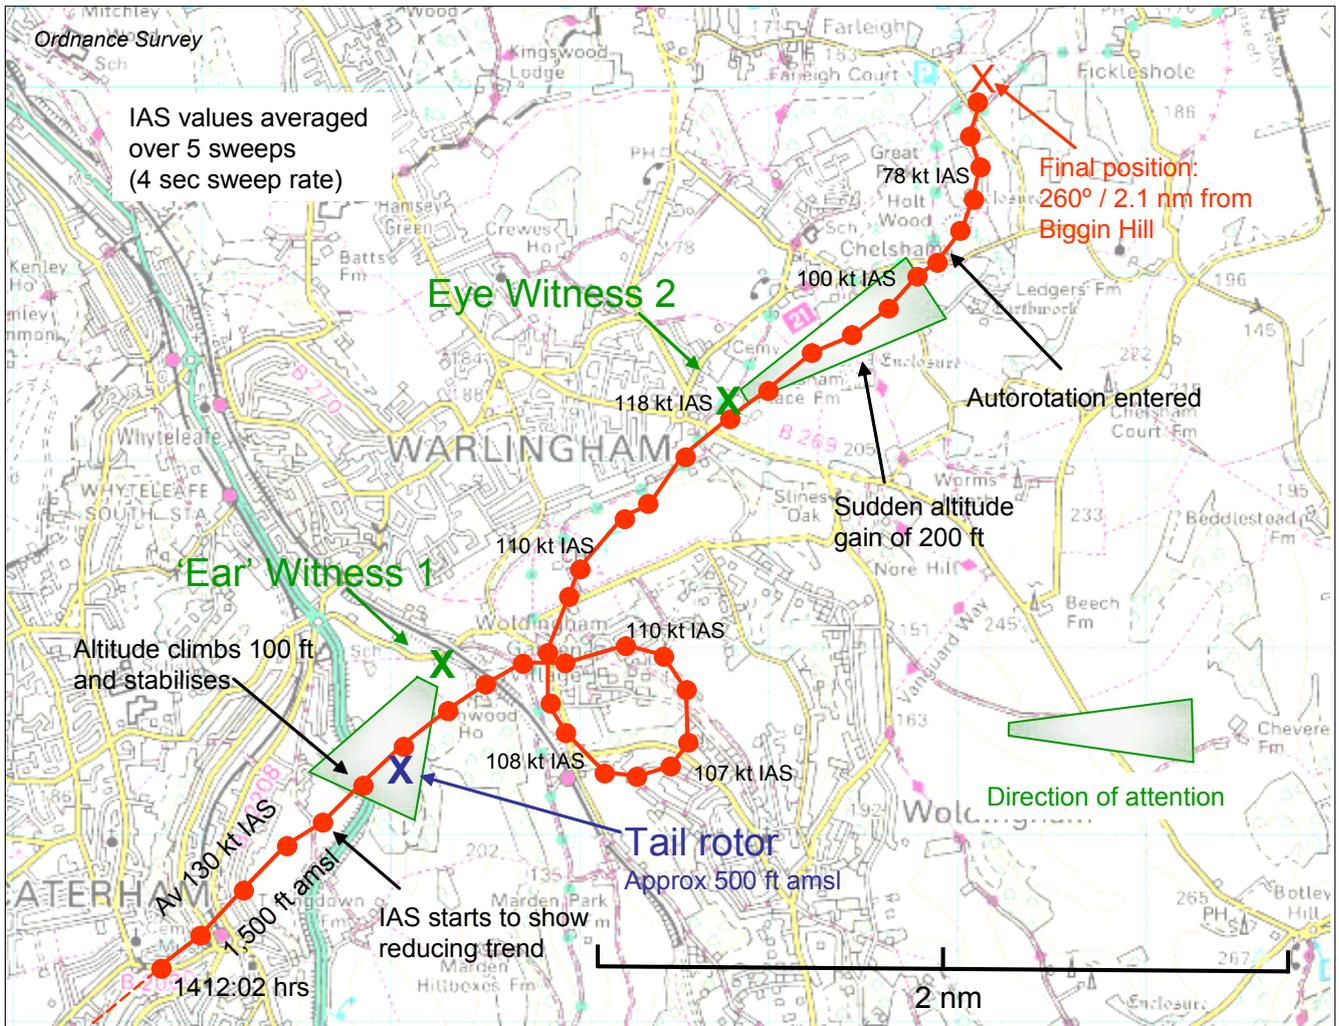
Figure 1

Diagram illustrating G-DNHI's track for the last part of the flight, and the location of witnesses

Radar altitude and groundspeed information confirmed the pilot's reported altitude and estimated IAS, based on a south-westerly airflow of 10 kt to 12 kt. When the helicopter was in the vicinity of the first witness, its altitude began to vary, to a maximum of +200 ft /-0 ft. At the same point the instantaneous and averaged IAS began to decay from about 130 kt. Radar returns then showed an orbit to the right before the helicopter resumed its original track. During this time, the IAS continued to decay, until it stabilised between 100 kt and 110 kt. The orbit was flown with an average rate of turn of 6°/sec, although the actual turn rate was highest mid-way through the orbit. The radius of the orbit was approximately 335 m.

The helicopter resumed a track towards Biggin Hill, maintaining a steady altitude and with a reduced IAS, which then began to increase gradually. About 25 seconds after regaining track, the altitude return showed a sudden increase of 200 ft and the IAS began to decay again. About 12 seconds after this event, the altitude information indicated that the helicopter had entered autorotation, with an IAS between 85 kt and 95 kt and an average rate of descent of 2,100 fpm. The last recorded radar position was within 80 m of the landing site, with a calculated height of 300 ft agl.
