BV234 Main Drive System Component Layout

Page
1	Preliminary	
1.1	Accident	80
1.2	Investigation	80
1.3	Proceedings of Review Board	80
2	Facts	
2.1	Narrative	83
2.2	History of failed transmission, A7-1625	86
3	Decision of the Board	87

2.2 History of the Failed Transmission, A7-1625

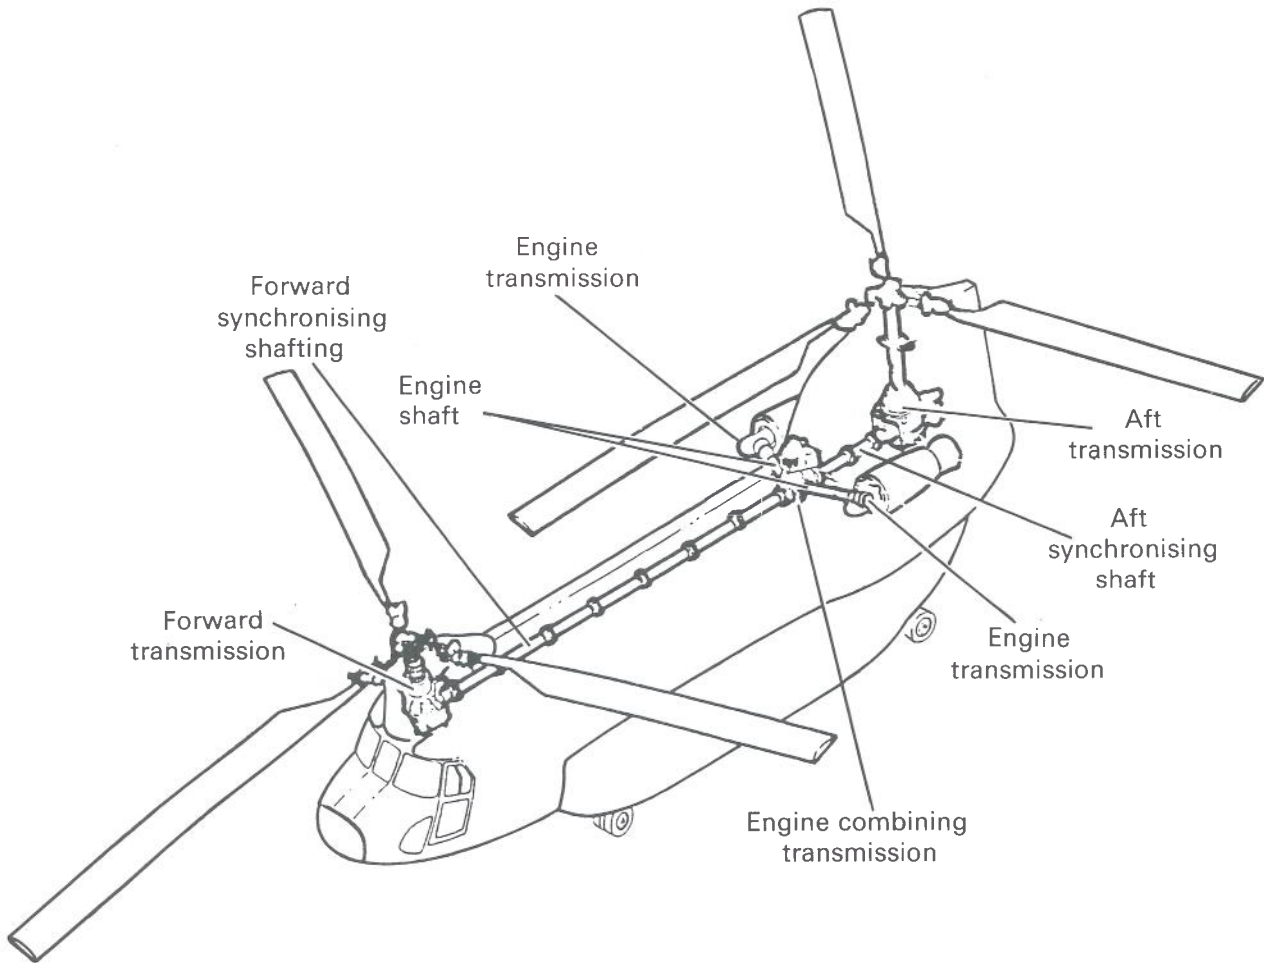
It is common ground that the crash of the aircraft was caused by the failure of the spiral bevel ring gear, and in particular by the substantial fracturing of the attachment flange of that gear. There were two transmissions, one for each set of rotors. It was the forward transmission which failed: the layout of the main drive system, including the forward transmission, is illustrated in Figure 1.

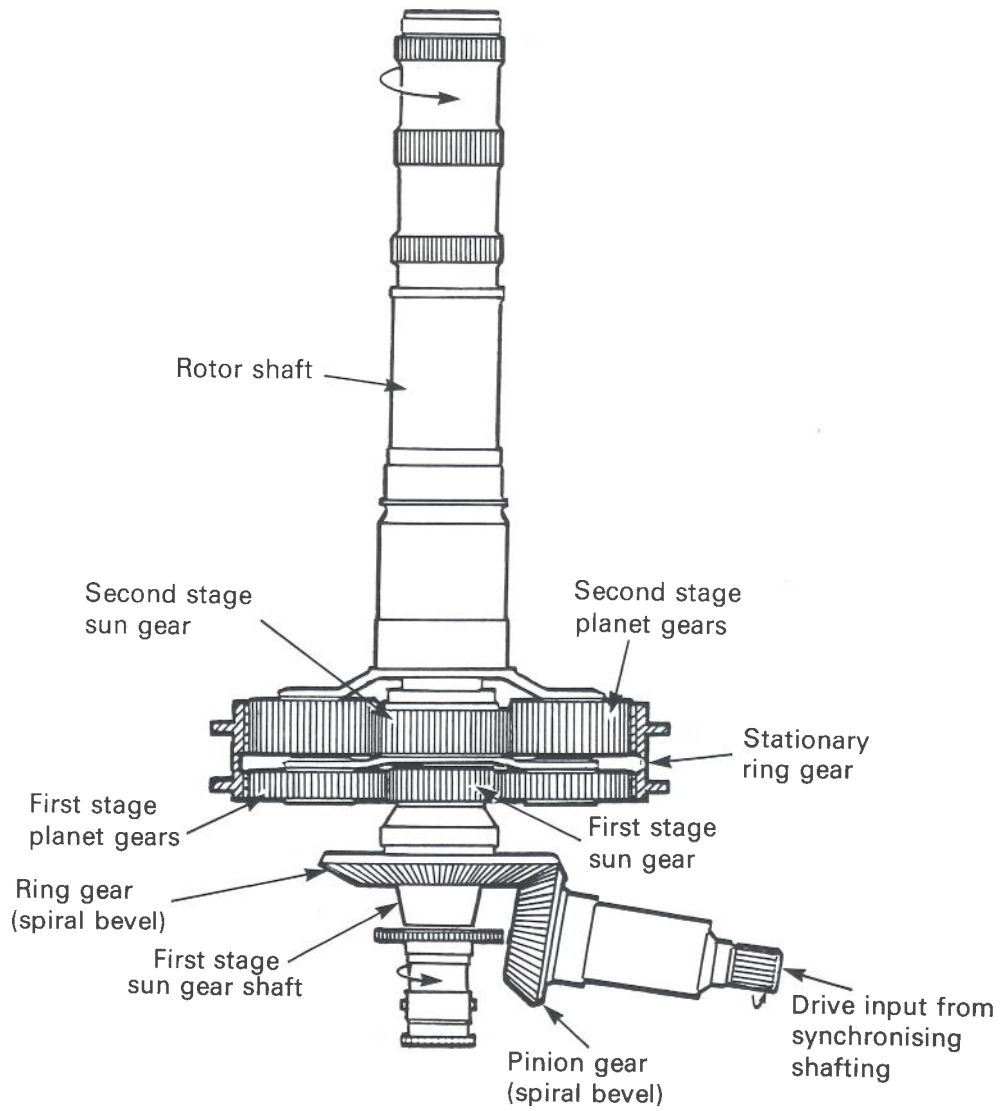
BV234 Forward Transmission Gear Train

The forward transmission gear train is illustrated in Figure 2; and the assembly of the spiral bevel ring gear is illustrated by the exploded diagram, Figure 3.

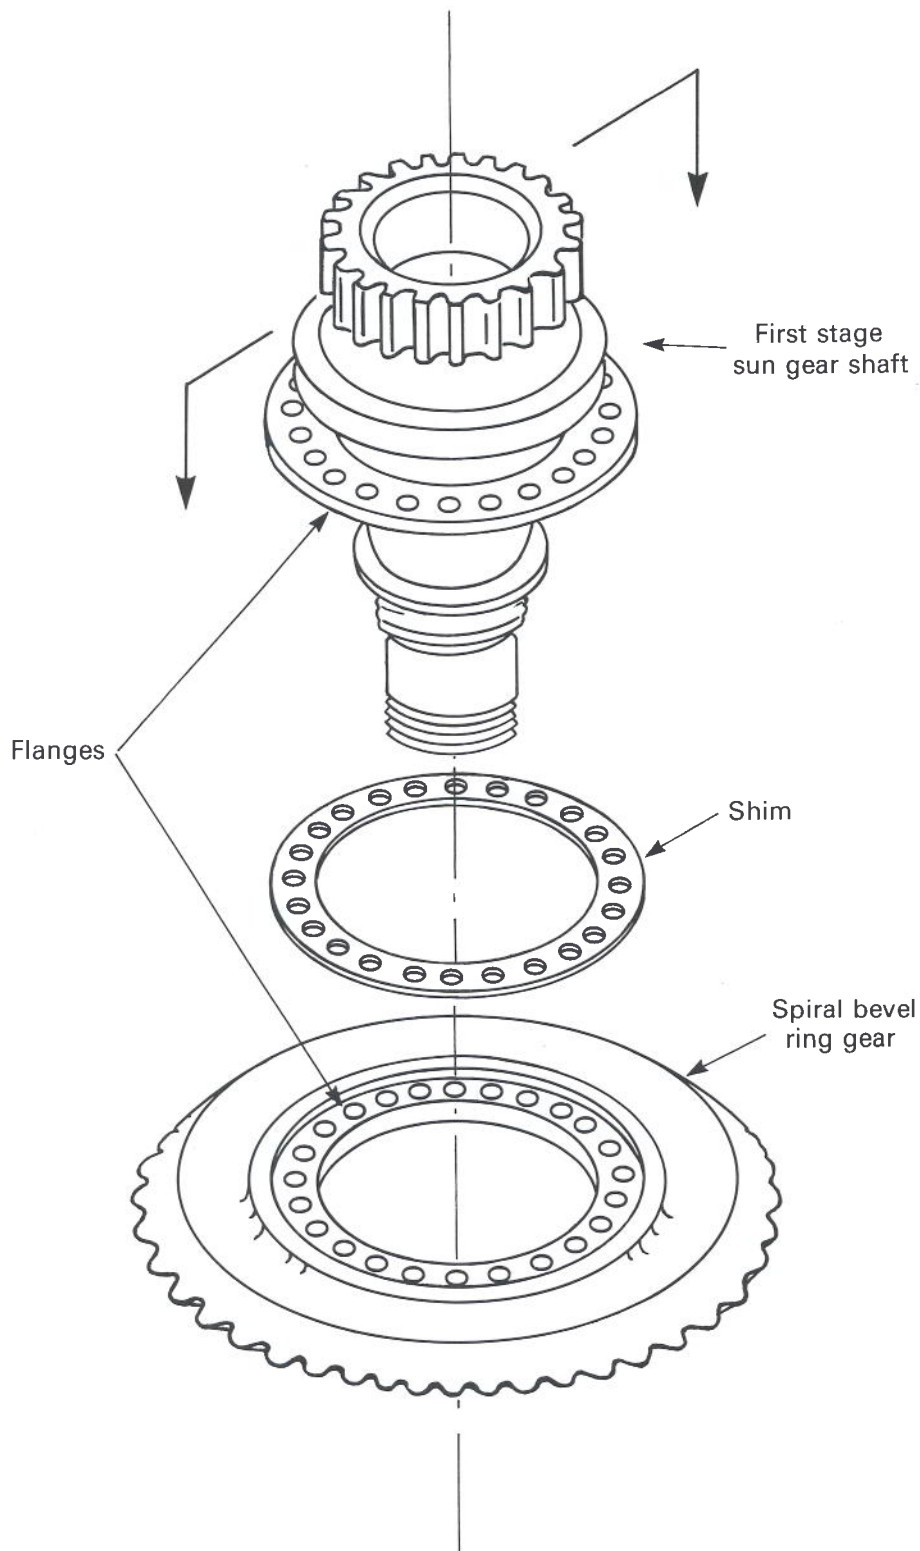
Exploded Diagram of Assembly of Spiral Bevel Ring Gear onto First Stage Sun Gear Shaft (24 Clamping bolts not shown)

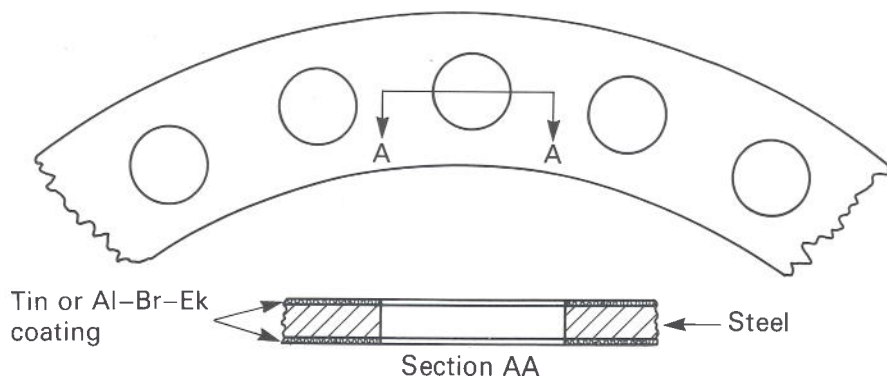
Solid Shim (as used with -6 Standard Ring Gear)

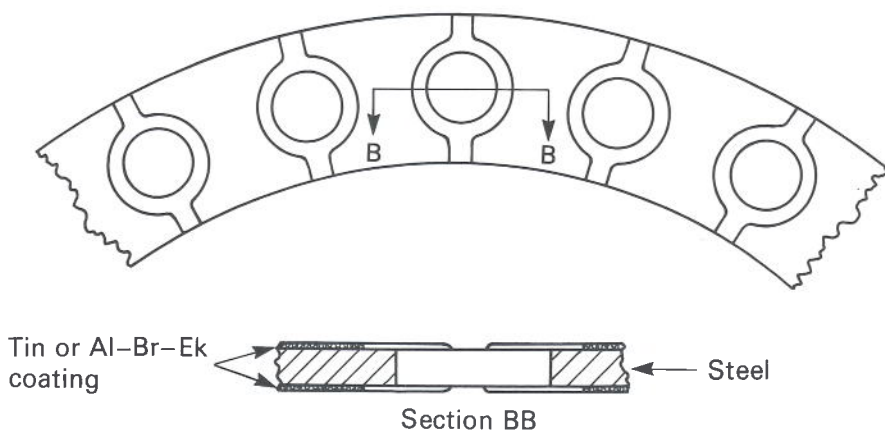
Scalloped Shim (as used with -5 Standard Ring Gear)

The -5 joint was found to give problems in terms of loosening of the bolts and therefore "in order to improve the joint, and so reduce the frequency of inspection, the manufacturers introduced a modification, by Service Bulletin 234-63-1014 for the forward transmission and -1015 for the aft transmission, in which the clamping force was increased by introducing larger diameter bolts which were installed at a higher torque. This in turn had necessitated a return to the solid type shim to avoid bearing overload of the Al-Br-Ek coating" (Figure 6).

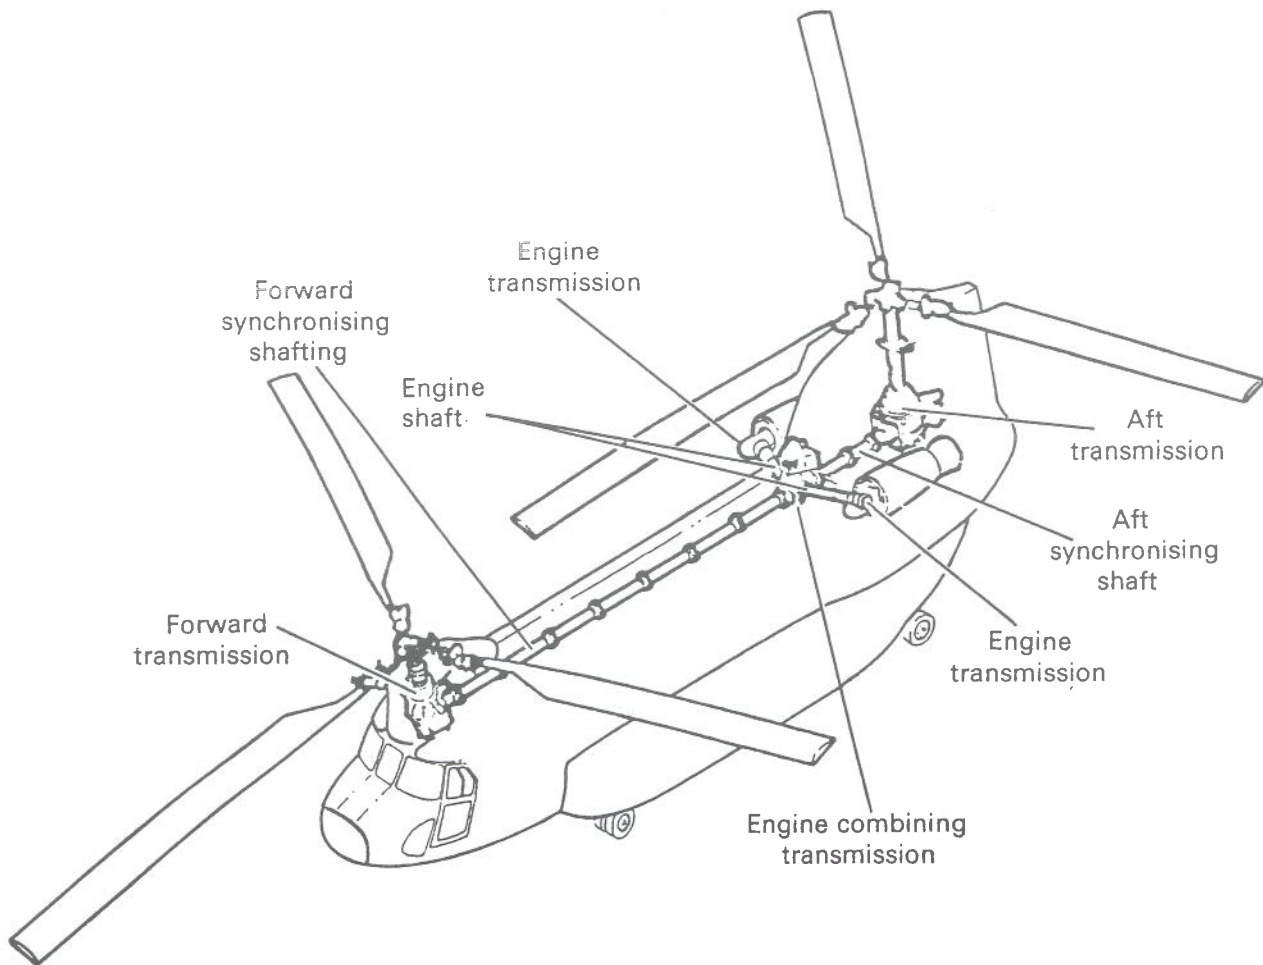
FIGURE 1

BV234 Main Drive System Component Layout

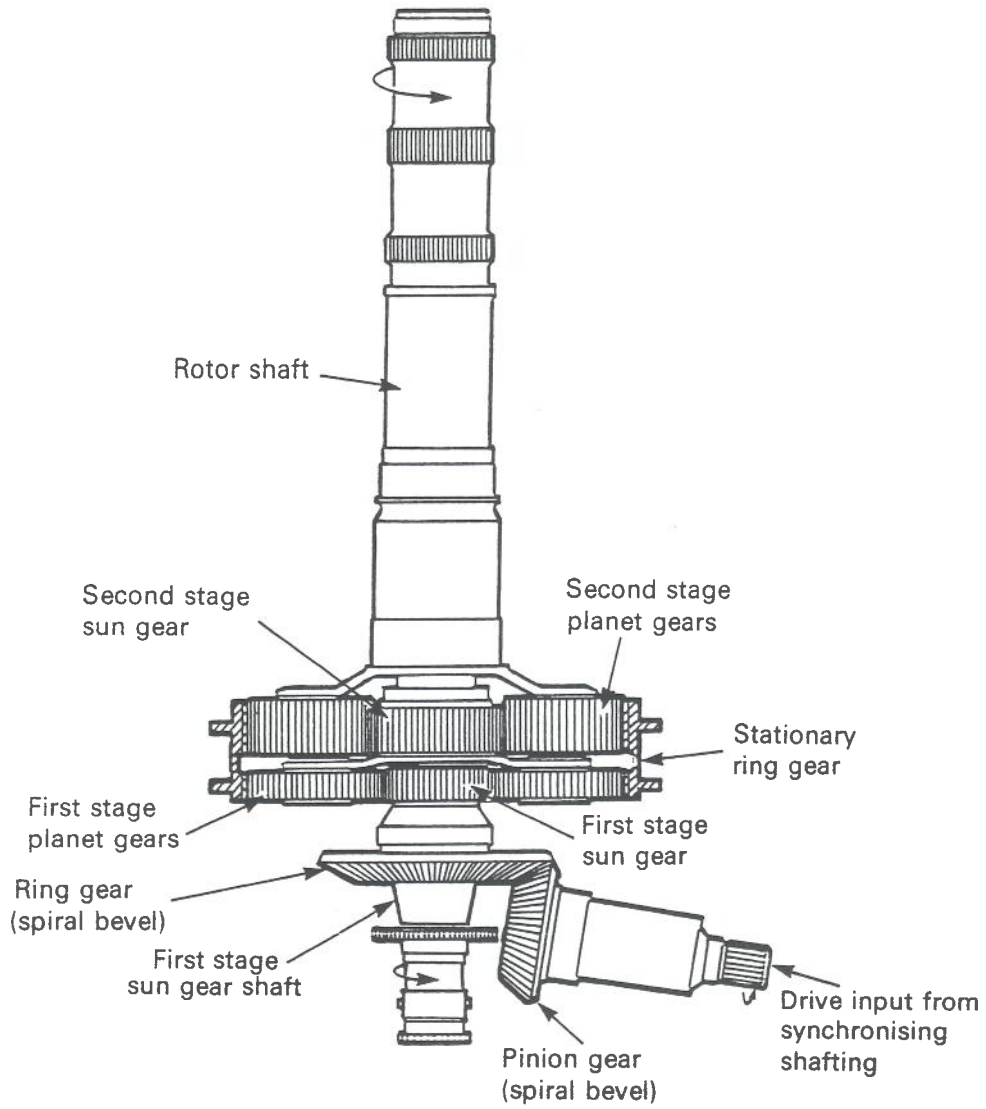
FIGURE 2

BV234 Forward Transmission Gear Train

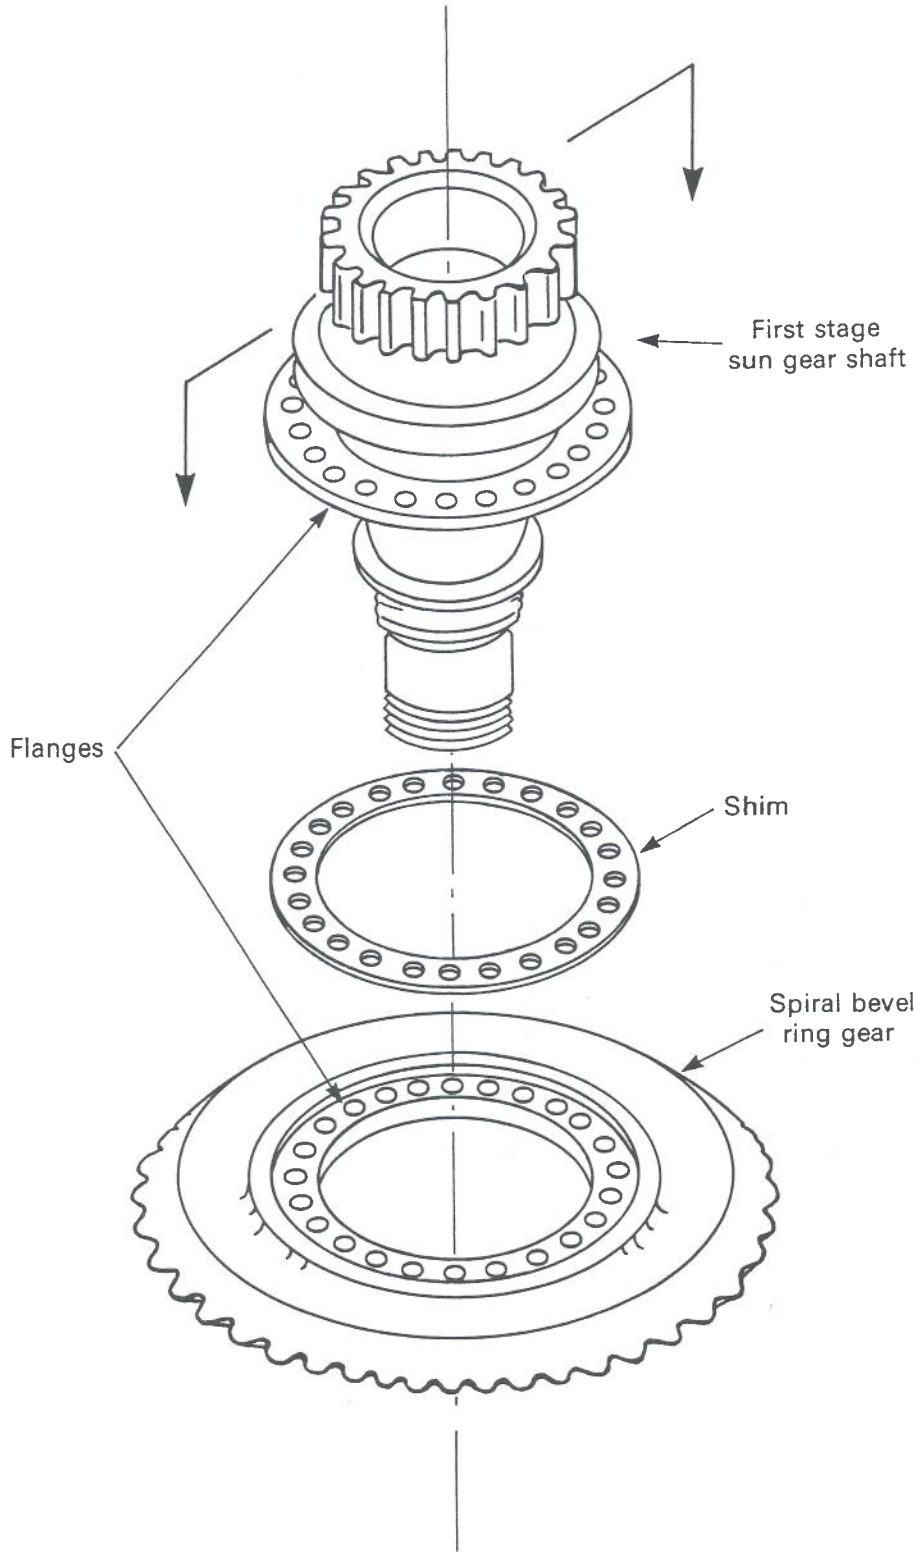
FIGURE 3

Exploded Diagram of Assembly of Spiral Bevel Ring Gear onto First Stage Sun Gear Shaft (24 Clamping bolts not shown)

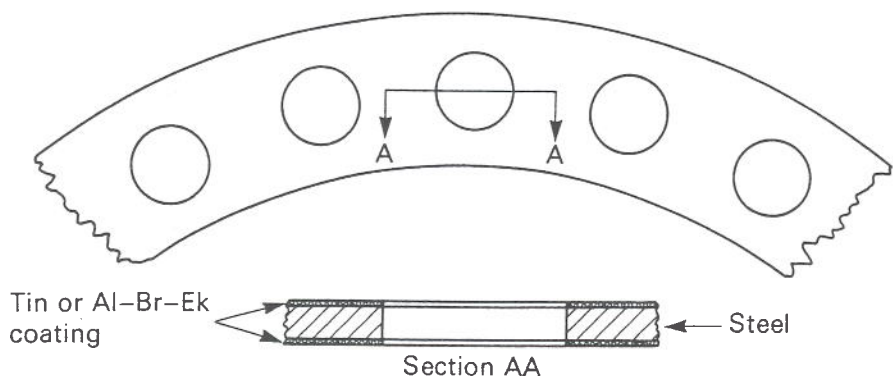
FIGURE 6

Solid Shim (as used with -6 Standard Ring Gear)

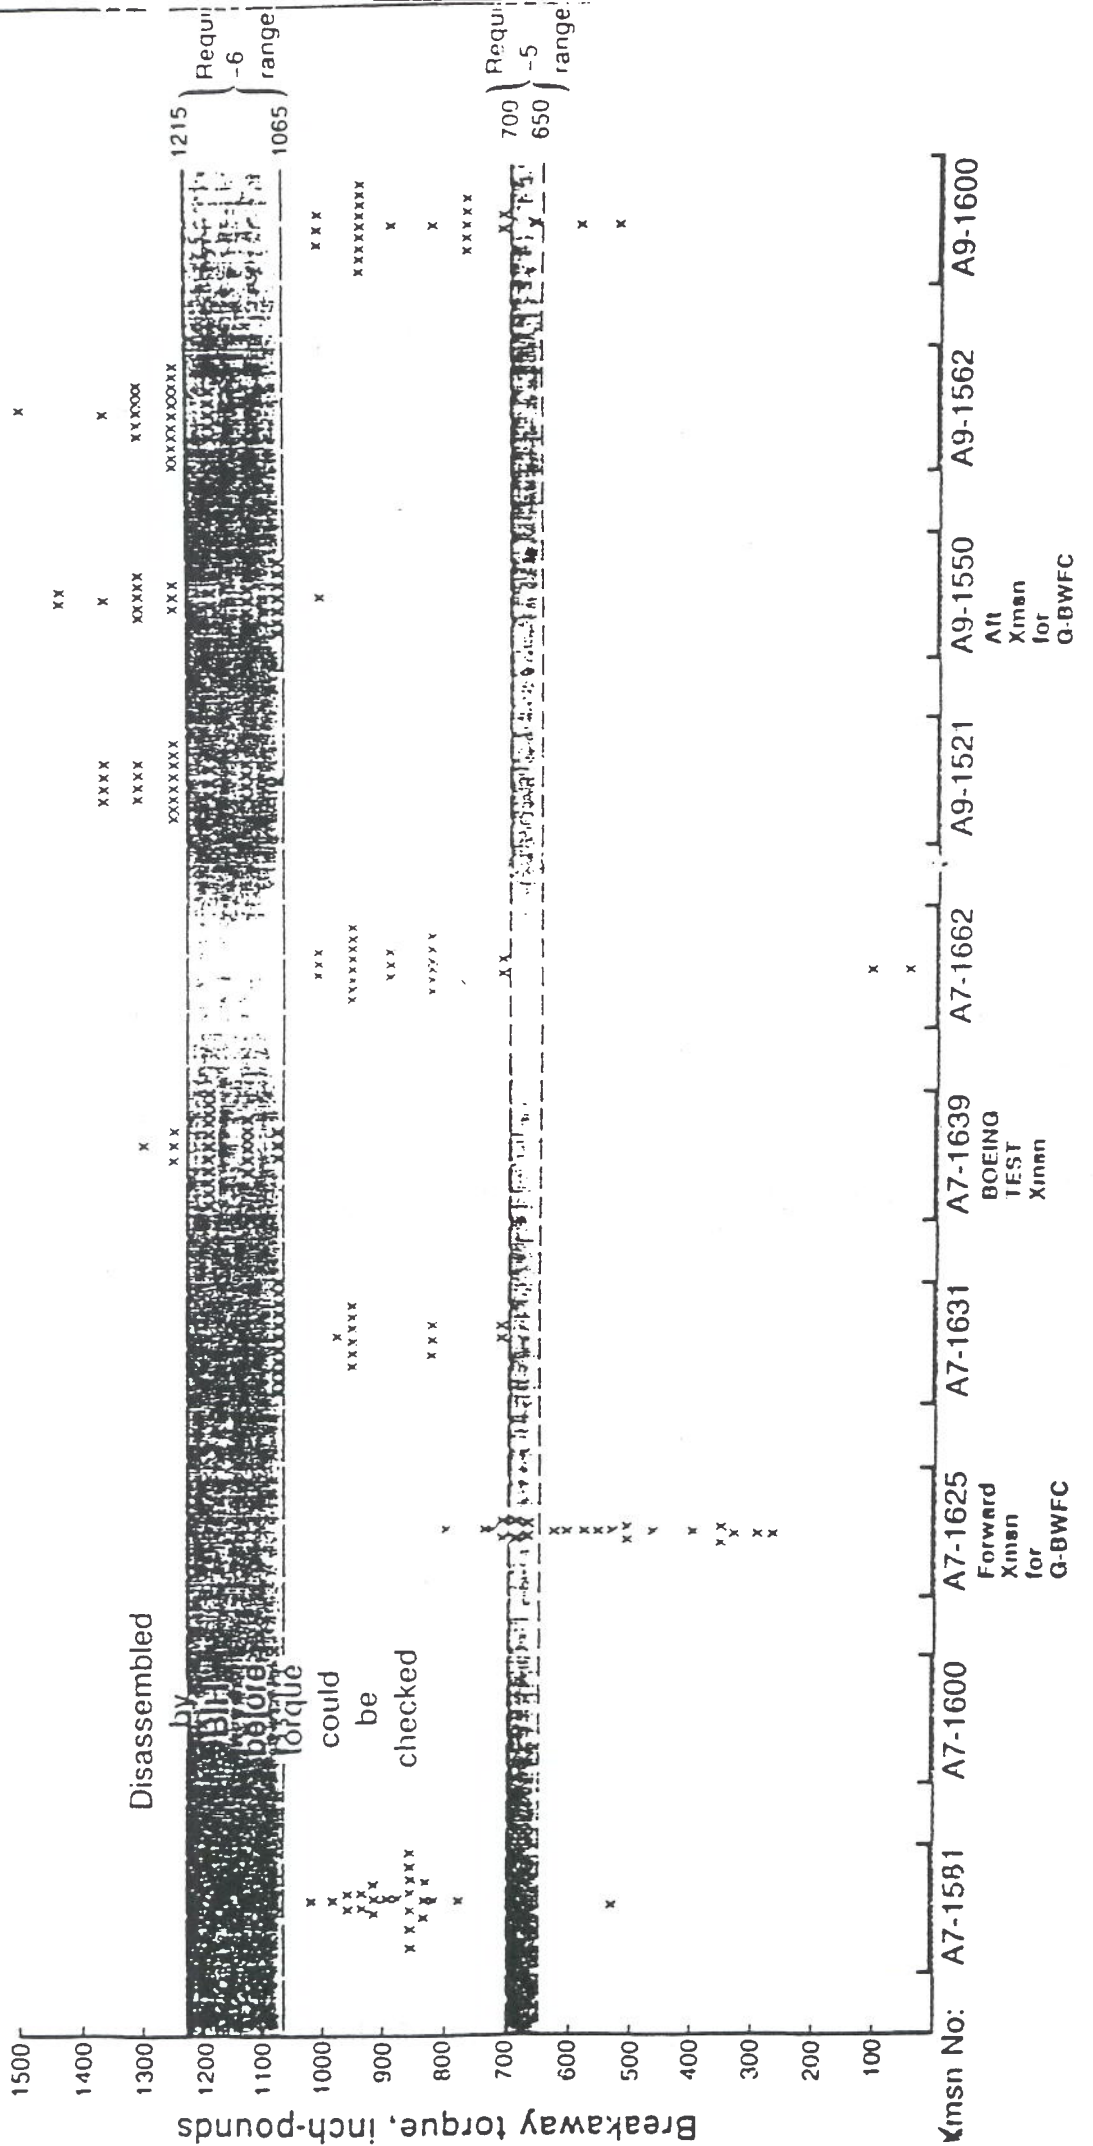
FIGURE 7

On consideration of the chart which showed the breakaway torques of several forward and aft gears set against the band of proper torque levels for -5 and -6 configurations (Figure 7), it appears that there is a distinction between forward and aft gears in that with service, the torque values of the aft gears appear to go up whereas the torque values of the forward gears go down. We think it appropriate to disregard (as did Mr King) all the aft gears and to consider only available test results from the forward gears which had been in service, all of which showed a drop in torque values. The only gear that did not show reduced values was the gear which underwent a salt test rather than operational service (see Mr King at 18.2019). In this regard, Mr Albrecht said that if the gears A7-1581 and A7-1662 had in fact been torqued to the -6 values, the chart indicated a drop in torque values after service.

The sixth and last consideration of Mr King was the disassembly torques on other transmissions as indicated in Figure 7. The inference to be drawn from these is twofold: that they come down during service and that all A7 torques come down even more with trauma. This is not just the evidence of Mr King. Mr Albrecht indicated that he thought the unopposed tightening torques would go up because of the greater frictional force on the bolts, but he also said that these values could go up or down due to distortion. We regard the frictional forces as the smaller of the two effects. We are of this view because the unopposed tightening levels were generally only about 100 in.lb. higher than the opposed untightening values, and this increase would be indicative of the additional frictional forces. However, the average dropped several 100 in.lb. from the initial torque levels.

BREAKAWAY TORQUE VALUES FOR MODIFIED TRANSMISSIONS OPERATED BY BIH AND HELIKOPTER SERVICES
