AAIB Bulletin No: 10/95

Ref: EW/C95/3/1

INCIDENT

Aircraft Type and Registration: BAe ATP, G-MANP

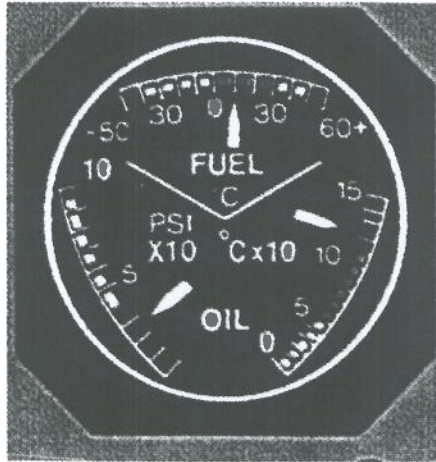
TRIPLE INDICATOR (actual size)

The engine oil temperature is indicated to the flight crew on a 'triple indication' gauge mounted within the engine instrumentation group on the central instrument panel, the temperature being taken from a sensor located in the oil supply line to the main bearings of the turbomachine (Figure 2). The scale of the oil temperature gauge is 27 mm in length and shows a range of 0 to 150° in 10 degree divisions. The scale is colour coded amber from 0 to 45 degrees and green from 45 to 115 degrees.

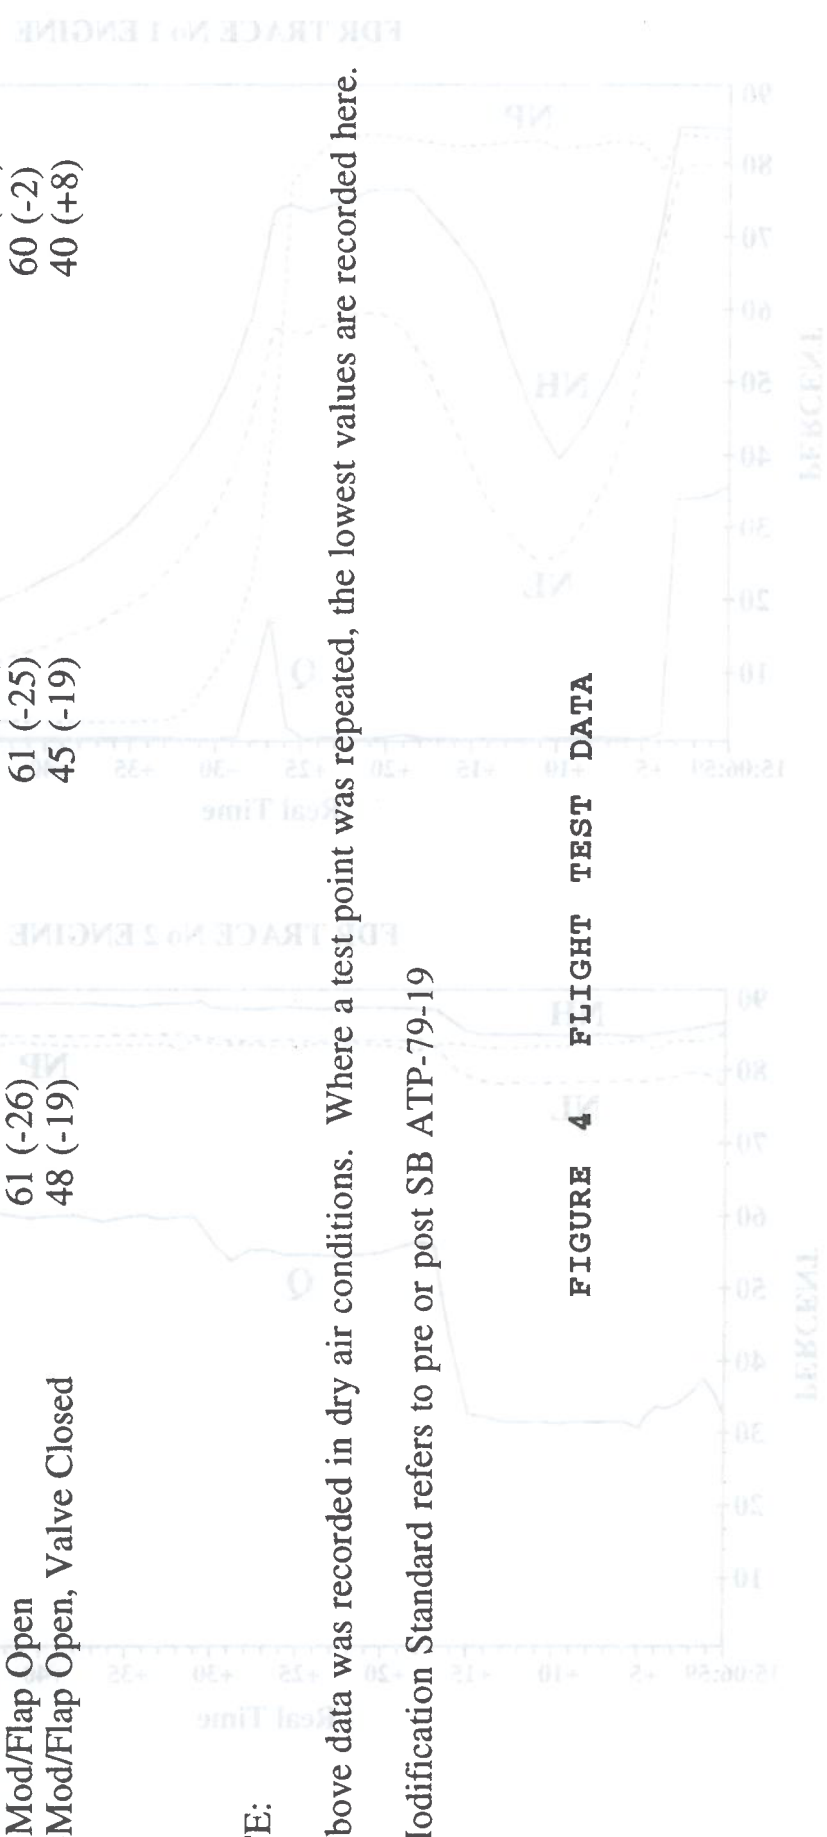
FIGURE 4 FLIGHT TEST DATA

The aircraft manufacturer conducted a number of flight tests with pre and post SB ATP-79-19 aircraft. The details of these tests are described below and the significant findings are summarised in Figure 4:

In order to determine the effect of a failed bypass thermal control valve and oil cooler flap valve on the engine oil temperature of a pre-SB ATP-79-19 installation, the aircraft manufacturer conducted a number of flight tests. One of the aircraft's two engines was nominated as the test engine on which the fault conditions were reproduced. The test engine was fitted with a special oil cooler bypass thermal control valve which was fixed in the 'full cooling' position. In the cruise and with the flap valve operating normally, the failed oil cooler bypass thermal control valve had no significant effect on the engine oil temperature, indicating that the flap valve had enough authority to compensate for the failed bypass thermal control valve. In the descent, the test engine oil temperature was 50°C, ie 10°C colder than that of the fully serviceable engine.

1. Above data was recorded in dry air conditions. Where a test point was repeated, the lowest values are recorded here.
2. Modification Standard refers to pre or post SB ATP-79-19
