Gill SA Pulsar, G-BSFA

AAIB Bulletin No: 5/2003	Ref: EW/G2002/08/13	Category: 1.3
Aircraft Type and Registration:	Gill SA Pulsar, G-BSFA	
No & Type of Engines:	1 Rotax 582 piston engine	
Year of Manufacture:	1992	
Date & Time (UTC):	14 August 2002 at 1845 hrs	
Location:	Gloucestershire Aerodrome, Staverton	
Type of Flight:	Private	
Persons on Board:	Crew - 1	Passengers - 1
Injuries:	Crew - None	Passengers - None
Nature of Damage:	Damage to nose leg and floor aft of firewall	
Commander's Licence:	Private Pilot's Licence	
Commander's Age:	40 years	
Commander's Flying Experience:	526 hours (of which 34 were on type) Last 90 days - 26 hours Last 28 days - 11 hours	
Information Source:	Aircraft Accident Report Form submitted by the pilot and metallurgical examination of failed pin from the nose landing gear

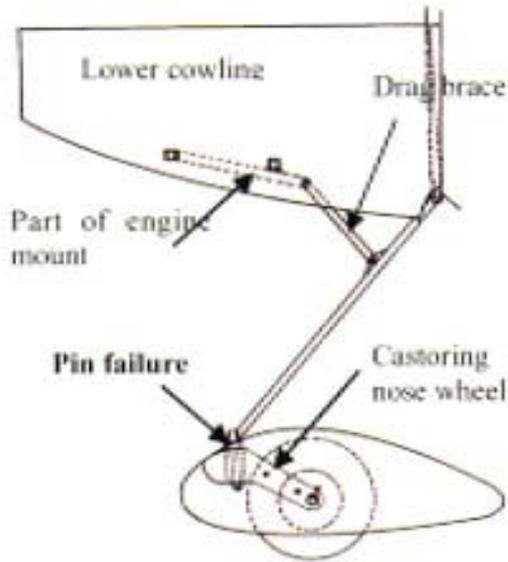
Fig 1. Nose landing gear layout

The nose landing gear strut on this type of aircraft consists of a thick-walled tube, with a castoring nosewheel assembly attached to the lower end. The upper end is welded to a cross tube running beneath the lower edge of the firewall. Lateral bracing is provided by additional tubes welded

between the ends of the cross tube and a point on the strut approximately one third of its length from the top. A drag brace runs from the same point on the strut to the centre member of the engine mount. Some aircraft, including G-BSFA, have a damper incorporated with the strut. The salient features of the nose landing gear are shown in the attached Figure 1.
