**No:** 7/92

**Ref:** EW/C92/3/5

**Aircraft Type and Registration:** Rotorway Executive, G-BMYH  
**No & Type of Engines:** 1 Rotorway RW 152 piston engine  
**Year of Manufacture:** 1986  
**Date & Time (UTC):** 28 March 1992 at 1520 hours  
**Location:** Coalport, Shropshire  
**Type of Flight:** Private  
**Persons on Board:** Crew - 1                      Passengers - Nil  
**Injuries:** Crew - Fatal                      Passengers - N/A  
**Nature of Damage:** Aircraft destroyed  
**Commander's Licence:** PPL (Helicopters)  
**Commander's Age:** 61  
**Commander's Flying Experience:** 3747 hrs, including 447 on helicopters  
(of which 14 were on type)  
**Information Source:** AAIB Field Investigation

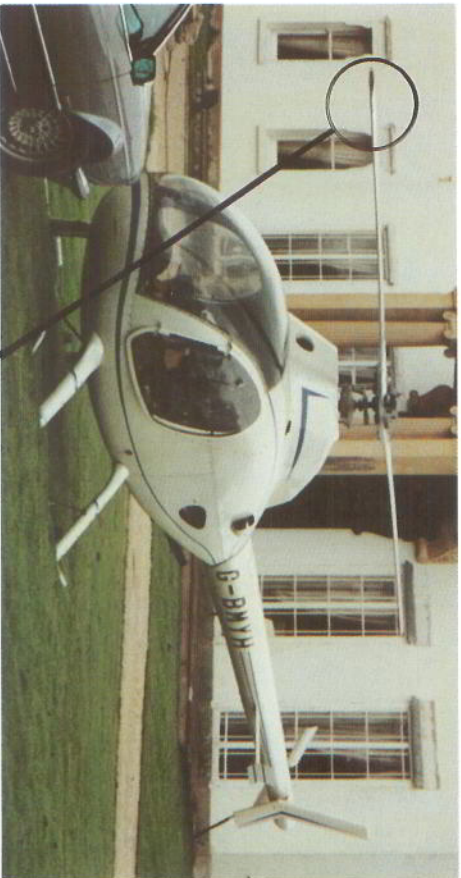
The areas of bonding were also examined and, in the main, exhibited no signs of any significant pre-existing defect. However, examination of the bonded regions between the spars and skins at the tip of the 'slave' blade revealed that disbonding had occurred due to the ingress of water (aqueous disbonding) over a length of approximately 4 inches inboard from the tip on the upper surface, and over a length of 12 inches on the lower surface. An area of disbond was also present up to 4 inches in from the tip on the upper surface of the 'master' blade. The limit of the disbond was equi-spaced between rivets 2 and 3 on the upper surface and centered on rivet 3 on the lower surface (Figures 2 and 3). Another area of aqueous disbonding was present at the trailing edge join between the upper and lower skins between the outermost two rivet locations. This was of particular interest since it was coincident with a region of pre-existing upwards deformation/separation of the skins which was evident at the trailing edge on one of the blades on a photograph (Figure 4) taken of the helicopter shortly before it departed on the accident flight. Figure 5 shows a computer-enhanced enlargement of this area. Examination of the skins of both blades at this point showed nothing of interest on the 'master' blade, but on the 'slave' blade both skins exhibited a nearly identical upward distortion in this area. Additionally, there were a series of spanwise witness marks on the outer surface of the lower skin in the affected area, the appearance of which suggested that they existed prior to the accident. Similar marks, however, were present at other locations along the trailing edge, although not to quite the same extent, and may have been associated with the manufacture of the blade skins.

It therefore appeared likely that the primary reason for the detachment of the bottom skin from the 'slave' blade was because an area of adhesive disbond had developed between the skin and the spar, extending approximately 12 inches inboard from the blade tip. If, as was reported, this helicopter had been exposed to the elements for the whole of the preceding winter period, the effect of ingress of water between the spar and layer of adhesive would have been accelerated by freezing of the contained water film. It was not established whether or not this failure had been influenced by the pre-existing distortion and disbond of the skins which was apparent at the trailing-edge in this region.

Tip section of blade lower surface showing evidence of aqueous disbonding
