INCIDENT

Aircraft Type and Registration:	De Havilland Canada DHC-8 Series 311, G-NVSB
No & Type of Engines:	2 Pratt & Whitney Canada PW123 turboprop engines
Year of Manufacture:	1998
Date & Time (UTC):	9 August 2005 at 0830 hrs
Location:	On departure from Manchester Airport
Type of Flight:	Public Transport (Passenger)
Persons on Board:	Crew - 4 Passengers - 33
Injuries:	Crew - None Passengers - None
Nature of Damage:	Damage to right engine and propeller assembly
Commander's Licence:	Airline Transport Pilot's Licence
Commander's Age:	62 years
Commander's Flying Experience:	15,735 hours (of which 3,634 were on type) Last 90 days - 205 hours Last 28 days - 81 hours
Information Source:	AAIB Field Investigation

Synopsis

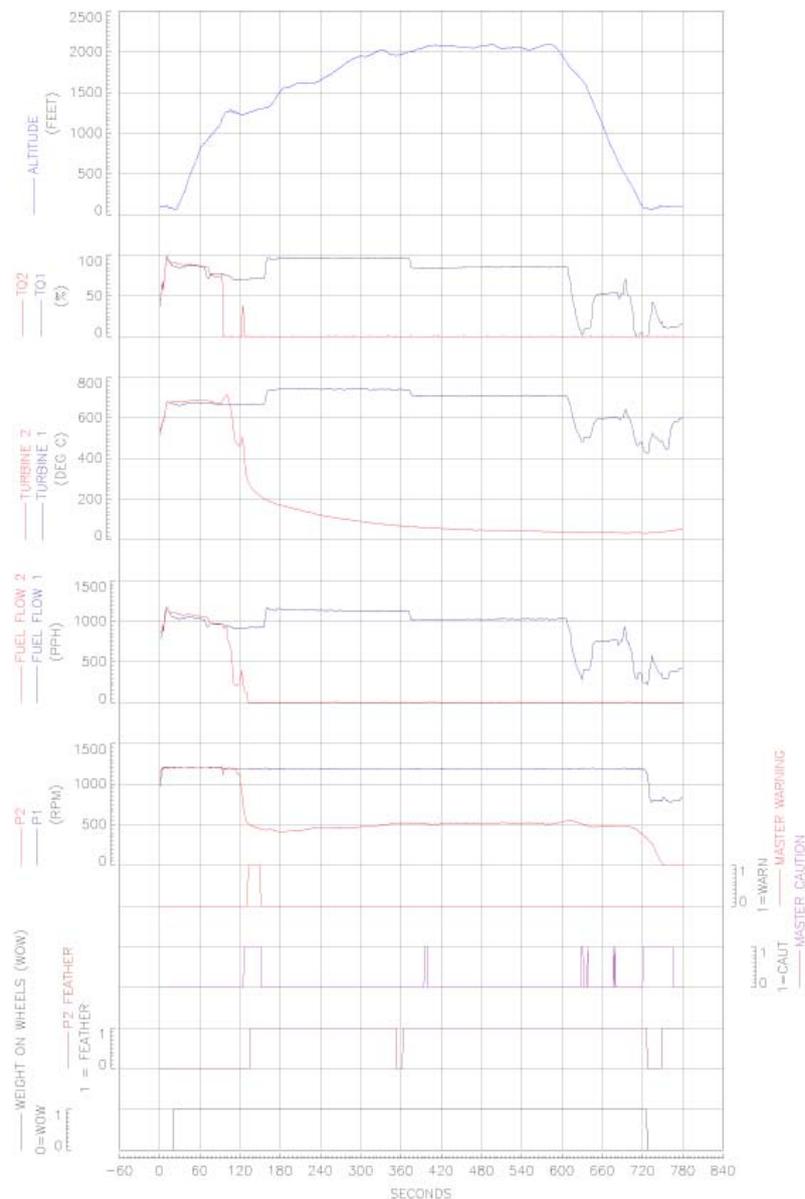
Figure 3
Salient FDR Parameters
(Incident to G-NVSB on 9 August 2005)

Data from the aircraft's flight data recorder covering the incident flight is presented in Figures 3 and 4.
