ACCIDENT

Aircraft Type and Registration:	Cessna 750 Citation X, G-CDCX	
No & Type of Engines:	2 x Rolls-Royce AE 3007C1 turbofan engines	
Year of Manufacture:	2002	
Date & Time (UTC):	9 December 2010 at 1021 hrs	
Location:	Doncaster Airport, South Yorkshire	
Type of Flight:	Private	
Persons on Board:	Crew - 2	Passengers - None
Injuries:	Crew - None	Passengers - N/A
Nature of Damage:	Right mainwheels detached, damage to flaps and outboard wing skin, puncture of right elevator	
Commander's Licence:	Airline Transport Pilot's Licence	
Commander's Age:	34 years	
Commander's Flying Experience:	4,800 hours (of which 600 were on type) Last 90 days - 72 hours Last 28 days - 34 hours	
Information Source:	AAIB Field Investigation

Synopsis

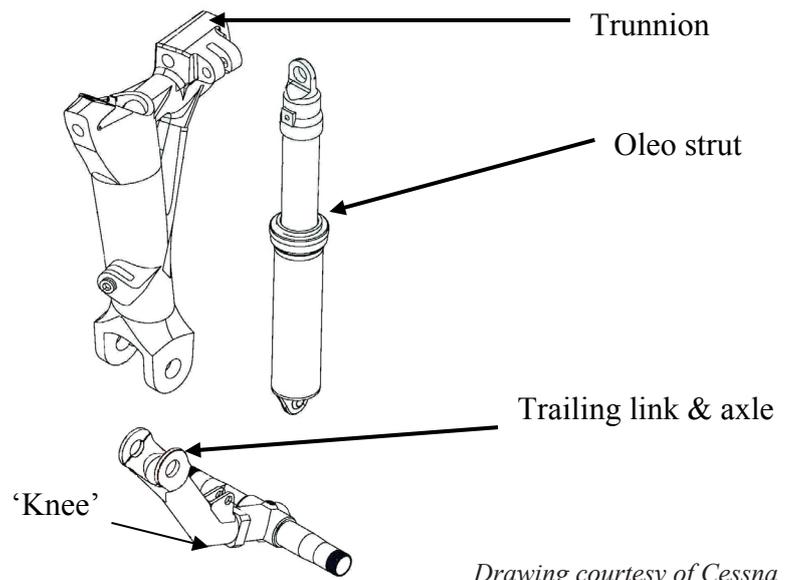
Figure 2
Citation X Main Landing Gear

G-CDCX used a 'trailing link' design (part number 6741013-3) of MLG. The vertical cylinder, incorporating the retraction trunnion, at the top, has the trailing link articulated at the bottom (Figure 2). At the rear of the link, the axle for the double wheels is pressed and bolted into it and a lug roughly in the middle serves as the attachment for the oleo shock absorber strut. The change in angle of the axis of the link at this point is referred throughout this description as 'the knee'.

The wiring harness for the anti-skid transducers runs inside the trailing link and, at the forward end, emerges through a closing end cap and a grommet which is additionally sealed with a flexible sealant to keep moisture out of the interior. The link itself is made from a 300M forging, an ultra-high tensile strength steel which, after machining where necessary, is shot-peened, grit-blasted and cadmium plated. The interior of the link bore is then finished with a corrosion-resistant chromate primer whilst the exterior is primed and finish-painted.
