**AAIB Bulletin No:** 3/95      **Ref:** EW/C94/7/5      **Category:** 1.1

**Aircraft Type and Registration:** Airbus A300-B4, OO-ING

**Date & Time (UTC):** 23 July 1994 at 0115 hrs

**Location:** Stand 23, London Gatwick Airport

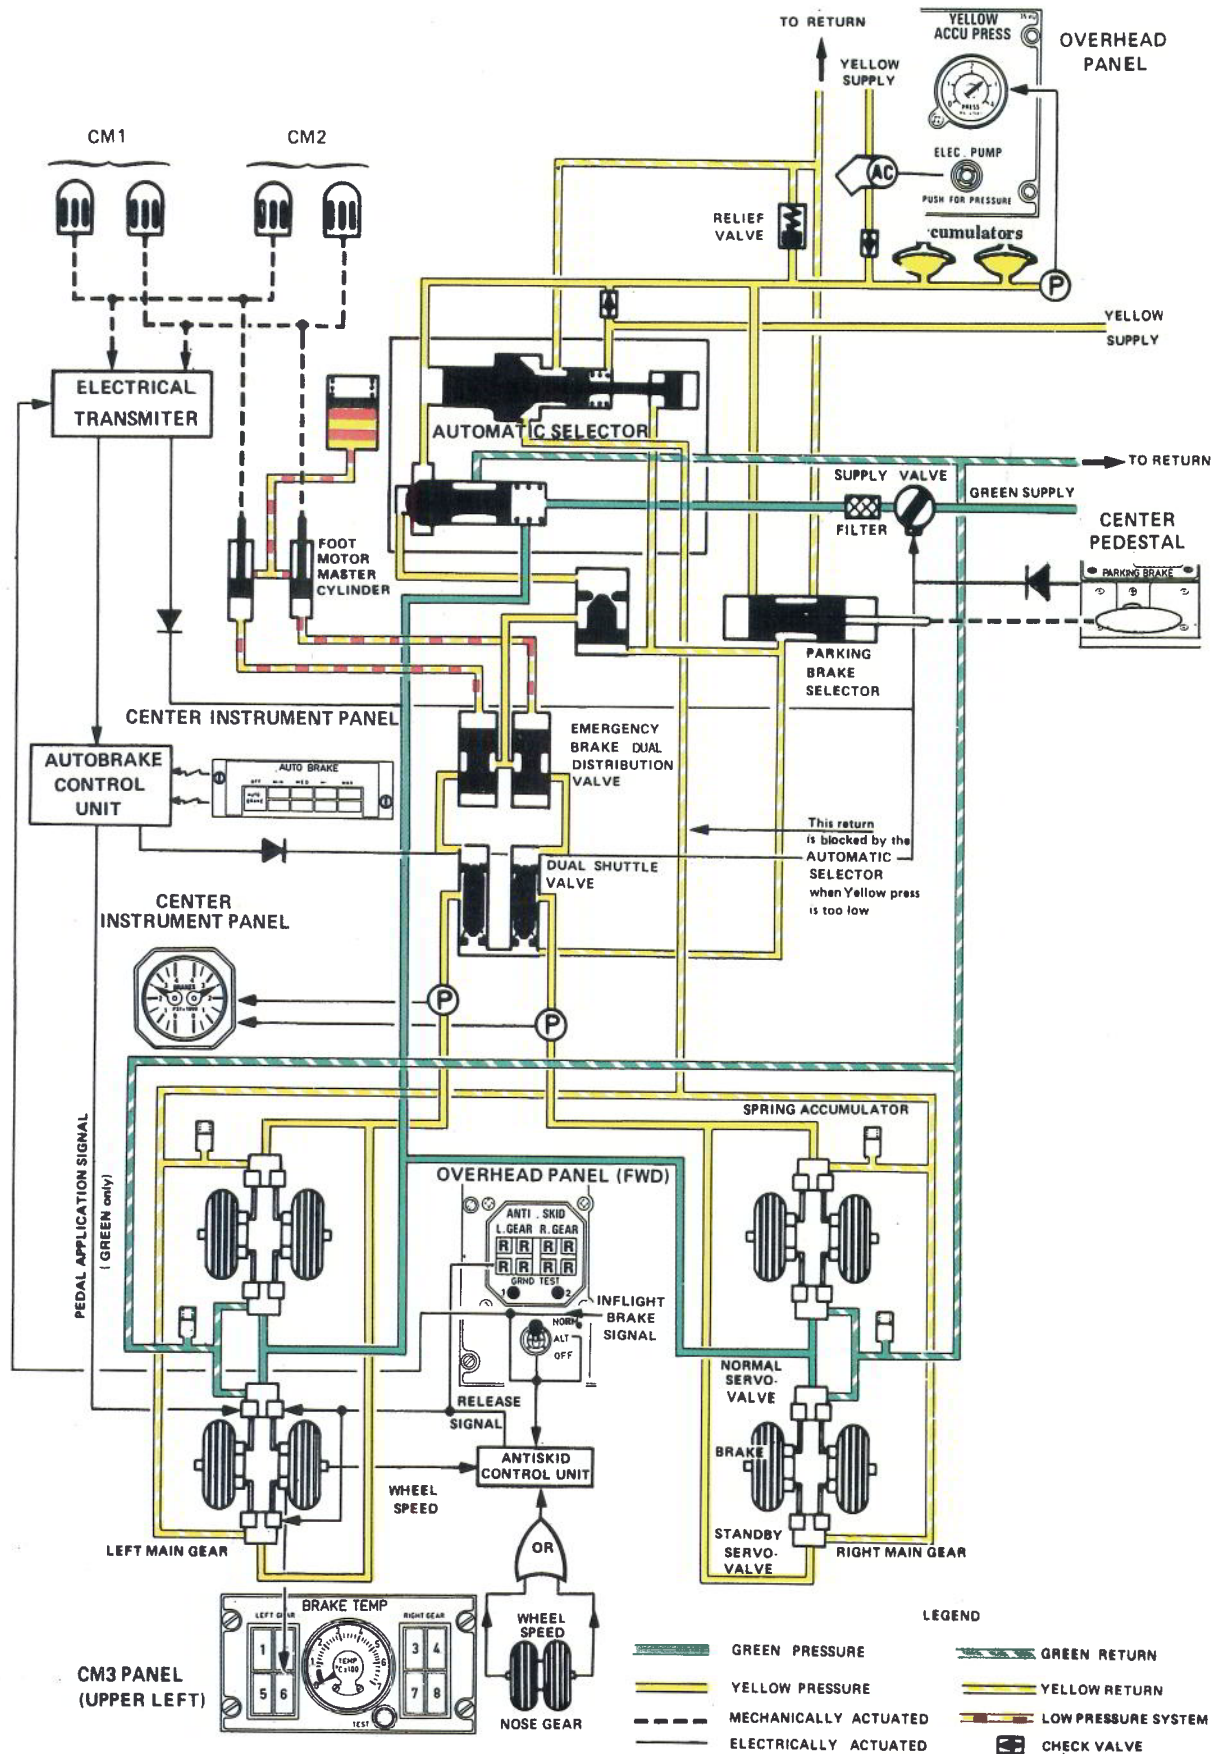
Figure 1

Three other brake system components that were bench tested were found to have minor faults. The Parking Brake Selector, part number 746161-101 had a very small internal leak between the input and return ports when the parking brake was selected ON. This would allow a very slow decay of the parking brake pressure and a very slight increase in the time required to pressurise the Yellow accumulators when using the AC electric pump when the park brake was applied. This fault was due to normal inservice wear within the valve.

The Automatic Selector Valve, part number A25461-103 was found to have an internal leak between Yellow supply and Yellow return when there was no Green input pressure; this would occur when the Green system was OFF, or the brake system was not selected to NORMAL, or the brake pedals were not being applied or the parking brake was ON. The leak only occurred when the Yellow pressure was below 23 bar. This would have increased the time required to pressurise the Yellow accumulators from below 23 bar using the AC electric pump. This unit was fitted to the aircraft as an overhauled item eight days prior to the accident.

The BDDV, part number A25434, was found to have a leak rate between the Yellow pressure input and the Yellow return one third in excess of the maximum allowable. This would allow the Yellow system pressure, when supplied only by the Yellow accumulators to bleed away quicker than normal. This would not occur when the Park Brake was selected ON because of the operation of the Parking Brake Hydraulically Operated Valve (not shown in Figure 1).

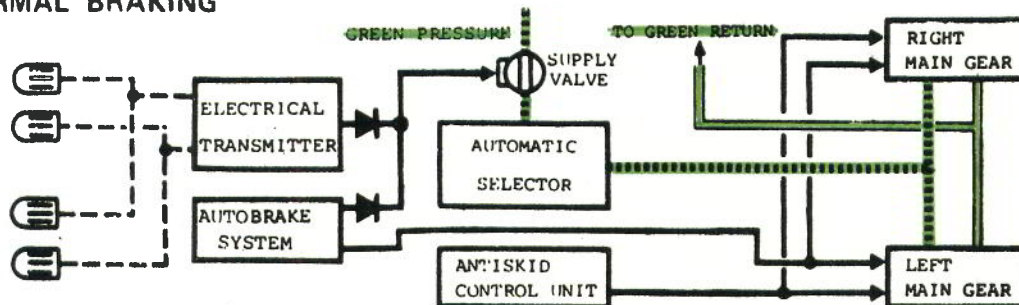
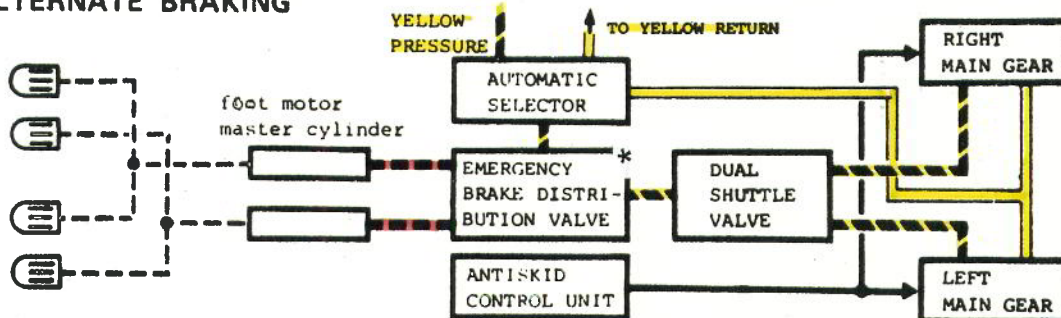
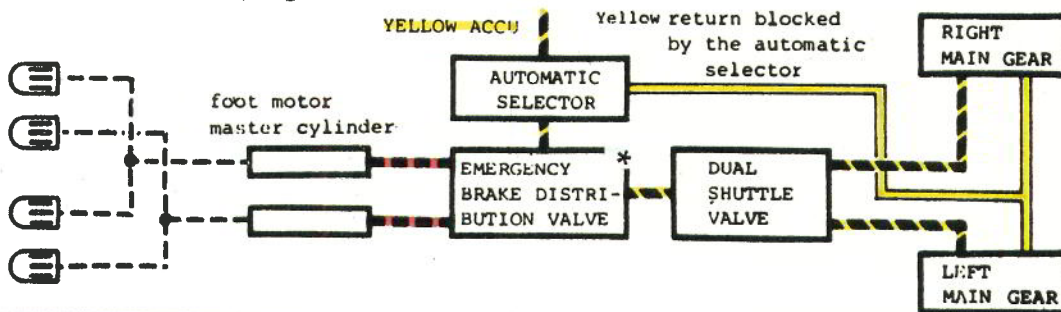
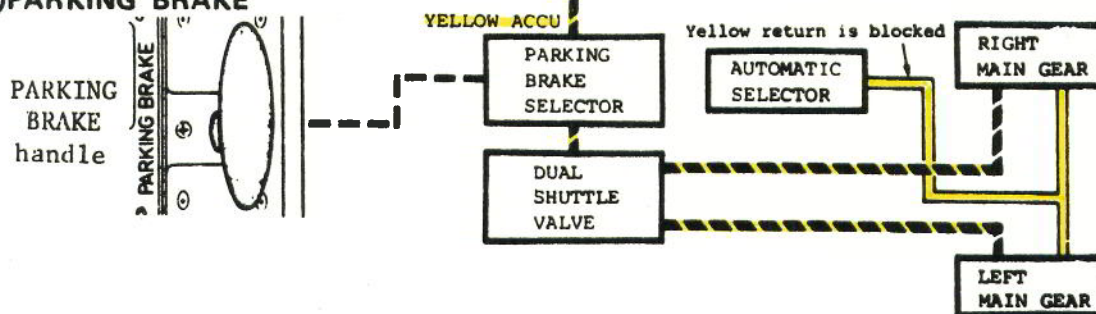
Figure 2

The braking system provides four braking capabilities (Figure 2) using hydraulic pressure delivered by the Green system, the Yellow system or the Yellow accumulator.
