INCIDENT

Aircraft Type and Registration:	Boeing 757-236, G-BIKN	
No & Type of Engines:	2 Rolls-Royce RB211-535C-37 turbofan engines	
Year of Manufacture:	1984	
Date & Time (UTC):	23 January 1993 at about 1130 hrs	
Location:	Near London Heathrow Airport	
Type of Flight:	Public Transport	
Persons on Board:	Crew - 12	Passengers - 86
Injuries:	Crew - None	Passengers - None
Nature of Damage:	None	
Commander's Licence:	Airline Transport Pilot's Licence	
Commander's Age:	45 years	
Commander's Flying Experience:	9,500 hours (of which 2,726 hours were on type) Last 90 days - 77 hours Last 28 days - 26 hours	
Information Source:	AAIB Field Investigation

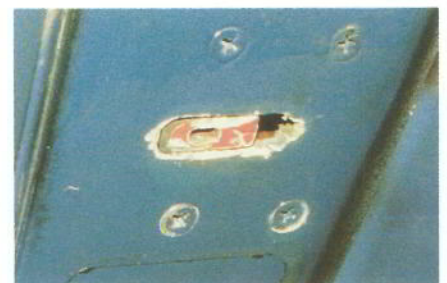
that any stiffness in the indicator mechanism could also influence the sensor/target gap and that wear in the same system could allow the indicator to protrude 'leading edge first' into the slipstream and potentially generate additional movement of the target lever. Such protrusion might also be subject to icing, which could only exacerbate the problem. Modifications are in hand to reduce the effects of wear and stiffness, although these were not considered factors in this incident since the 'C' ducts (complete with reverse thrust mechanism) had been replaced in October 1992 and were known to be in good condition. (It is reported that aircraft which have had this mechanism modified are experiencing a reduced incidence of warnings). However, since that time false REV amber indications have occurred on both engines of G-BIKN, although not on the right engine between 2 December 1992 and the time of the incident. The right engine left lock sensor was replaced in mid November 1992.

Visual Lock Indicator 'drooped' due to wear in mechanism T/R closed and locked

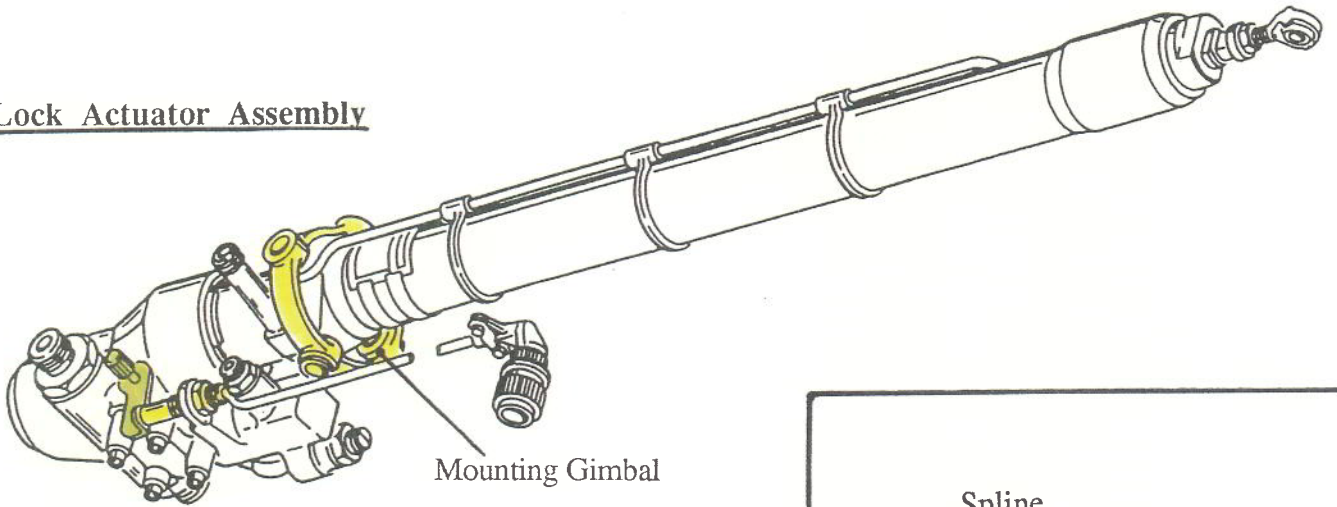
Lock Actuator Assembly

At the AAIB's request, arrangements were made to transport the lock actuator to the aircraft manufacturer's facility in Seattle where, following a meeting attended by representatives of the airline, engine and cowl manufacturers and the AAIB to discuss various aspects of the thrust reverser and warning system, it was examined in detail. After a partial strip examination, which revealed the unit to be in good mechanical condition, the unit was reassembled and sent to its manufacturer for a full 'production acceptance test'. This demonstrated that the unit was serviceable, in good condition and with all internal leakage rates within limits. The external leak rate from the ram seal was outside limits but had no effect on the operation of the actuator. It was, however, established that the gap between the proximity sensor and its target, with the internal lock fully engaged, was inconsistent (an observation made by maintenance personnel generally) and could be set anywhere between a zero gap and .028 inches, due to clearances within the actuator between the lock lever and non-rotating serrated lock disc, ref. Figure 4. A light torsion spring is installed to bias the lock lever with the intention of removing the effects of backlash, the allowable limits of which are given as 0.050 inches. The gap rigging limits specified in the maintenance manual are $0.010 \pm .003$ inches.

*
Required sensor/target gap
when closed and locked:-

$$0.010'' \pm .003''$$

Gap measured on actuator:-
Max= 0.028'' Min 0.000''

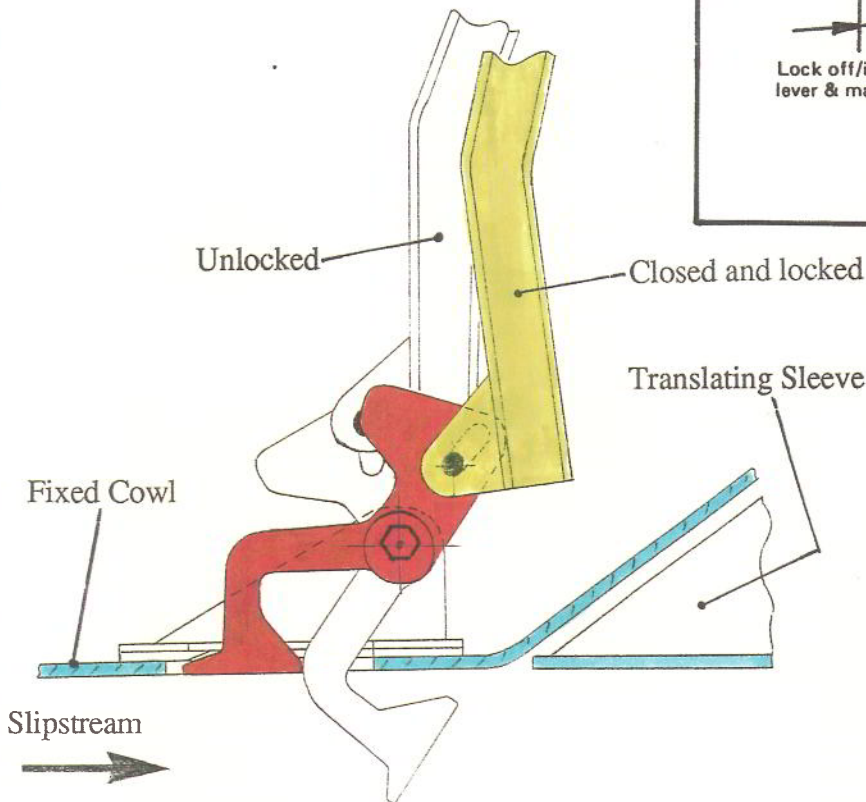
Sectional View of Actuator Head

Actual Indicator shown in
unlocked position
