**INCIDENT**

<b>Aircraft Type and Registration:</b>	Airbus A330-323X, N270AY
<b>No &amp; Type of Engines:</b>	2 Pratt & Whitney PW4000 SER turbofan engines
<b>Year of Manufacture:</b>	2000
<b>Date &amp; Time (UTC):</b>	29 May 2008 at 1025 hrs
<b>Location:</b>	Manchester Airport
<b>Type of Flight:</b>	Commercial Air Transport (Passenger)
<b>Persons on Board:</b>	Crew - 12                      Passengers - 250
<b>Injuries:</b>	Crew - None                      Passengers - None
<b>Nature of Damage:</b>	Damage to main landing gear and brake pack; debris recovered from runway
<b>Commander's Licence:</b>	Airline Transport Pilot's Licence
<b>Commander's Age:</b>	60 years
<b>Commander's Flying Experience:</b>	14,650 hours (of which 2,390 were on type) Last 90 days - 58 hours Last 28 days - 26 hours
<b>Information Source:</b>	AAIB Field Investigation

**Synopsis**

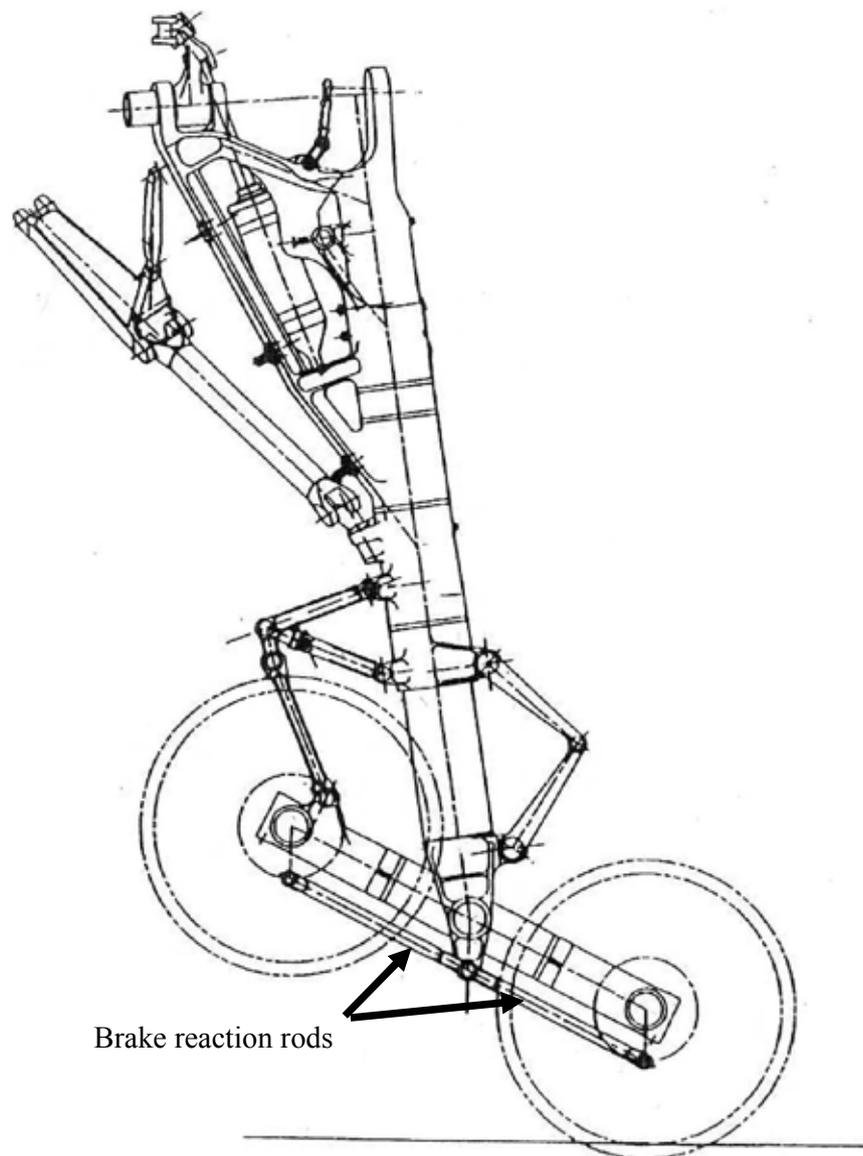
**Figure 1**

During brake operation, hydraulic pressure causes the pistons within the housing to apply axial pressure to the rotors and stators between thrust plates at either end of the heat pack. This results in a torque on the brake unit that is reacted by a steel rod attached, by means of a pin, to the brake housing at one end and a lug in the centre of the bogie beam at the other. The arrangement of these components can be seen in the diagram at Figure 1 and in the photographs of the aircraft at Figure 2, taken shortly after the incident.

Main landing gear shown in 'flying attitude'

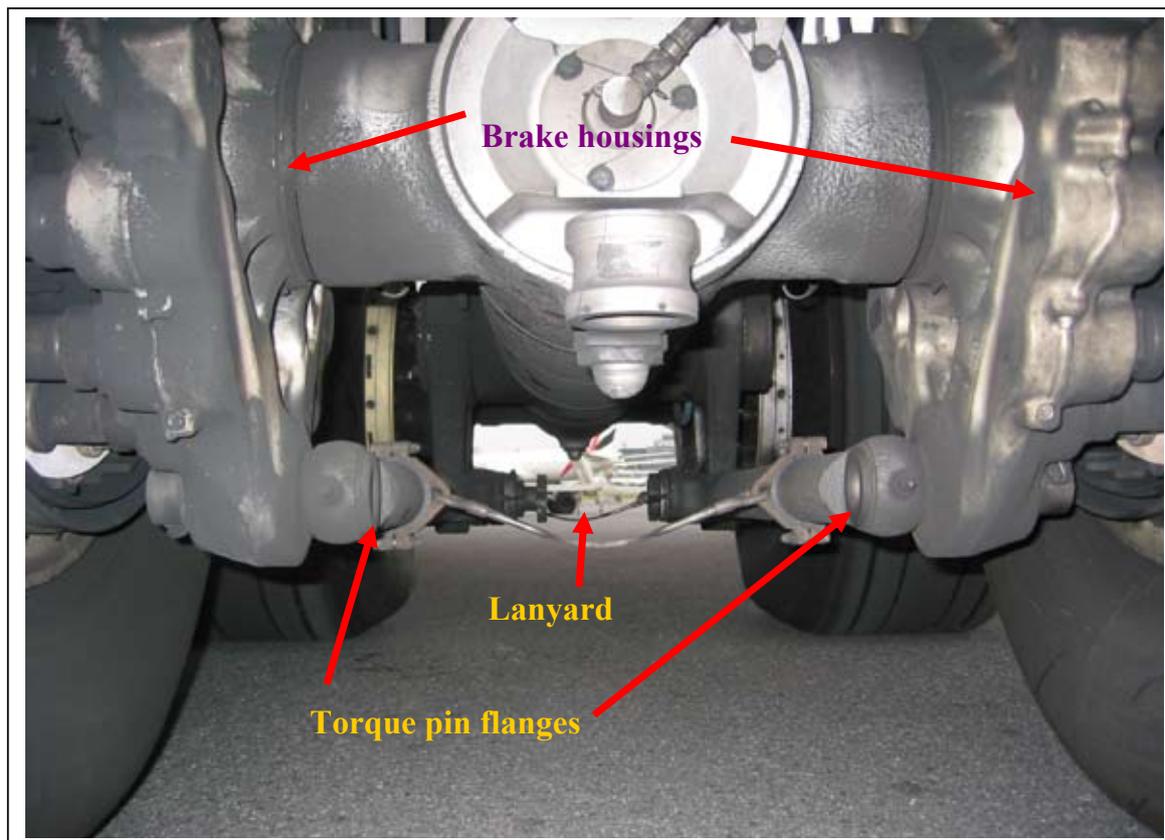
**Figure 3**

Figure 3 shows a photograph of the unaffected right landing gear of N270AY, showing the layout of the components described above.

View looking forward on intact right landing gear, showing layout of components
